MEADOWBANK DIVISION

## **Monitoring Program Summary Report**

**June 2015**

Type A Water License 2AM-MEA0815

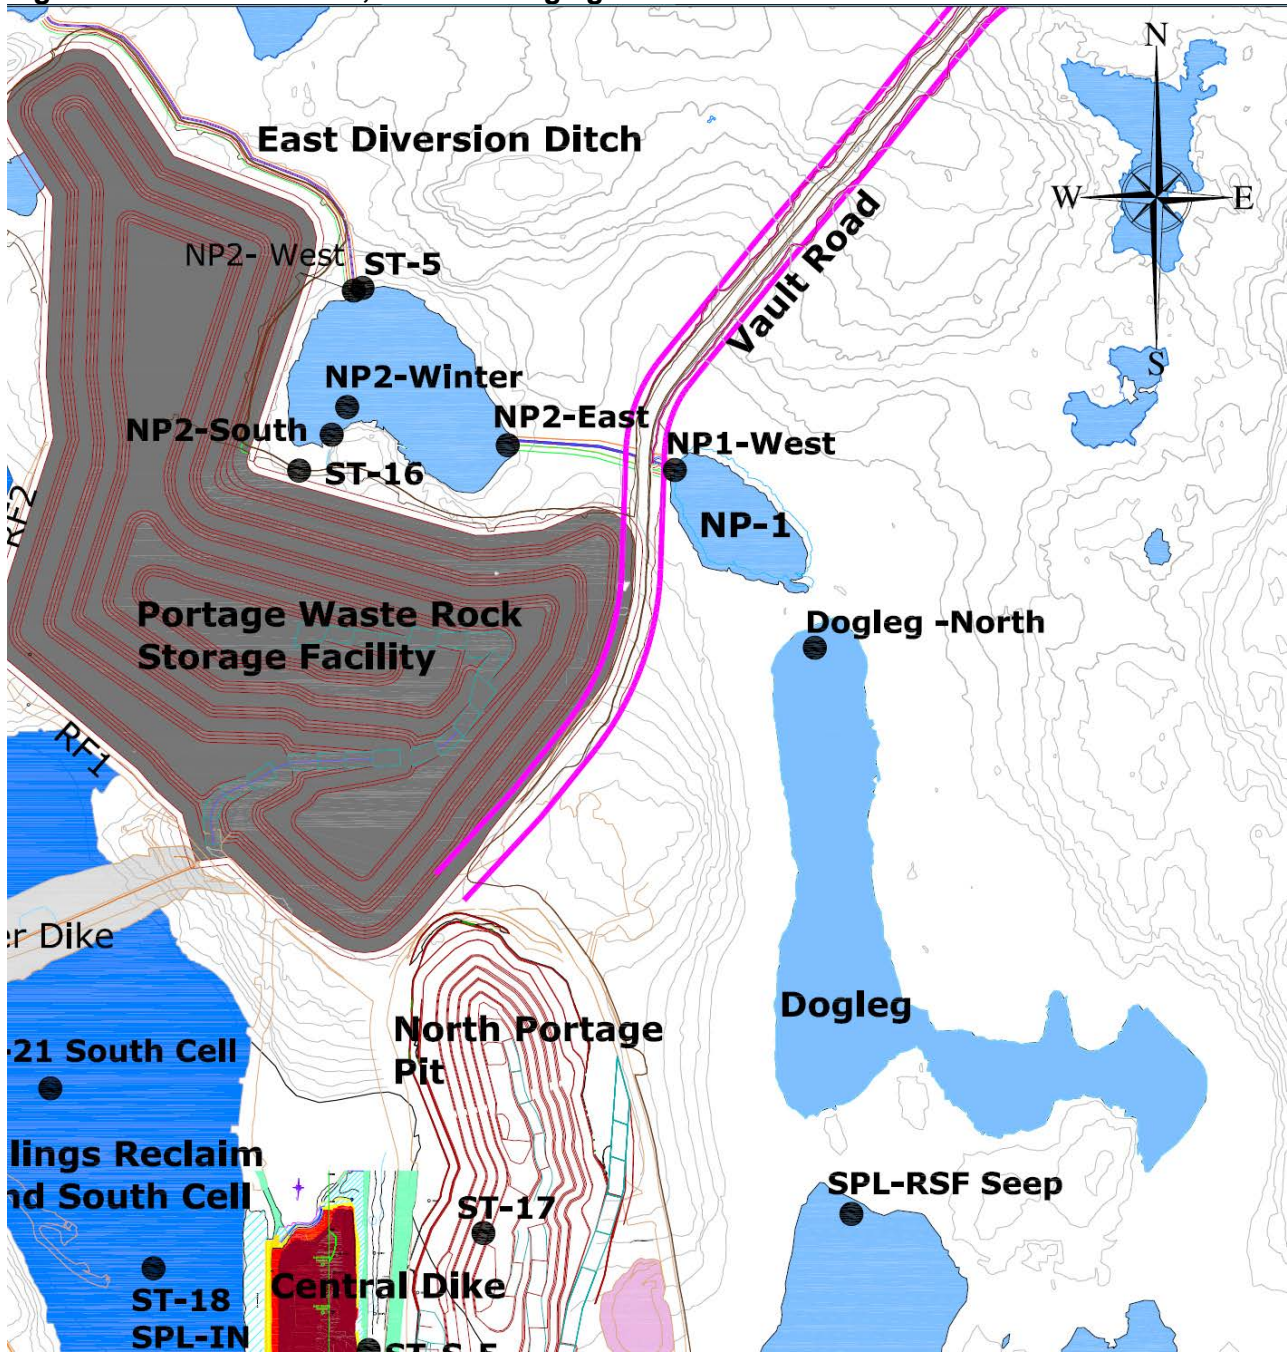
Figure 1: Location of NP2, NP1 and Dogleg Pond

On June 7<sup>th</sup>, 2015, while conducting regular inspections as per the Freshet Action Plan, AEM staff observed elevated TSS in the water running under Vault Road (culvert) toward Lake NP-1. At this time it was observed that there was a very small flow coming from Lake NP-2 toward the Vault Road culvert leading to NP-1. The flow exiting and around the culvert and leading to NP-1 was much greater. This indicated that the flow was largely localized due to a large accumulation of snow in this area, significant snowmelt occurring due to spring freshet and recent heavy rain. NP-1 is a shallow pond - ~ 3.8 m at deepest and was noted as being non-fish bearing in the EIS for the Meadowbank Project. On June 8<sup>th</sup> after some additional melting of ice and snow it was clear that water with elevated TSS was flowing past a turbidity barrier that was in place from last year, onto the lake ice. The excess water and TSS was confirmed to be coming from snowmelt and rain in the area transporting fine material from the road through the course rock of the road and discharging on the NP-1 (east) side of the road and culvert (see Photo 1 and map below). There is a deposition of very fine mud material (from the road) along the shoreline. Evidently, meltwater is transporting this onto the lake ice. As stated, a turbidity barrier was in place and another one has been deployed as a secondary measure (see Photo 2 below). As a precautionary measure, an additional barrier will be placed at the outlet of NP-1 as there is a flow (across tundra) toward Dogleg Lake. Samples will be taken of the NP-1 pond water and submitted to our offsite accredited laboratory.

As stated previously a turbidity barrier (orange barrier # 1) was left in place from last year at the inlet of NP-1. A second turbidity barrier (yellow barrier #2) was installed just outside of the first barrier in the early morning of June 8<sup>th</sup> (see Photo 2). Two additional barriers were also installed as a precautionary measure at the outlet of NP-1 (barrier #3) and at the inlet of Dogleg Lake (barrier #4) (see Photos 3 and 4). These were installed on June 9<sup>th</sup> and 10<sup>th</sup> respectively. Cloudy water was not observed at Dogleg Lake. Following the installation of the barriers, samples were taken on June 10<sup>th</sup> at NP1-Culvert, NP1-West (outside barrier #2), NP1-South and Dogleg (outside barrier #4) (Figure 1 below) and sent to our accredited laboratory for TSS analysis (Table 1). AEM also took a weekly sample at NP1-West and NP1-South. These were analysed at the Meadowbank onsite assay lab (unaccredited) and used as indicator samples. All results show levels of TSS at or below our regulatory discharge (NWB, MMER) limit of 30 mg/l. On June 22<sup>nd</sup>, AEM took another set of samples which were analysed at our accredited laboratory, Multilab. The results are located in Table 1 below. As of June 22<sup>nd</sup>, the water coming from NP-1 (Lake NP-2) culvert into NP-1 Lake was visually clear (Photo 5). AEM will continue to monitor and sample locations in NP-1 and Dogleg as per the regular Freshet Action Plan Monitoring (see Schedule 1 below which is the ST-16 RSF Seepage monitoring program). Currently the watercourses referenced in this report are visually clear thus no additional TSS sampling is necessary. It should be noted that the incident was for a short duration and that Lake NP-1 is not a fish bearing lake (FEIS).

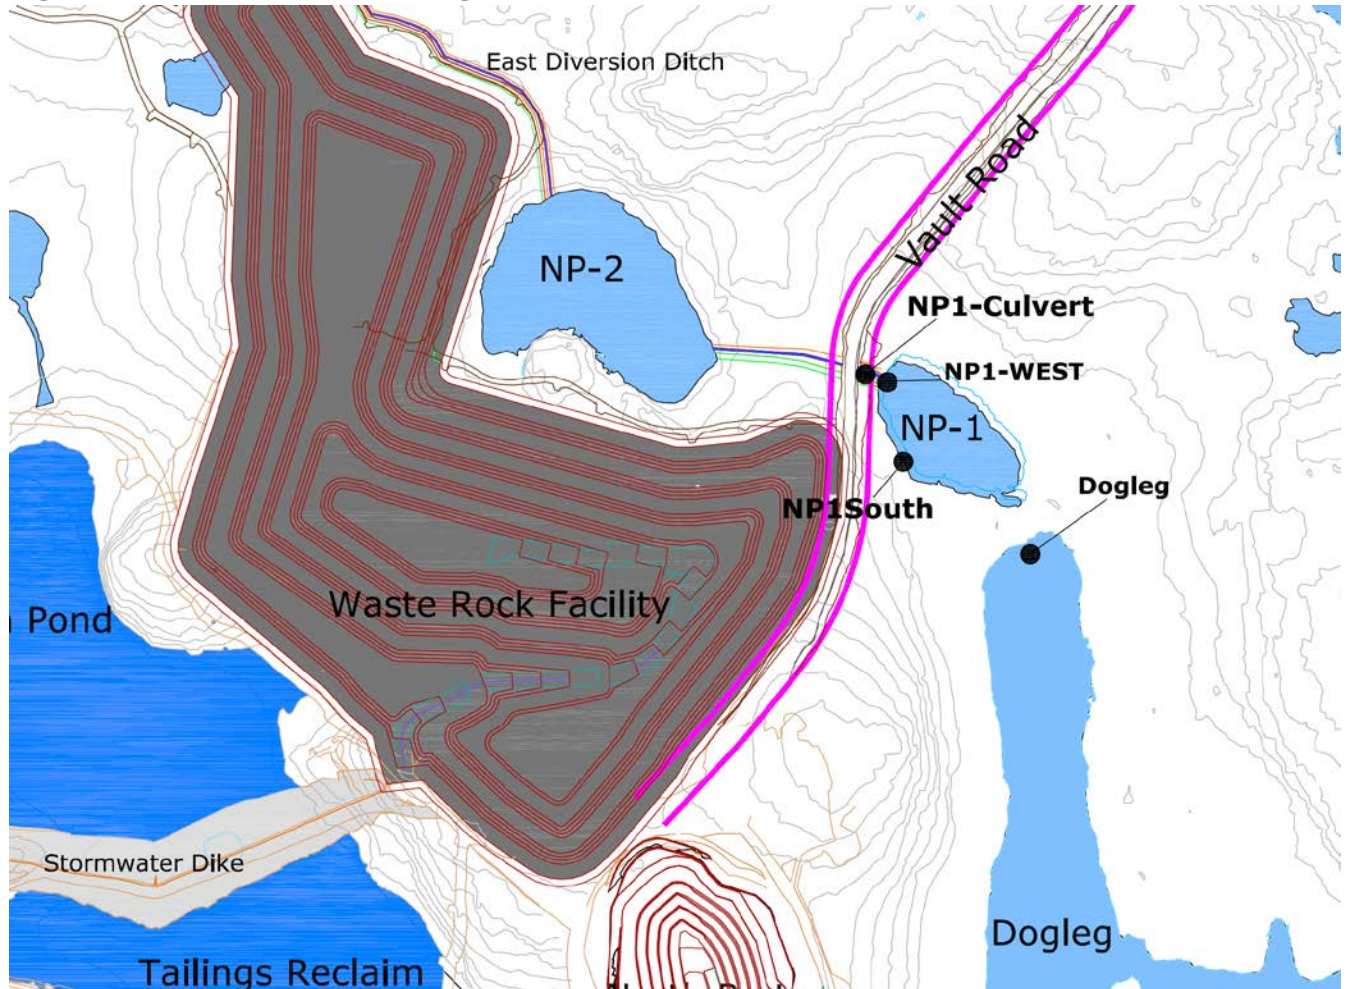
Figure 1: NP-1 station monitoring

On June 7<sup>th</sup>, 2015, while conducting regular inspections as per the Freshet Action Plan, AEM staff observed elevated TSS in the water running under Vault Road (culvert) toward Lake NP-1. On June 8<sup>th</sup> after some additional melting of ice and snow it was clear that water with elevated TSS was flowing past a turbidity and silt barrier that was in place from last year, onto the lake ice. The excess water and TSS was confirmed to be coming from snowmelt and rain in the area which transported fine material from the road through the coarse rock of the road discharging on the NP-1 (east) side of the road and culvert. On June 9<sup>th</sup>, 2015 AEM notified regulators, namely KIA, AANDC and DFO, of the incident. Following this notification, KIA conducted an onsite inspection of the area on June 11<sup>th</sup>. The KIA inspection report, which was received on June 15<sup>th</sup>, requested AEM to provide a full report of the situation.
