# Nunavut Impact Review Board 2019

## Site Visit Report

### *Meliadine Gold Mine Project*

(NIRB File No. 11MN034)

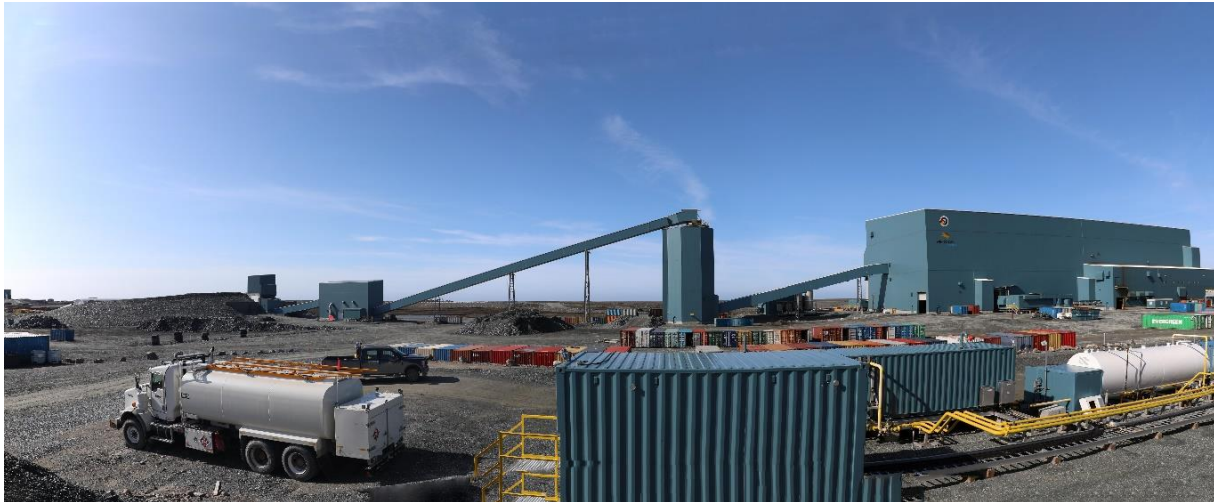
**Photo 1: Overview of Meliadine Mine Site**

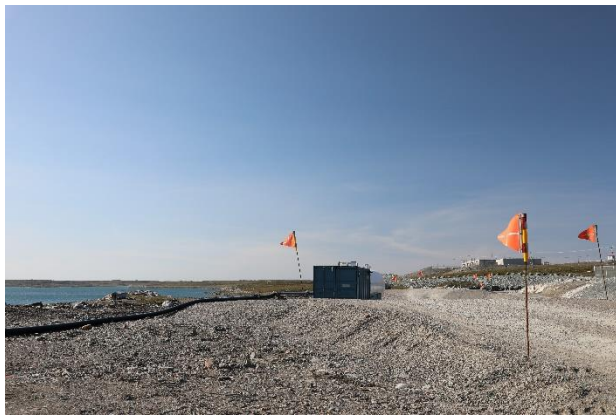
- c) It was observed that the signage on the seacan wall was updated and clearly noted to the community the public dock access and the Agnico Eagle barge area (see [Photo 5](#)).
- d) The Saline Water Discharge tank was installed at the Itivia site and appeared to be in working condition (see [Photo 6](#)).
- e) The snowmobile crossing within Agnico Eagle's Itivia area was also inspected and appeared to be in good repair.
- f) Overall the area appeared to be maintained in good order; however, debris was observed around the Itivia site.

**Photo 6: Saline Water Discharge tank**

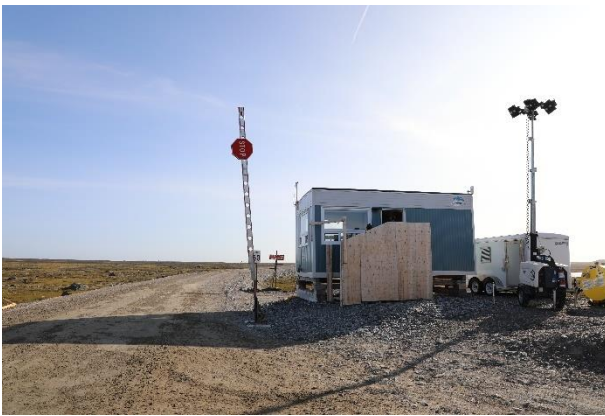
**Photo 10. Gatehouse closest to the community of Rankin.**

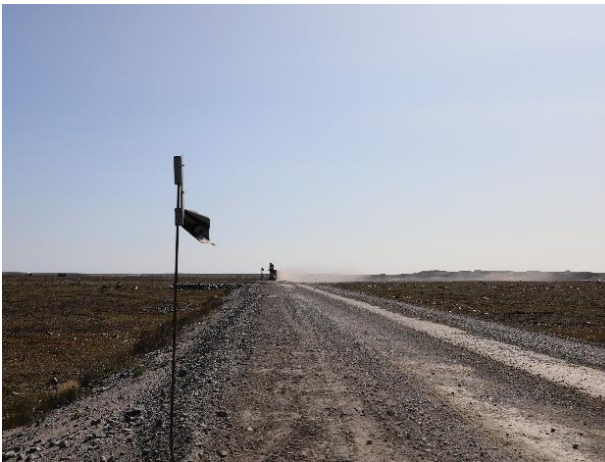
- a) While travelling along the AWAR towards Meliadine, it was observed that the road was extensively used by Rankin Inlet community members (see [Photo 11](#)) along with mine traffic travelling to and from the Itivia area (see [Photo 12](#)).
- b) The NIRB staff requested an update on the plan to build a dedicated ATV/snowmobile connection trail during the site visit and Agnico Eagle staff commented that this trail may not be constructed but discussions are ongoing with the Hunters and Trappers Organization.
- c) The NIRB staff noted that the environmental emergency seacans were located at or near all bridge crossings (see [Photo 13](#) and [Photo 14](#))

**Photo 12: Haul truck along the AWAR**

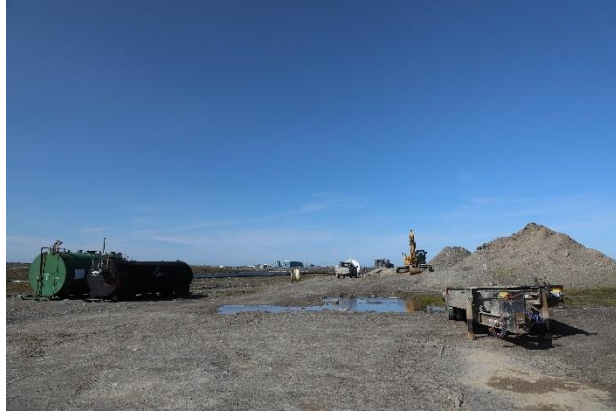
- f) The site visit also included the exploration/temporary fuel tank storage farm and temporary landfarm as following the 2017 site visit, Agnico Eagle noted that both locations would be decommissioned in the summer of 2018. During the current site visit, decommissioning work on the temporary fuel tank farm and temporary landfarm had not started and Agnico Eagle staff stated that remediation of the site had not commenced (see [Photo 27](#)).

**Photo 28: Temporary landfarm**

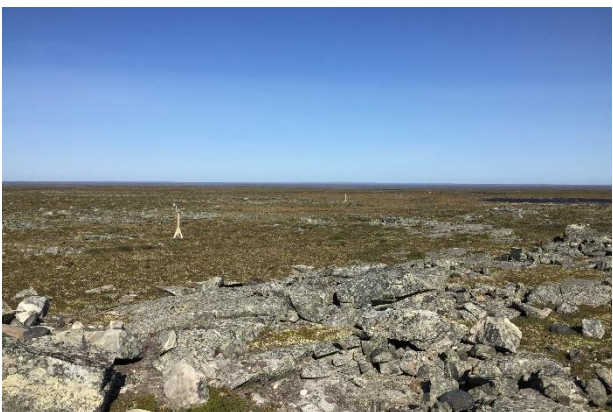
Agnico Eagle staff noted that it continues to apply TETRA flakes (calcium chloride) along the AWAR and that dust monitoring continues to be conducted along multiple stations along the AWAR (see [Photo 35](#)). In response to questioning by NIRB staff, Agnico Eagle noted that the trial using new dust suppressants on a portion of the AWAR in 2018 were not effective and the plan is to continue to use calcium chloride as a dust suppressant.

Photo 35: Dust Sampling Station along the AWAR
