# Meliadine Gold Mine Project

Agnico Eagle Mines Limited

NIRB File No. 11MN034

**Report Title:** The Nunavut Impact Review Board's 2021 Site Update Report for Agnico Eagle Mines Limited's *Meliadine Gold Mine Project* (NIRB File No. 11MN034)

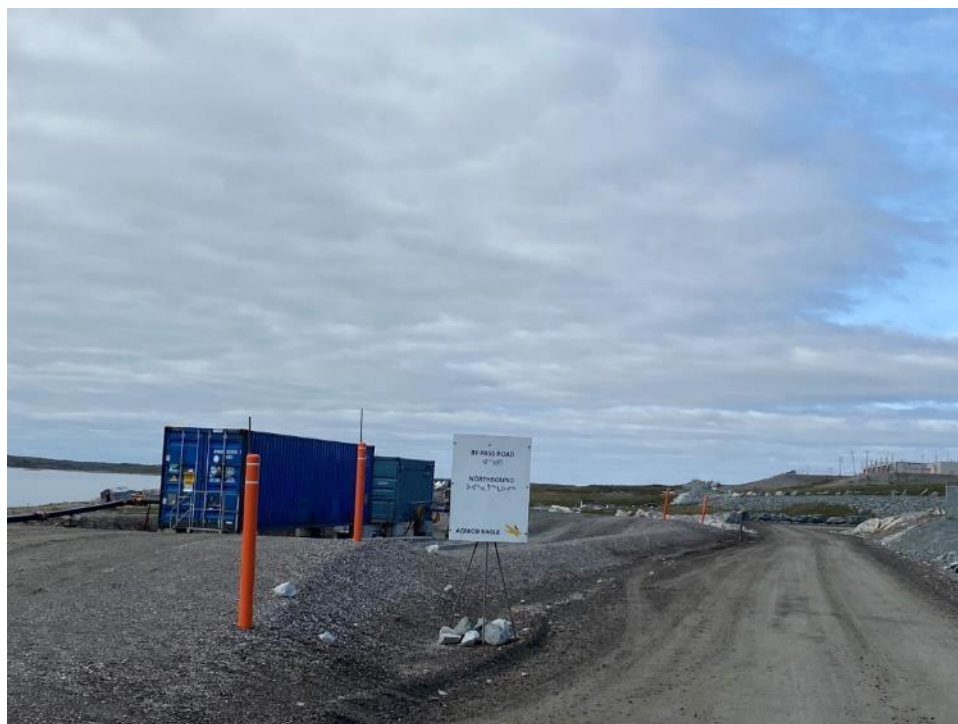
**Photo 3: Saline Effluent Discharge Seacans**

| T&C No. | Category | Observation |
|---|---|---|
| 25 | Groundwater Quantity and Quality | Photo 3 and Photo 4 show the saline effluent discharge facility and filtration station at Itivia Harbour.<br><a href="#">Photo 34</a> and <a href="#">Photo 35</a> depict the saline ponds for on-site saline water storage. |

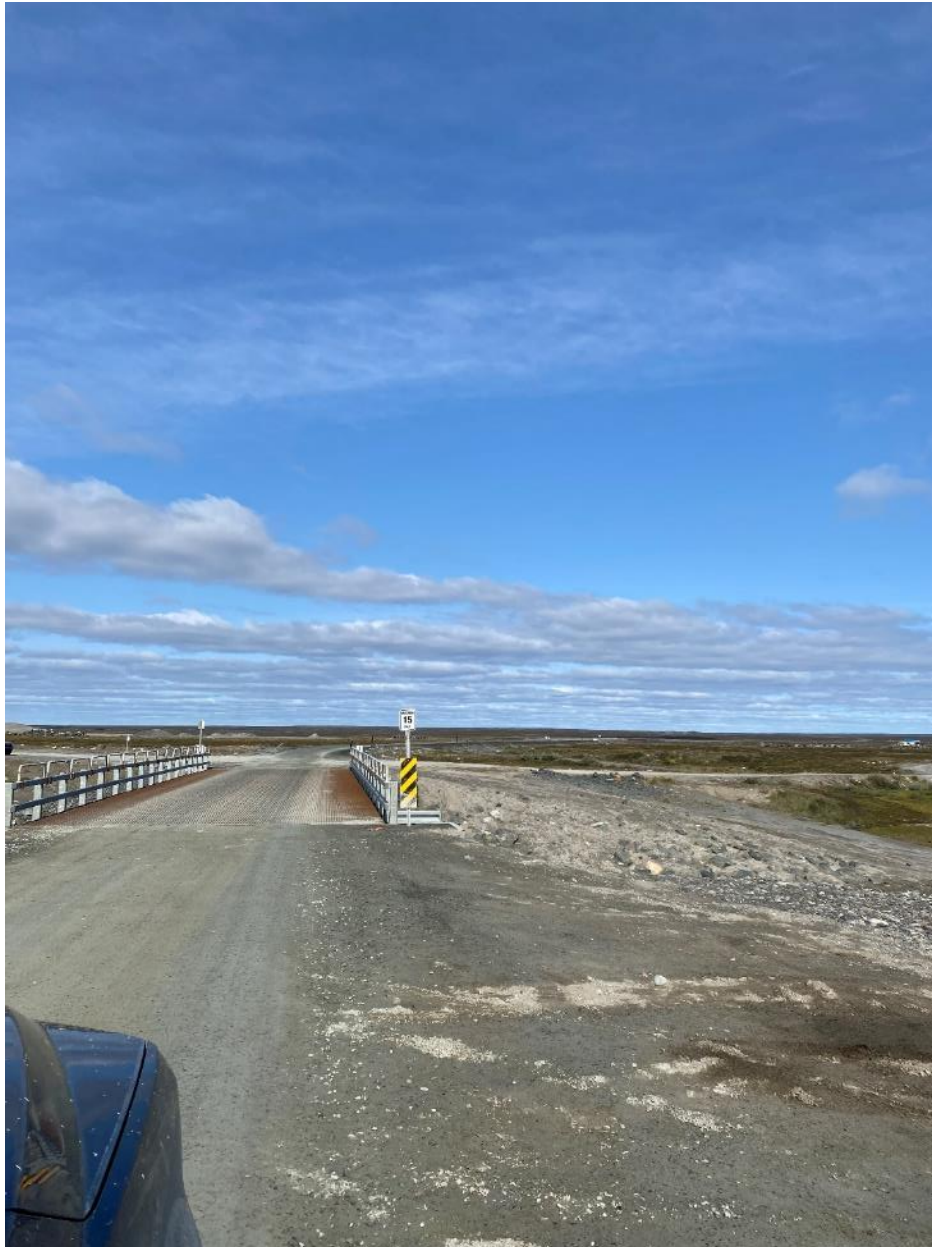
Photo 11: Char River Bridge

- Maintenance was performed on the bridges in August 2021.
- Bridges are inspected regularly.

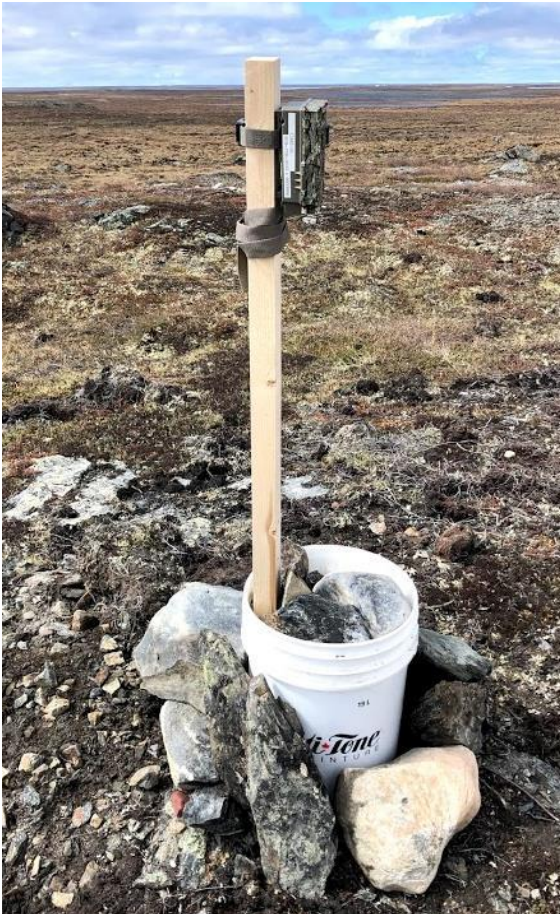
Photo 17: AWAR Camera

- Trail cameras were temporarily installed near the end of June 2021 to monitor the caribou migration and they were removed mid-July 2021, similar to instillation in 2020.

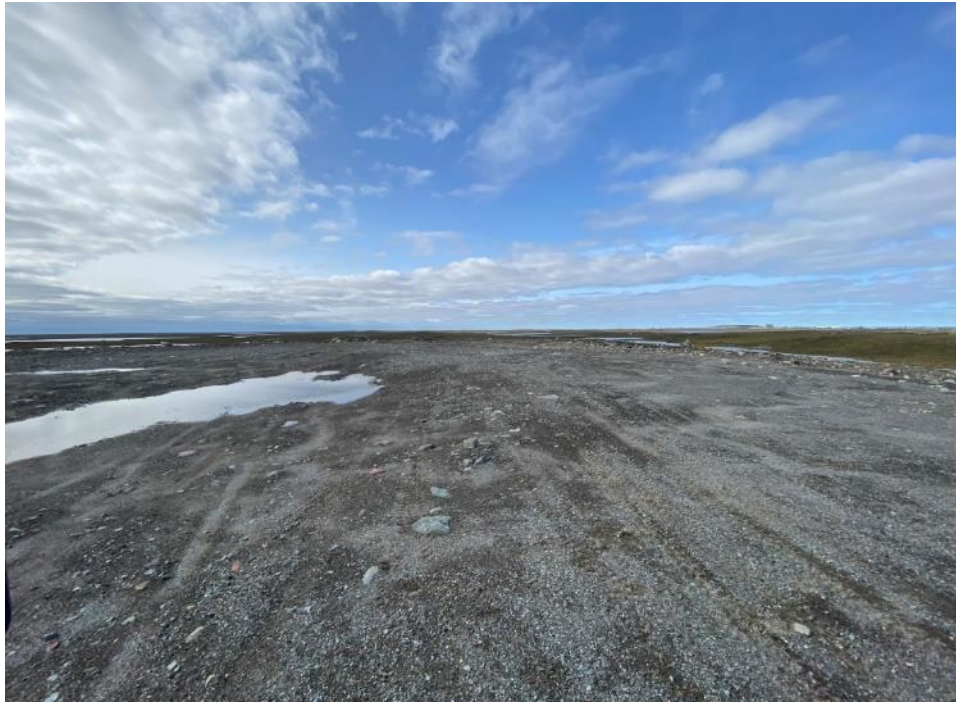
**Photo 29: Reclaimed Quarry B7-1**

- Agnico Eagle noted that reclamation of quarries and eskers was completed in 2019 (Photo 29 and Photo 30).

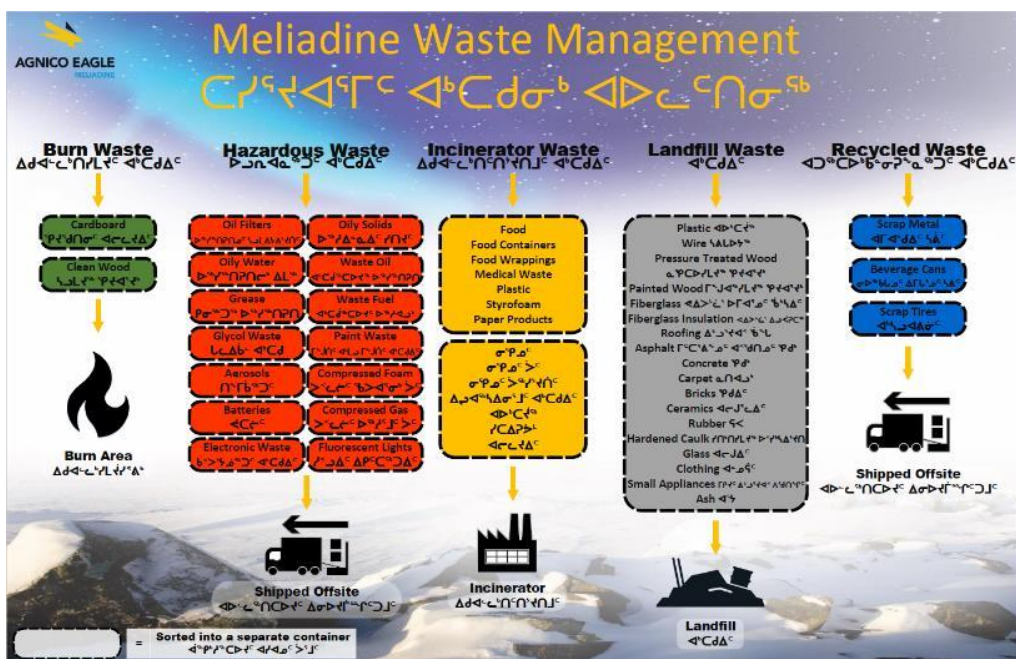
**Photo 46: Example Waste Segregation Information Poster**

- A site wide relaunch of waste segregation was completed in April 2021 with new signs and standardized bin labels and posters (Photo 46, Photo 47, Photo 48, and Photo 49).
- In 2020, a protocol was implemented to inspect seacans and individual items before they are moved from the users work location. This protocol is still in place in 2021 (Photo 50).

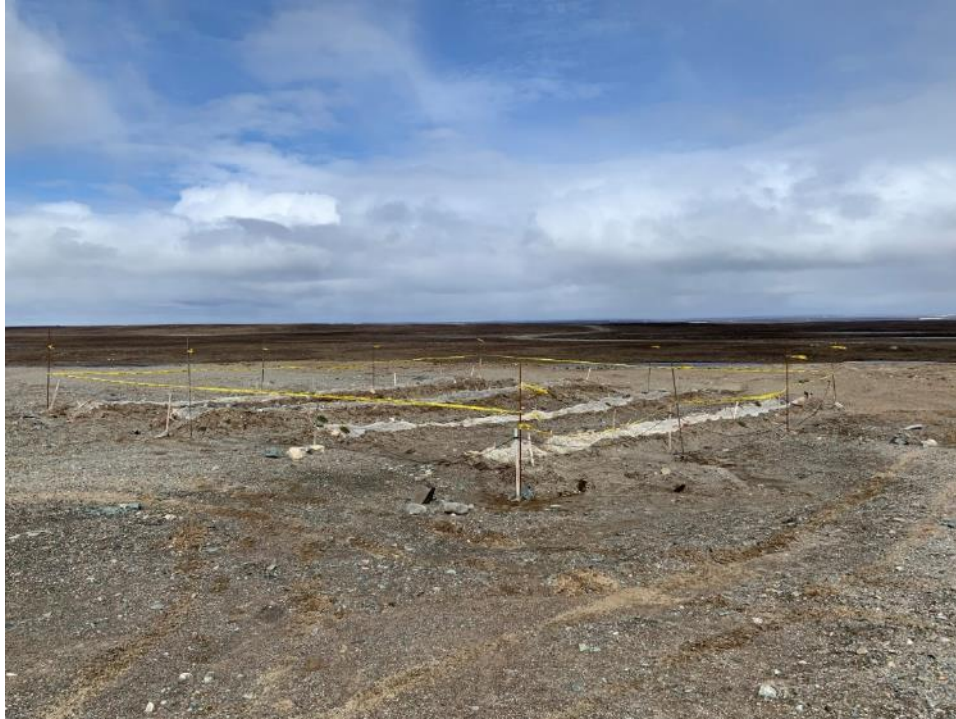
**Photo 51: Revegetation Plot**

| T&C No. | Category | Observation |
|---|---|---|
| 41 | Reclamation and re-vegetation | <a href="#">Photo 51</a> shows the revegetation plot. |

- University of Saskatchewan was able to come on-site mid June 2021 to monitor the plots and perform work (Photo 51).

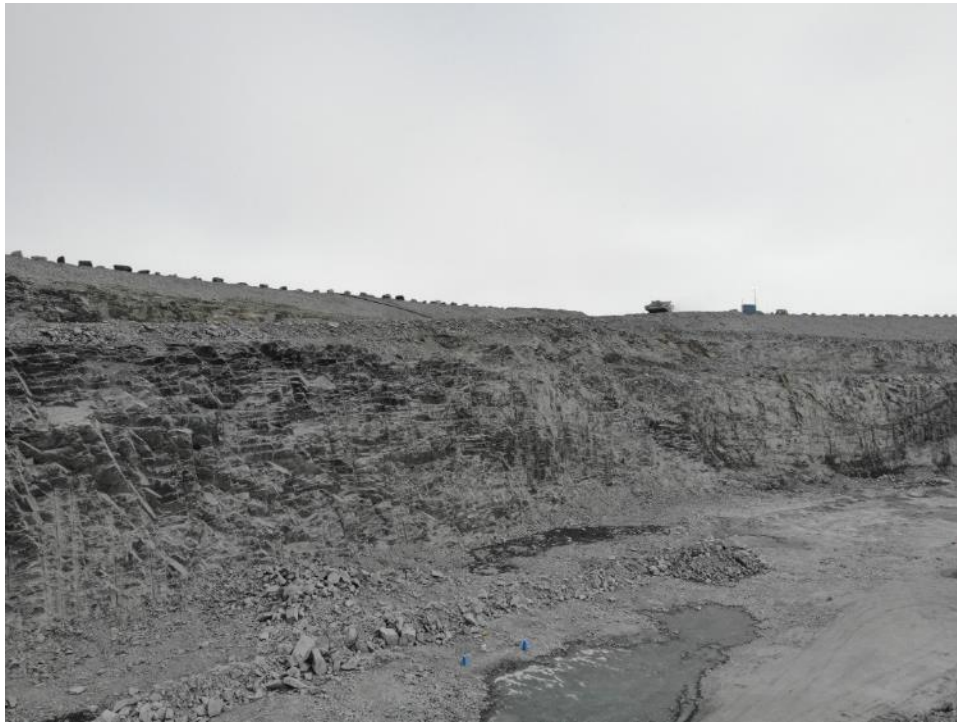
**Photo 53: Bird Deterrent**

| T&C No. | Category | Observation |
|---|---|---|
| 61 & 74 | Bird Deterrents | <a href="#">Photo 53</a> provides evidence of a bird deterrents. |

- A waterline crossing was installed on-site in June 2021 (Photo 52). There are no wildlife crossings on the AWAR, as the embankment gradient is gradual enough not to impede crossing.
- Snowy owls, reflector tourniquets, balloons, coyotes, kites, and propane cannons were used in the 2021 breeding season in several locations to prevent birds from nesting in critical locations to the operations (Photo 53).

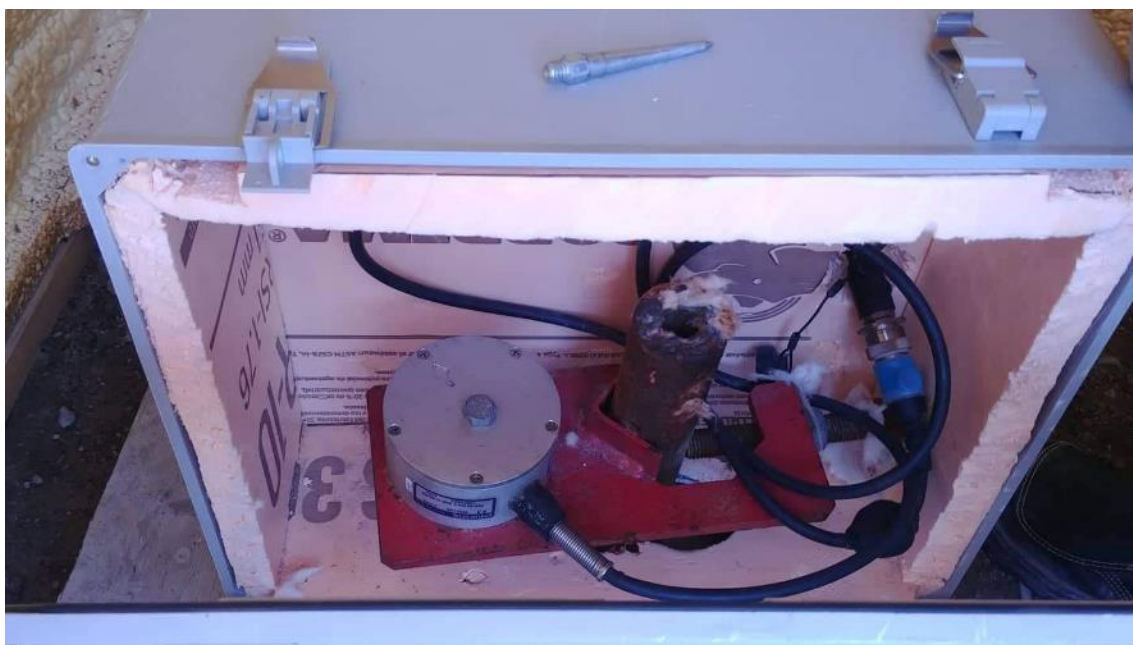
**Photo 54: Blast Monitoring Equipment**

| T&C No. | Category | Observation |
|---|---|---|
| 10 & 11 | Noise and Vibration Abatement Plan | Photo 54 and Photo 55 show the equipment used for blast monitoring and noise monitoring, respectively. |

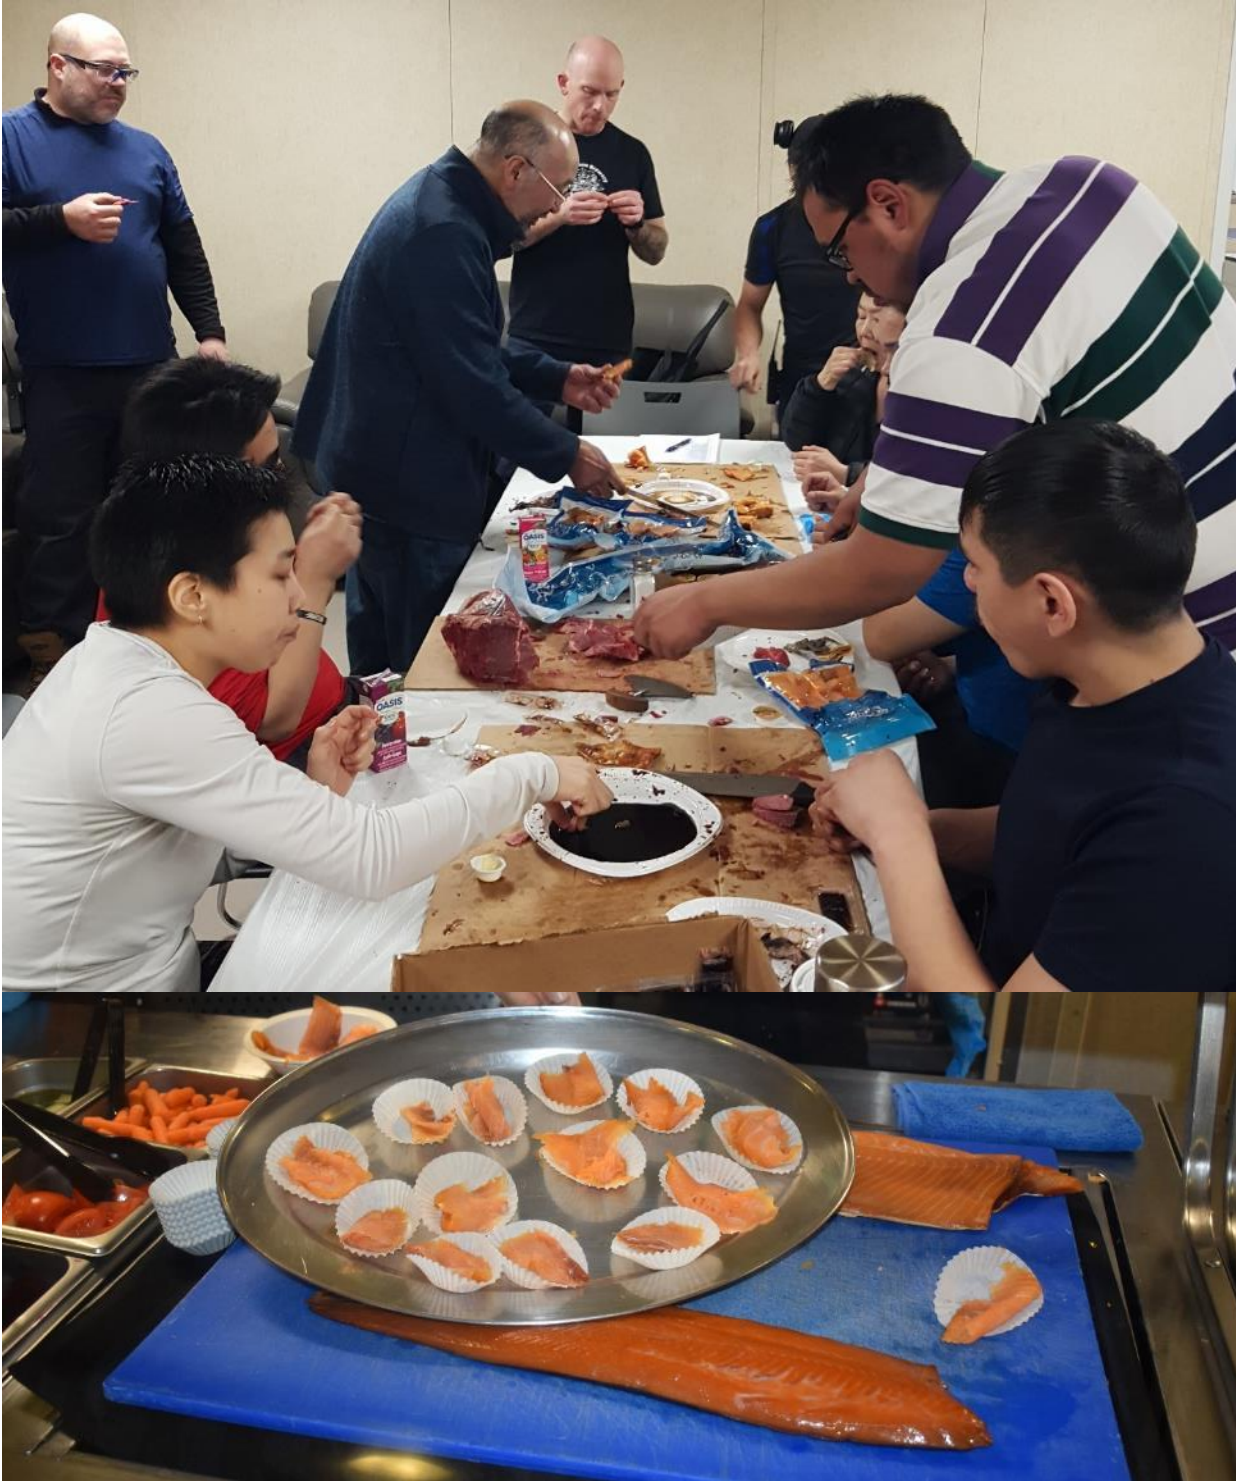
Photo 58: Country Food

| T&C No. | Category | Observation |
|---|---|---|
| 110 | Individual and community wellness | <a href="#">Photo 58</a> and <a href="#">Photo 59</a> show programs for country food and sewing at the mine site. <a href="#">Photo 61</a> , <a href="#">Photo 63</a> , and <a href="#">Photo 64</a> demonstrate cultural programs and activities in the communities of Rankin Inlet and Arviat. |

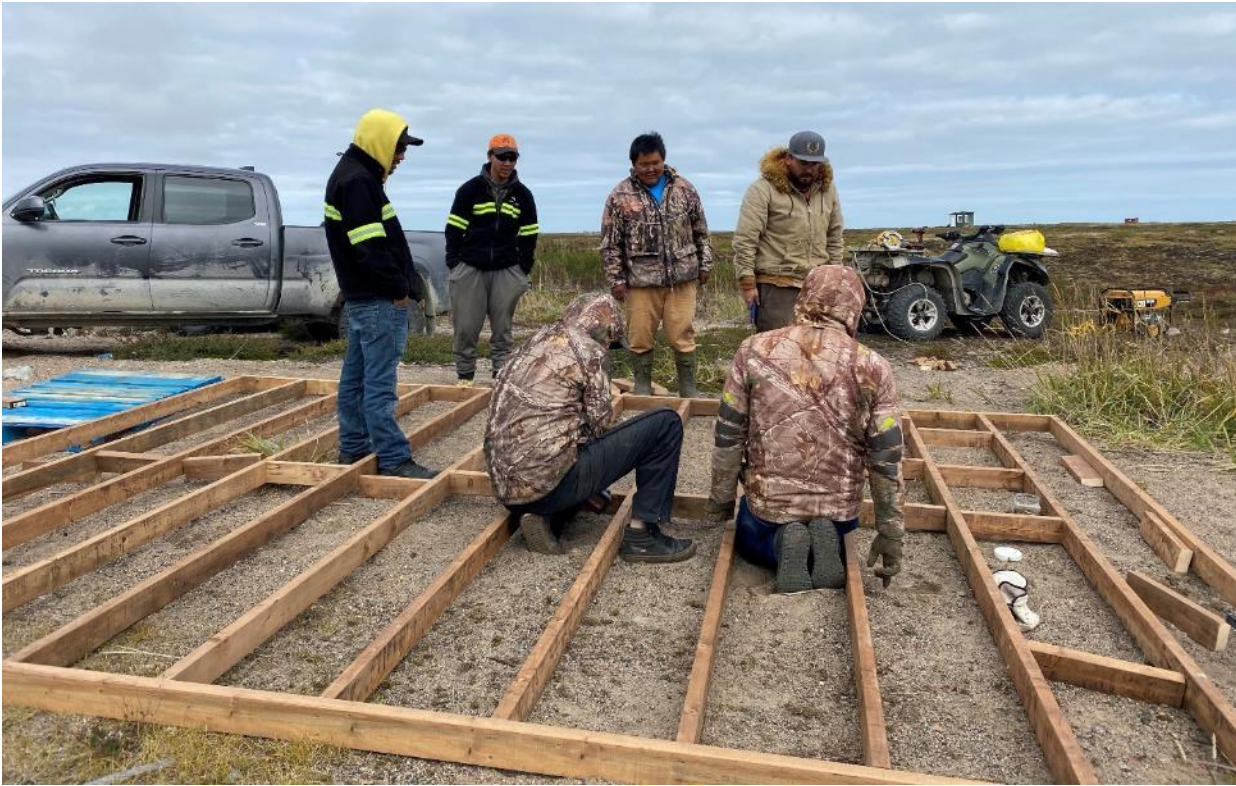
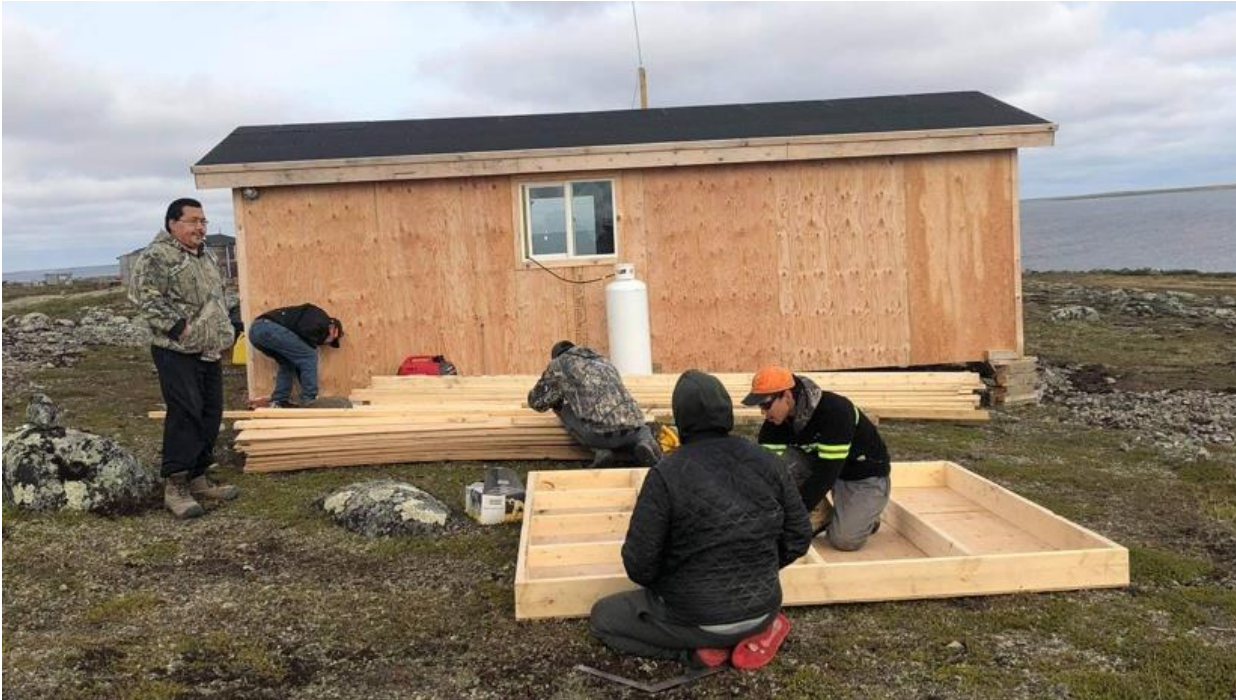
Photo 64: Land Camp Revamp in Arviat

- Agnico Eagle put in place the "Good Deeds Brigade", an initiative to help supplement some of the loss of income of Nunavummiut employees through the restriction of entry to site. Agnico Eagle paid employees full salaries to support local projects that may be lacking in a workforce. 91 employees participated completing 8,649.25 hours of work. Placements across Kivalliq communities included:
  - Rankin Inlet landfill clean-up (Photo 62);
  - Sewing programs;
  - Young hunters' programs (Photo 63);
  - Video creation;
  - Food basket distribution;
  - Land camp revamps (Photo 64);
  - Thrift store and prenatal project;
  - Foodbank; and
  - Daycare
