TSF WEEKLY INSPECTION FORM

Date: November 29, 2019	Time: 10:30
Weather: -14.3C; 39 km/h SW; drifting snow	Inspected by: Jennifer Pyluk
Present: Pierre-Luc Sevigny

TAILINGS PLACEMENT

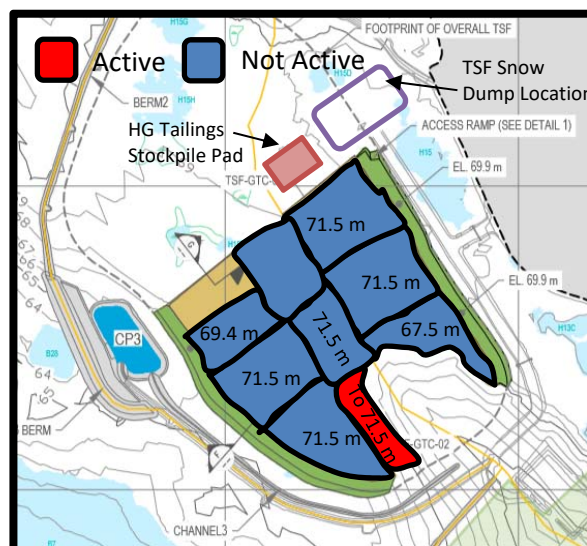
- The Church was observed to be approximately $\frac{3}{4}$ full. It is understood that tailings material to the east of the building have been in place "at least a week". It is noted that there has been no inclement weather during this time period. It is understood that both vehicle (haul truck) availability and driver availability have been issues. .

- No serious concerns were observed with the actual placement of tailings in the center cell at the time of the inspection and "fresh" (unfrozen) material was being placed. However, when asked how many passes with the compactor was occurring, the operator replied he was doing two (one forward and one backward). It is not clear as to why an operator was placed on a critical piece of equipment yet did not receive clear and correct directions as to what he was to be doing on that piece of equipment.

- Incomplete compaction/Rough tie-in was observed between sub-cells 4 and 5 and the center cell, leaving a trail of rough, dust generating material.

- Winter placement conditions must be followed in order to achieve proper compaction and reduce settlement in the summer months:**
 - Tailings must be removed from the Church immediately** to avoid freezing of this material prior to placement. **Stockpiling in the Church should only occur in extreme conditions.**

- Compaction of tailings must occur immediately following placement.** If compacted while unfrozen, the same number of passes (**3 slow passes on high vibrate where "1 pass = 1 forward + 1 backward"**) applies. If frozen tailings material has to be placed, Engineering must be notified so that the least harmful placement location and compaction specifications can be chosen.

- It is unacceptable that the packer operator did not know how many passes he was required to complete and this raises serious questions about the amount of compaction that is being achieved.** If

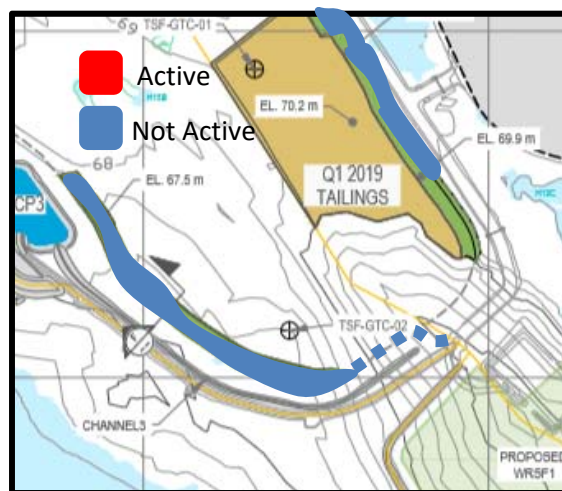
- Despite repeated warnings, all haul and light vehicle traffic was observed running across sub-cell 2 to reach the working area. This is exacerbating dust generation from the surface and is contrary to Section 5.0 of the Deposition Plan.

4. **There must be no vehicle traffic on the finished tailings surface.** Flash freezing of the surface will occur and erosion/dust generation will be at its peak. Traffic over snow will grind/compress the snow into the tailings surface and will make snow removal in these areas more difficult. **AEM has regulatory requirements to make every effort to control the dust generated from the TSF.**
5. **Any unusual observations** (ie. "pot-holes") **can be signs of serious instabilities and should be reported immediately to the GE.** If the GE is not on site, photographs should be emailed for a visual evaluation.
6. **Snow should not be placed/stockpile anywhere but the designated snow dump location in Cell 2.** The location of the snow dump was chosen based on experiences during freshet 2019.

1. Fill in and compact trench through the berm at sub-cell 1 and re-establish the access road.
2. **The west berm should be raised as soon as possible as the gap between the current berm and tailings is acting as a snow trap. This snow/ice must be removed prior to placing the next lift of waste rock.**
3. **Serious consideration should be given to the raising of the east berm as well, to a level just above the current tailings height for the winter period as a method of dust mitigation.**
