APPENDIX B

All Weather Access Road
Photographs

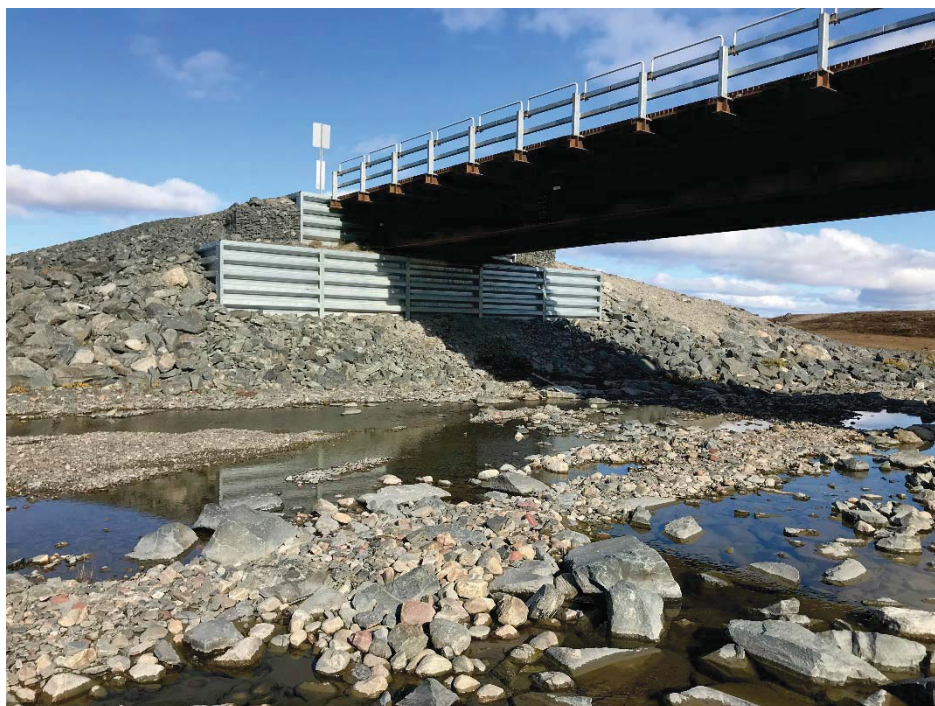
Photographs 1 to 5 were taken at KM6.0 of the Char River Bridge. Some finer grained material observed on downstream side of Left (north) Abutment, should be monitored for signs of erosion.

Photograph 1: Char River Bridge at KM6.0 Looking South (13 September 2018)

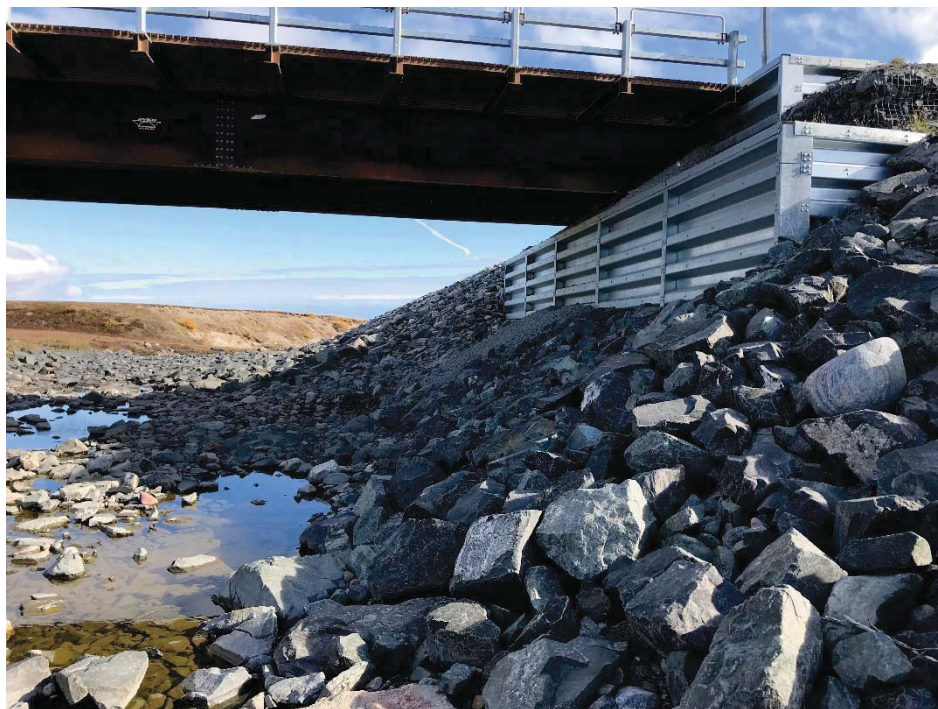
Photograph 2: Char River Bridge, Left (north) Abutment Armouring from the Upstream Side of the Right (south) Abutment (13 September 2018)

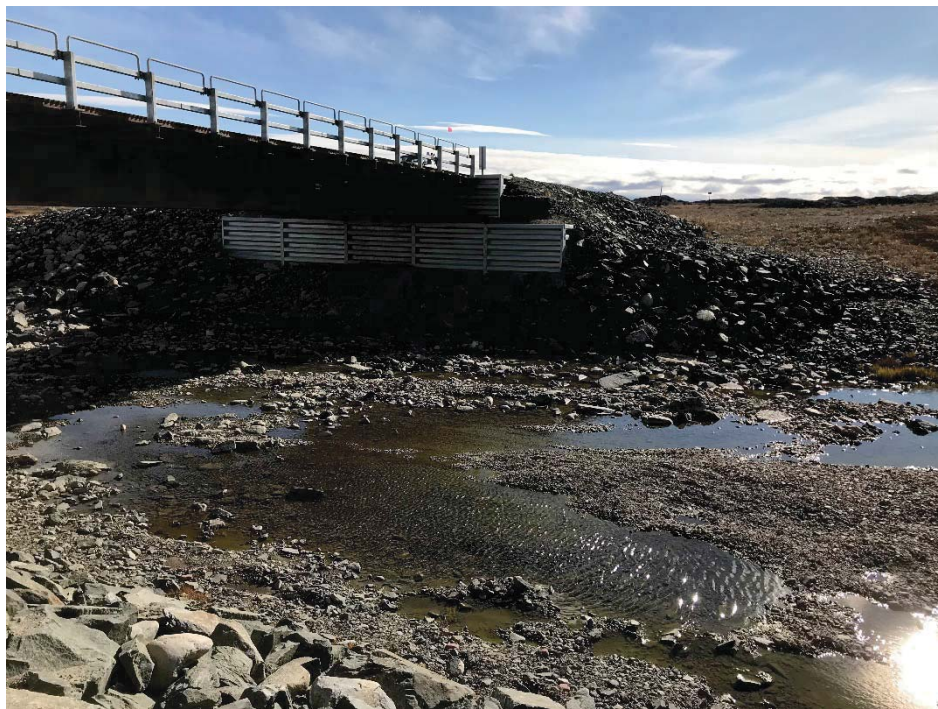
Photograph 3: Char River Bridge, right (south) abutment armouring, from the upstream side (13 September 2018)

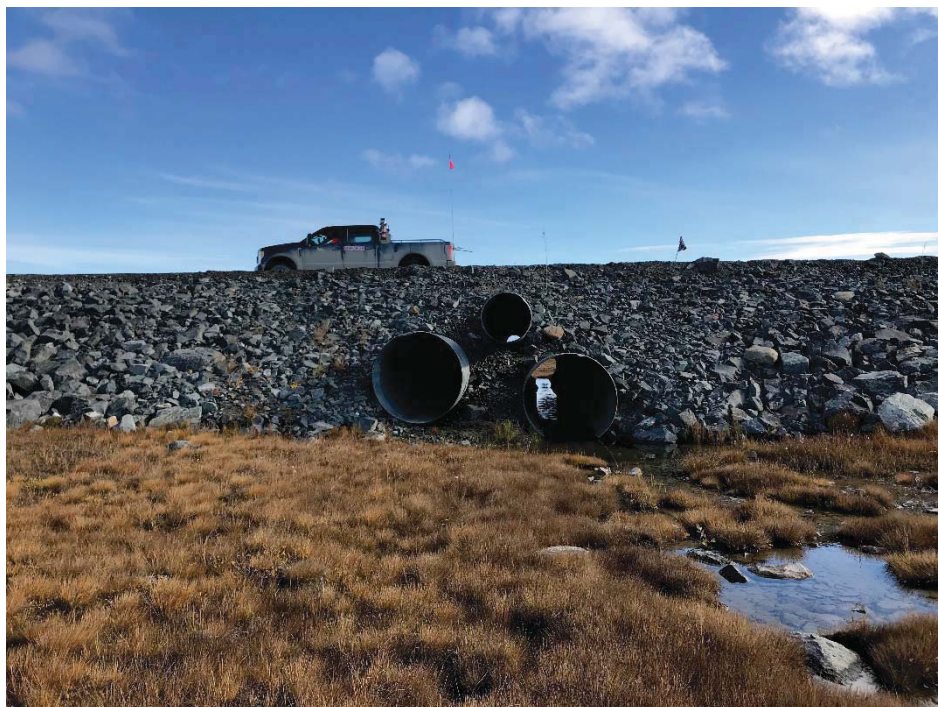
Photograph 6: At KM6.2, Downstream ends of 3 CSP culverts. Lower two culverts are 1300 mm \varnothing , upper culvert is 700 mm \varnothing . All are in good condition. Small erosion between culverts, consider adding armouring (13 September 2018)

Photographs 6 to 8 were taken at KM6.2 where there are 3 CSP culverts. The culverts are in good condition. Some minor erosion on the embankment between the culverts, consider additional armouring.

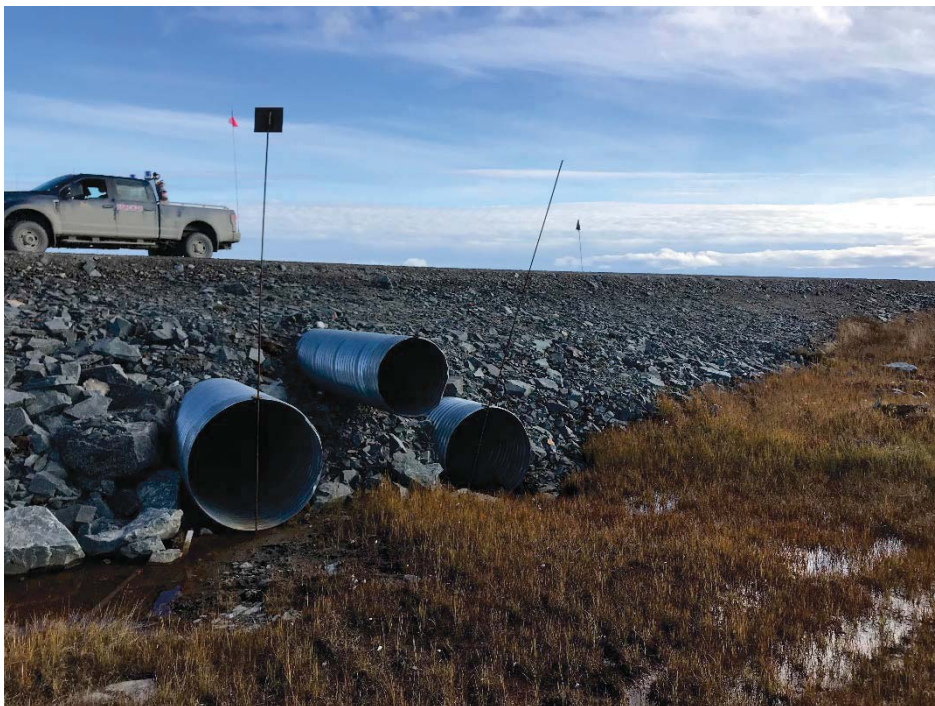
Photographs 13 to 16 were taken at KM7.1 where there are 3 CSP culverts. The culverts and riprap appear to be in good condition.

Photograph 13: At KM7.1, downstream ends of 3 CSP culverts. Lower two culverts are 1000 mm \varnothing , upper culvert is 700 mm \varnothing . All are in good condition. Small flow through lower culvert at time of inspection. Riprap in good condition (13 September 2018)

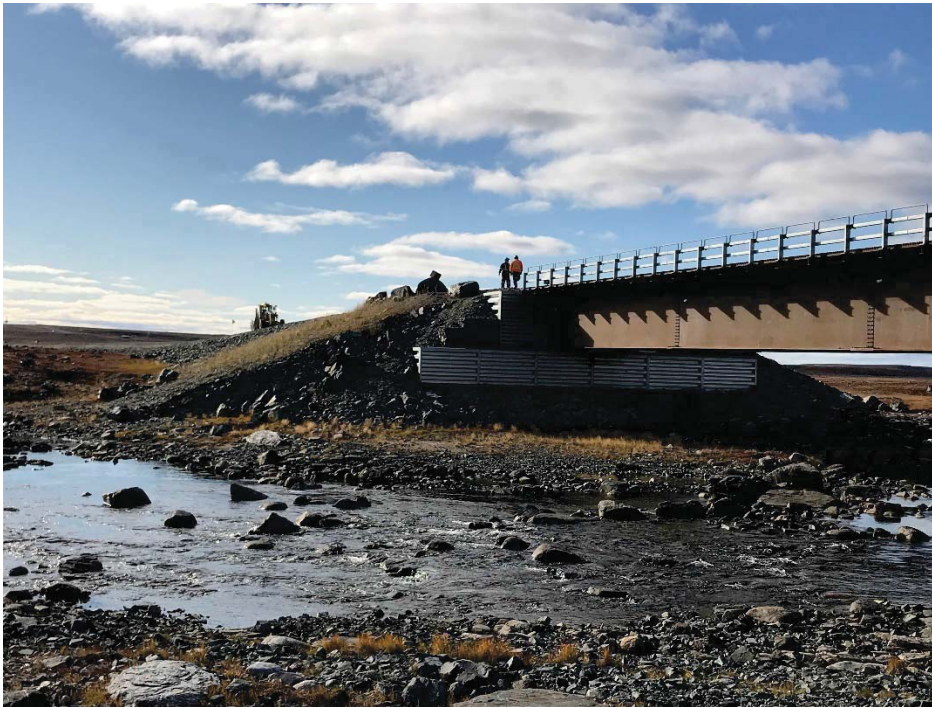
Photograph 28: Meliadine River Bridge at KM8.0. Embankment for the Right (southwest) Abutment, from the upstream side. The far abutment in the photo is the Left (northeast) Abutment. Riprap is in good condition (13 September 2018)

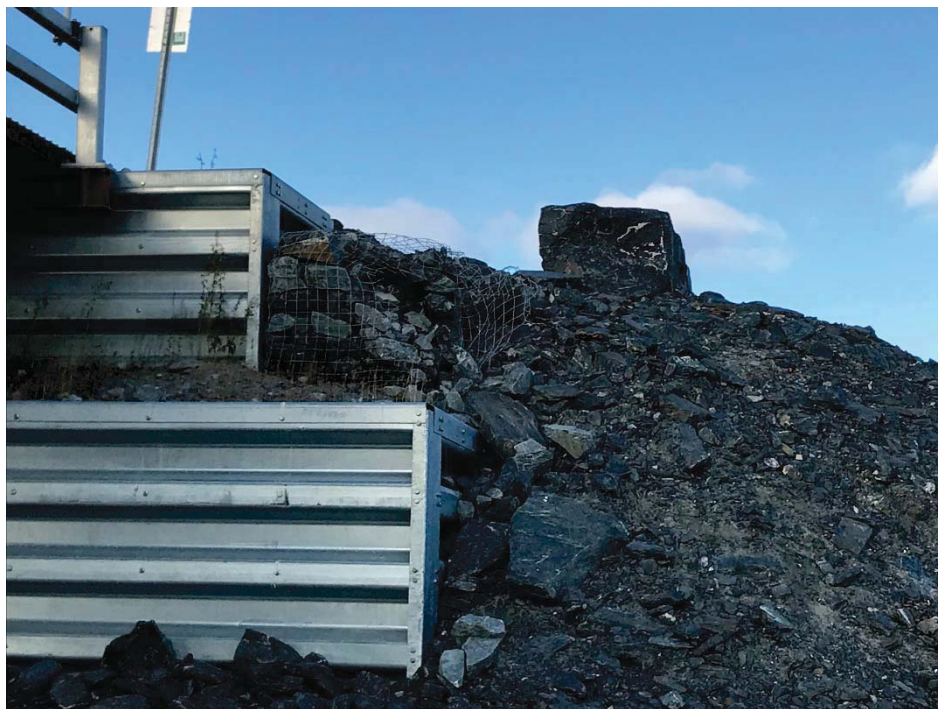
Photograph 40: M-5 Bridge at KM10.5, photo of Left (north) Abutment, downstream side taken from the Right (south) Abutment (13 September 2018)

Photographs 40 to 47 taken of M-5 Bridge, at KM10.5. The bridge abutments are generally in good condition. No change to area previously noted as possible erosion. There is a damaged gabion on the downstream side of the Left (north) Abutment that should be replaced.

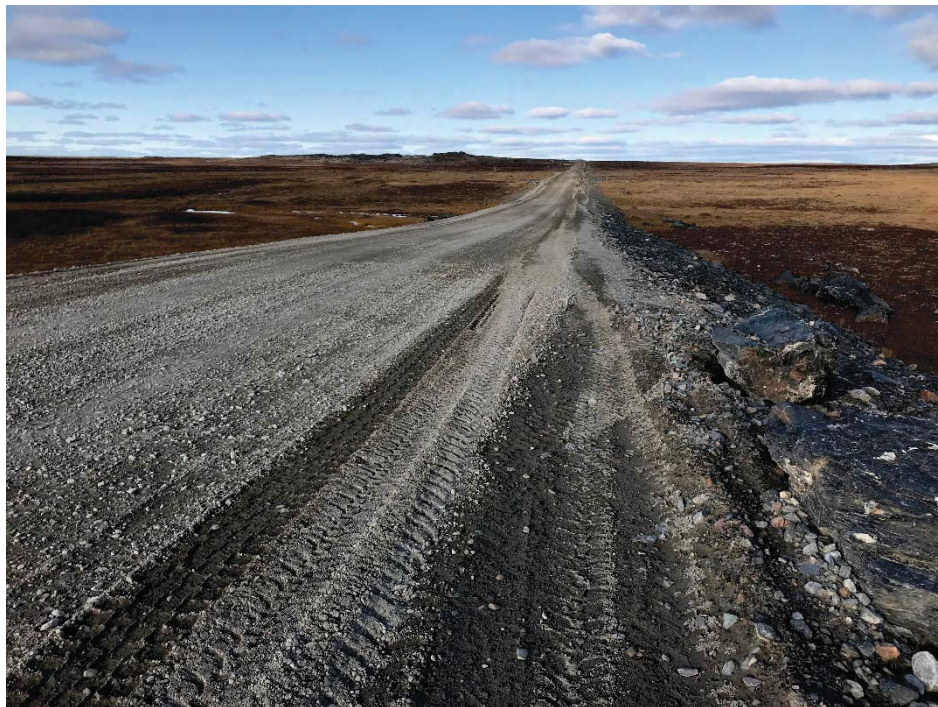
Photograph 46: M-5 Bridge deck at KM10.5, looking south. Speed limit sign was knocked down at time of inspection (13 September 2018)

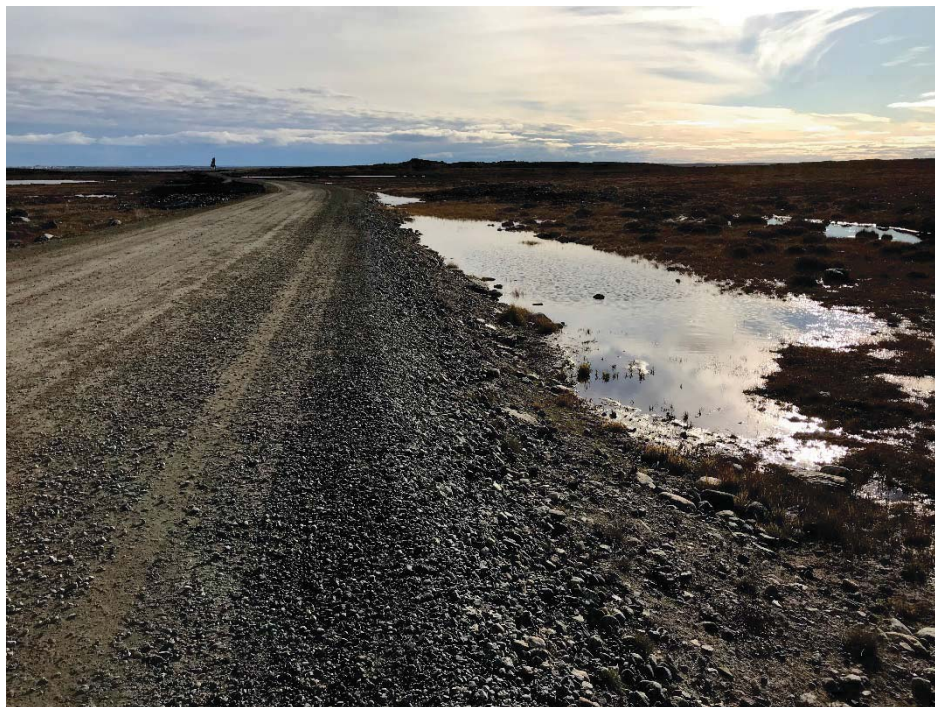
Photos 53 and 54 were taken along AWAR at KM12.6. At this location flow is visible along the road. No culvert is present and water seeps under the road.

Photograph 53: West side of AWAR at KM12.6 where water flows along the side of the road and seeps under the road from west to east (13 September 2018)

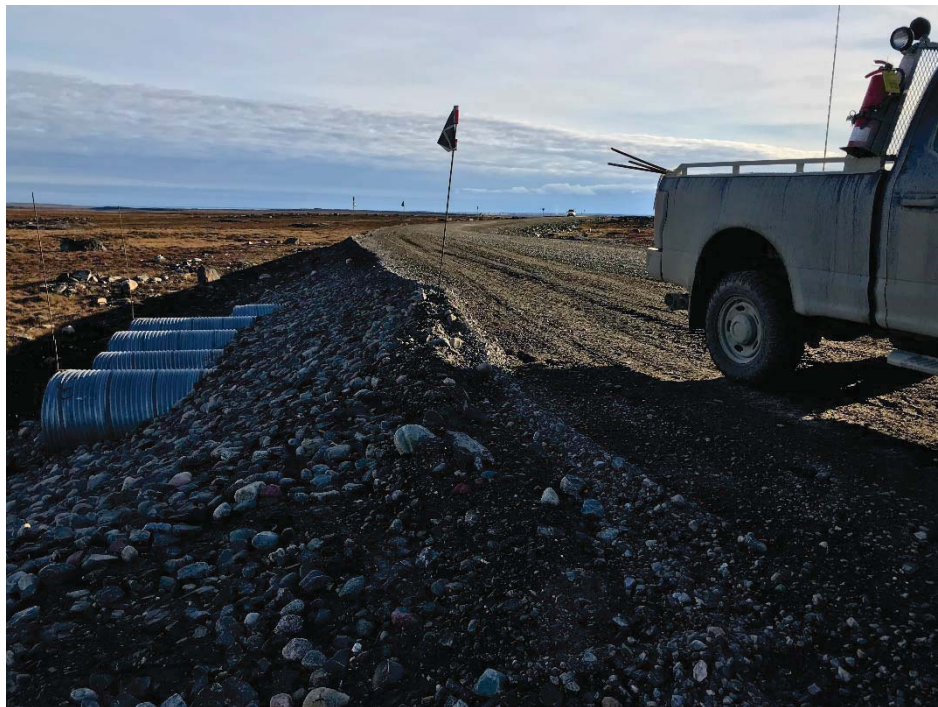
Photos 55 to 58 were taken along AWAR at KM13.5. Five CSP culverts are installed at this location, three of 1300 mm \varnothing and two of 900 mm \varnothing . The inverts of the 900 mm culverts are elevated higher than the inverts of the 1300 mm culverts. Minor deformation of the culverts noted under the road, embankments are generally in good condition.

Photograph 56: Downstream ends of 5 CSP culverts at KM13.5 (13 September 2018)

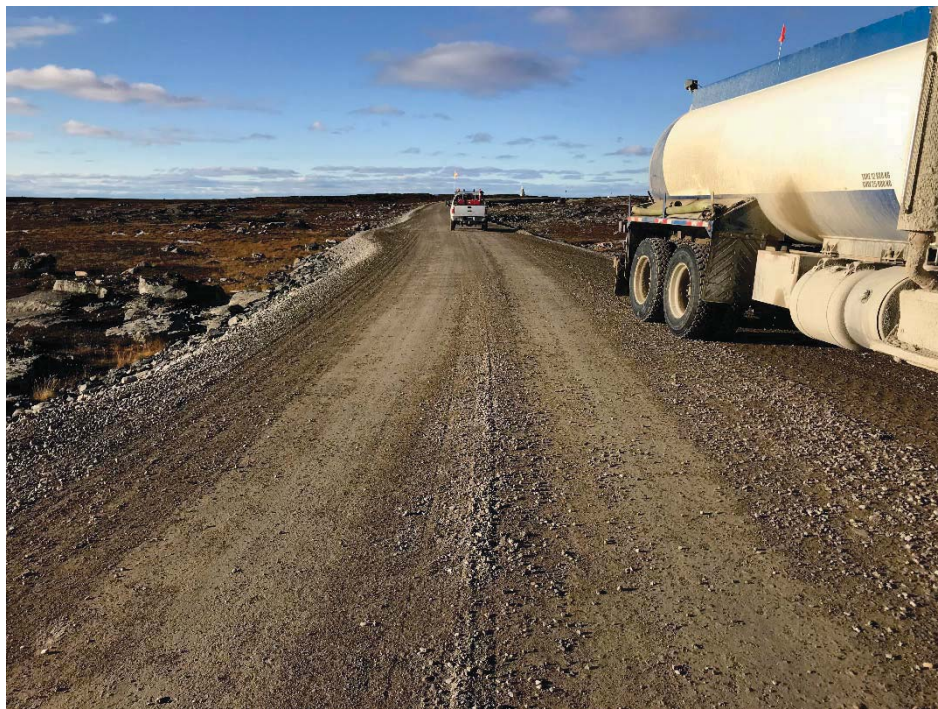
Photograph 57: View of the embankment and road over upstream ends of 5 CSP culverts at KM13.5 looking south (13 September 2018)

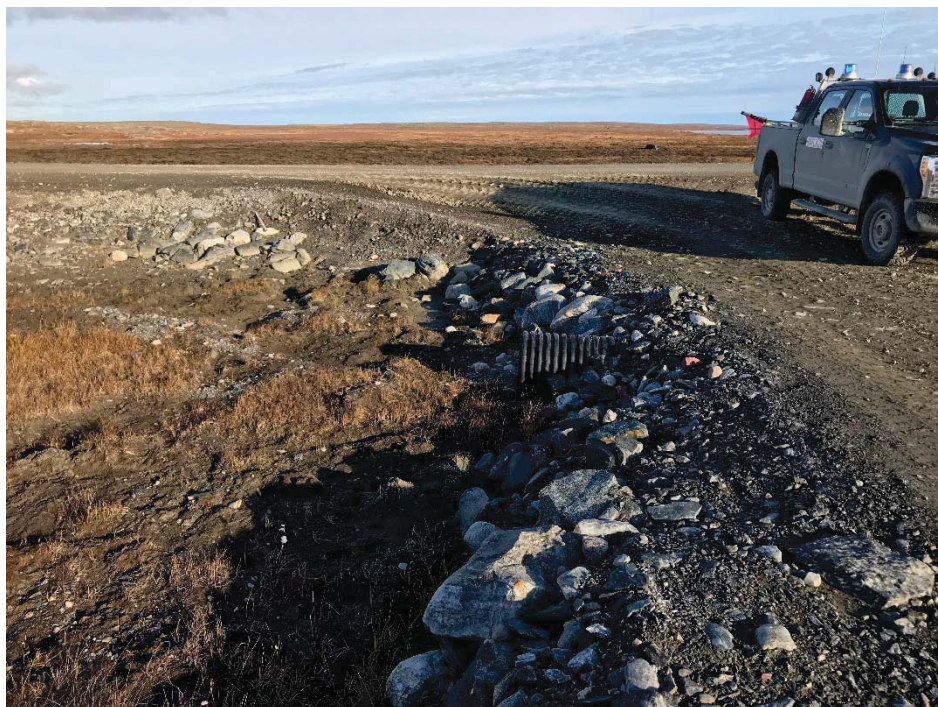
Photographs 59 to 62 were taken at KM14.7 on the AWAR at intersection with access road to B12 Quarry. There is a single corrugated HDPE culvert under the B12 access road. The culvert and road embankments are generally in good condition.

Photograph 60: View through culvert under B12 Quarry access road at KM14.7 of AWAR, no flow, small amount of ponded water within culvert (13 September 2018)

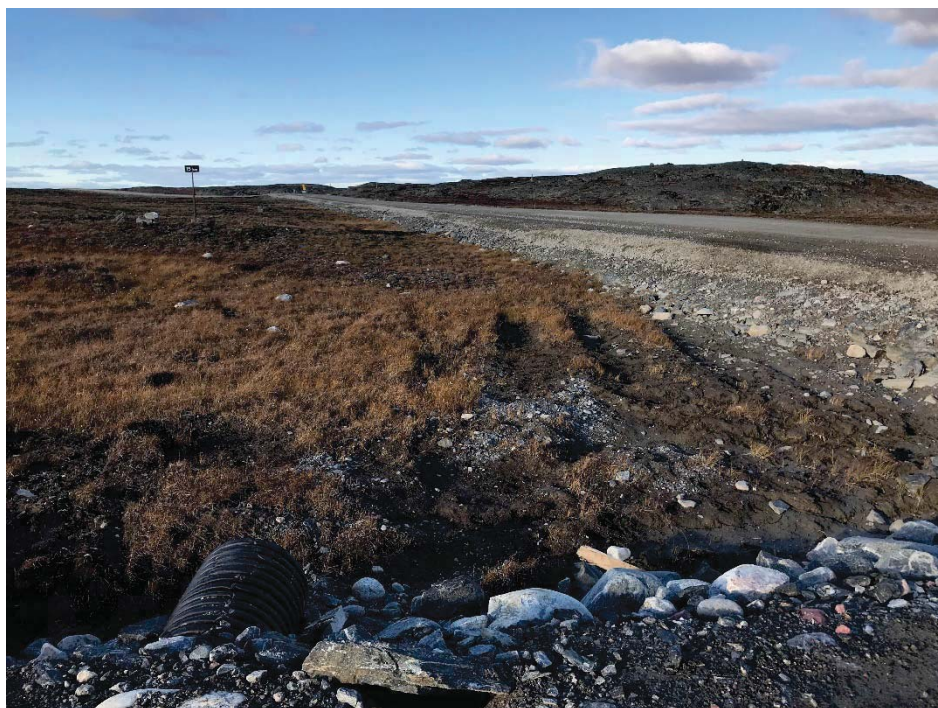
Photograph 61: Upstream end of culvert through B12 Quarry access road at KM14.7 of AWAR (13 September 2018)

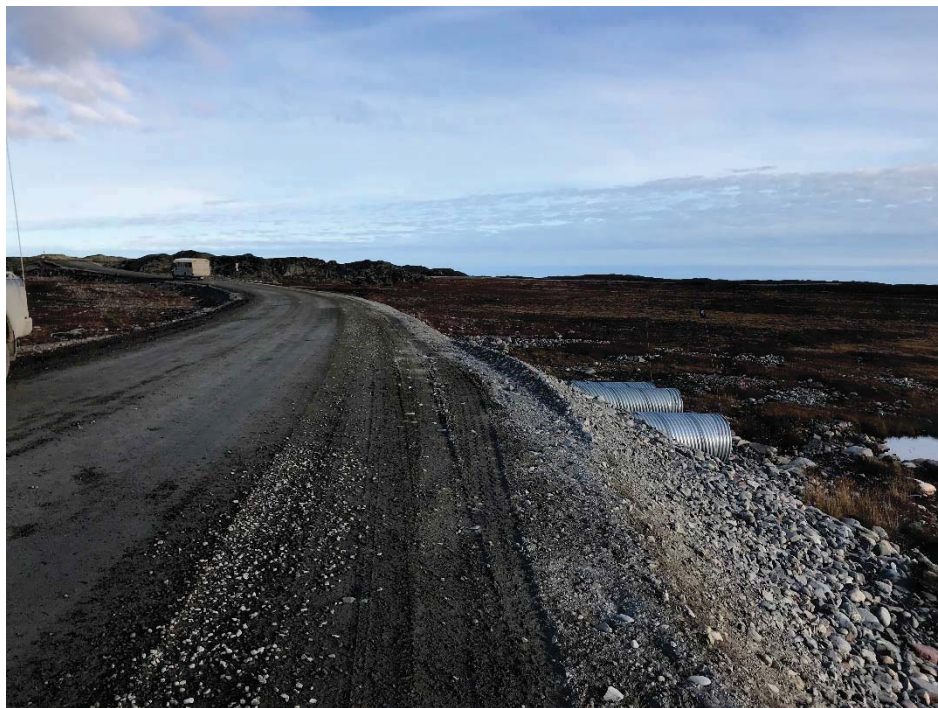
Photographs 63 to 66 were taken at KM16.3 where there are 3 CSP culverts. Some minor deformation of one culvert and erosion visible at the outlet of the lowest culvert.

Photograph 63: At KM16.3, upstream ends of 3 CSP culverts, looking south (13 September 2018)

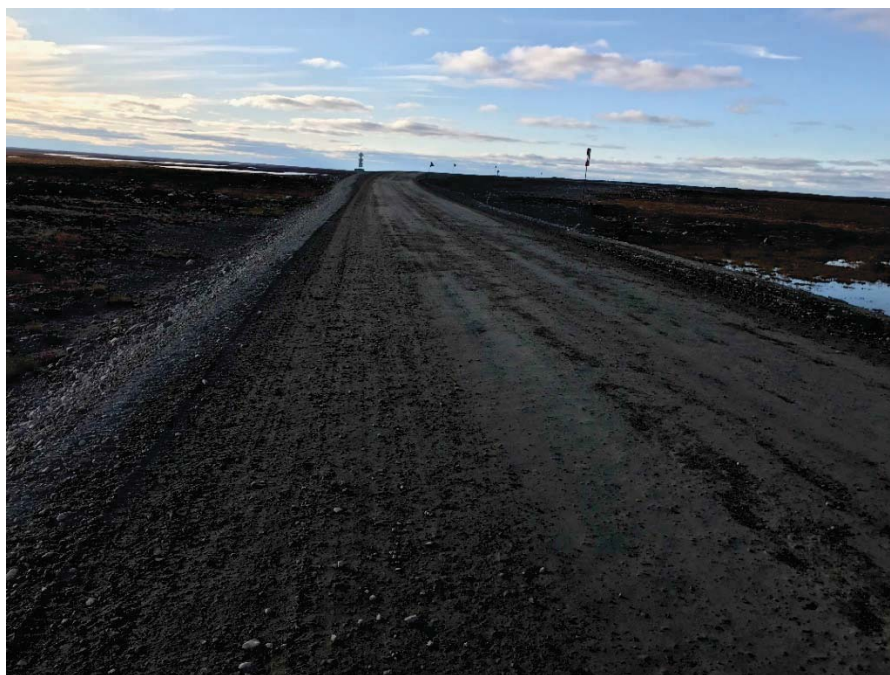
Photograph 65: Downstream ends of three CSP culverts at KM16.3. Diameters of the culverts from left to right are: 1000 mm, 700 mm, and 1300 mm Ø. Small flow in 1300 Ø culvert and minor deformation. Some erosion visible at outlet of 1300 mm culvert (13 September 2018)

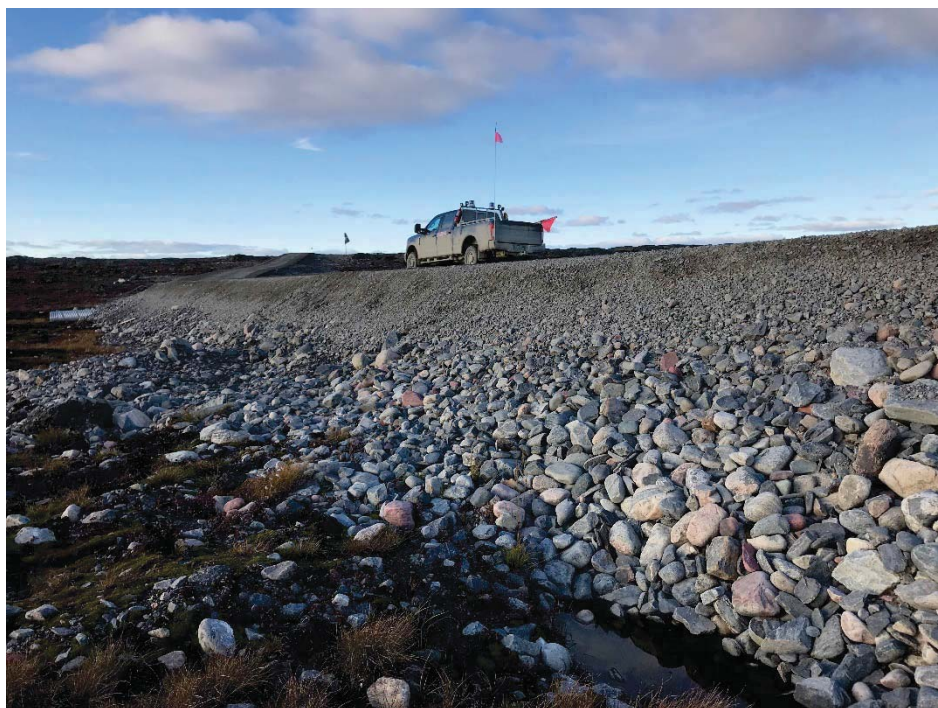
Photographs 67 to 70 were taken at KM18.1. There are 2 vertically offset, CSP culverts the upper culvert is 900 mm Ø and the lower culvert is 1000 mm Ø. Note that the road near KM18.1 would need to almost be flooded to reach inlet of 900 mm Ø culvert. If water management in this area is a problem, suggest lowering the culvert or installing another culvert at a lower elevation. Some damage was observed on the inlet of the lower culvert, embankment is generally in good condition. A ditch on the upstream side hydraulically connects the culverts at KM18.1 to culvert at KM18.15.

**Photograph 69: Downstream ends of two CSP culverts at KM 18.1
(13 September 2018)**

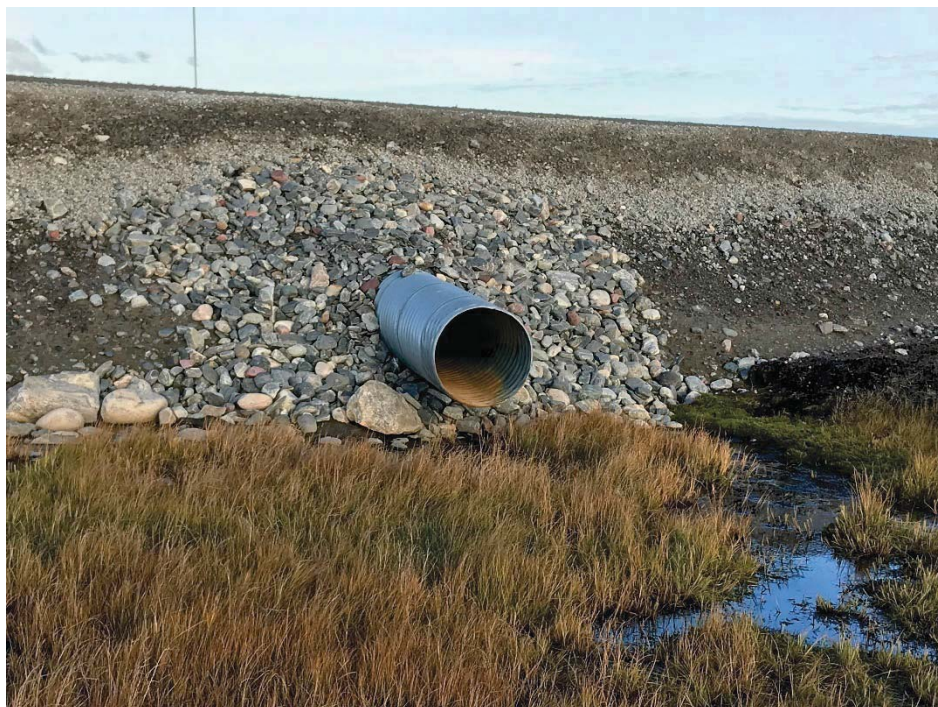
Photograph 72: Downstream end of 600 mm Ø CSP culvert at KM18.15 and view of AWAR slope, looking south (13 September 2018)

Photographs 71 to 75 were taken at KM18.15 where there is a single 600 mm Ø CSP culvert, the inlet of which is hydraulically connected to the inlets of the CSP culverts at KM18.1 by a ditch. The inlet of the culvert is elevated above some ponded water. Culvert and embankment are in good condition.

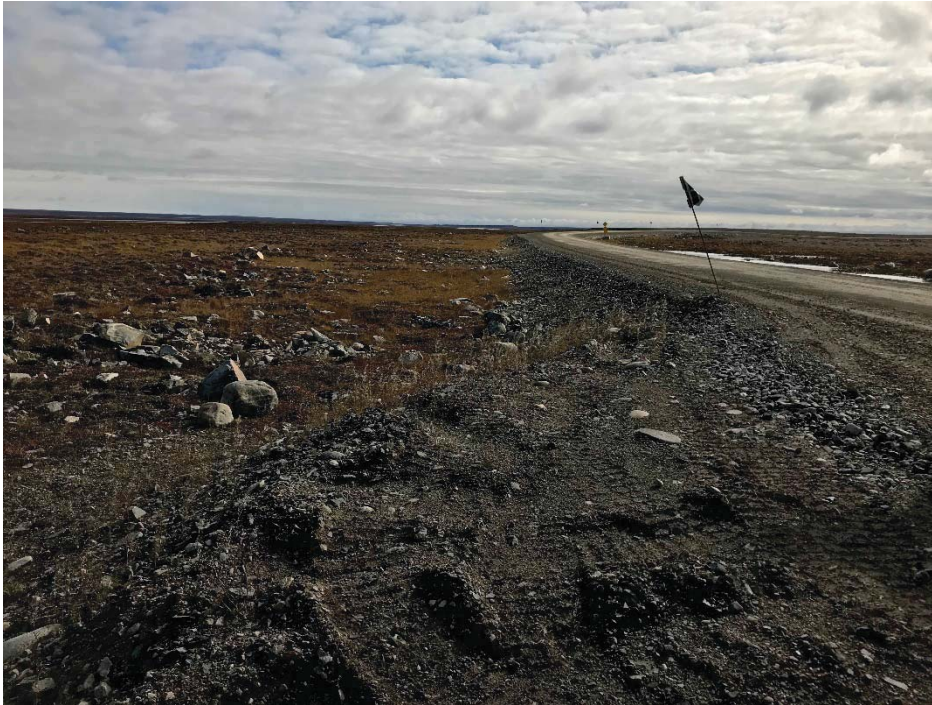
Photograph 76: Water ponding on the west side of the road at KM19.5, looking south. Installation of a culvert should be considered (14 September 2018)

Photographs 76 and 77 were taken at KM19.5 water is ponding on the west side of the AWAR, reportedly the water ponds here year-round and can reach as high as half way up the embankment. Installation of a culvert at this location should be considered.

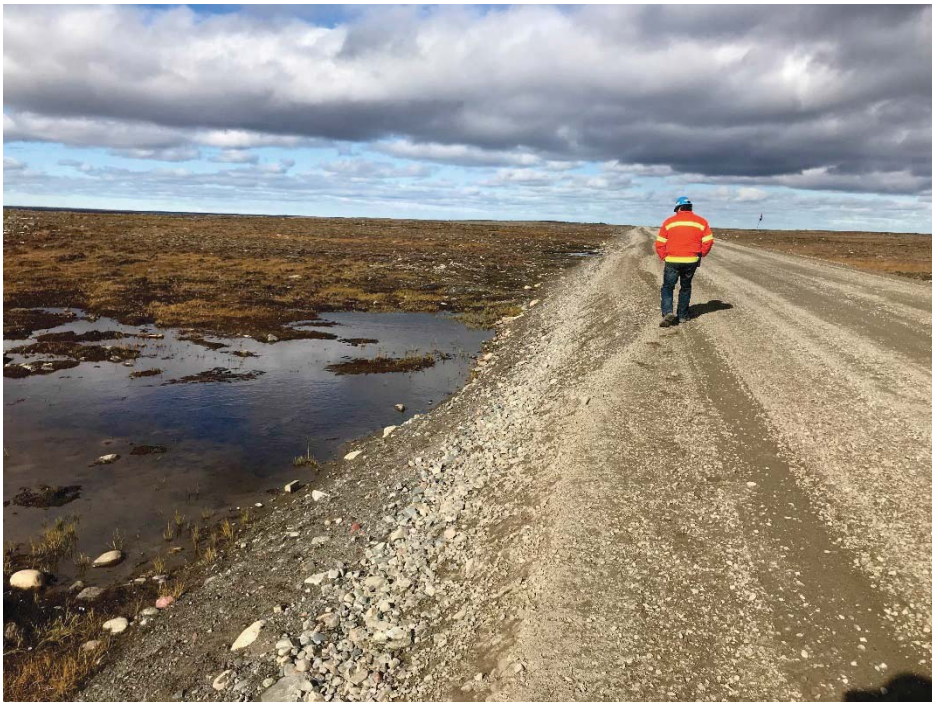
Photograph 77: East side of AWAR at KM19.5 where water is ponding on the west side, looking south (14 September 2018)

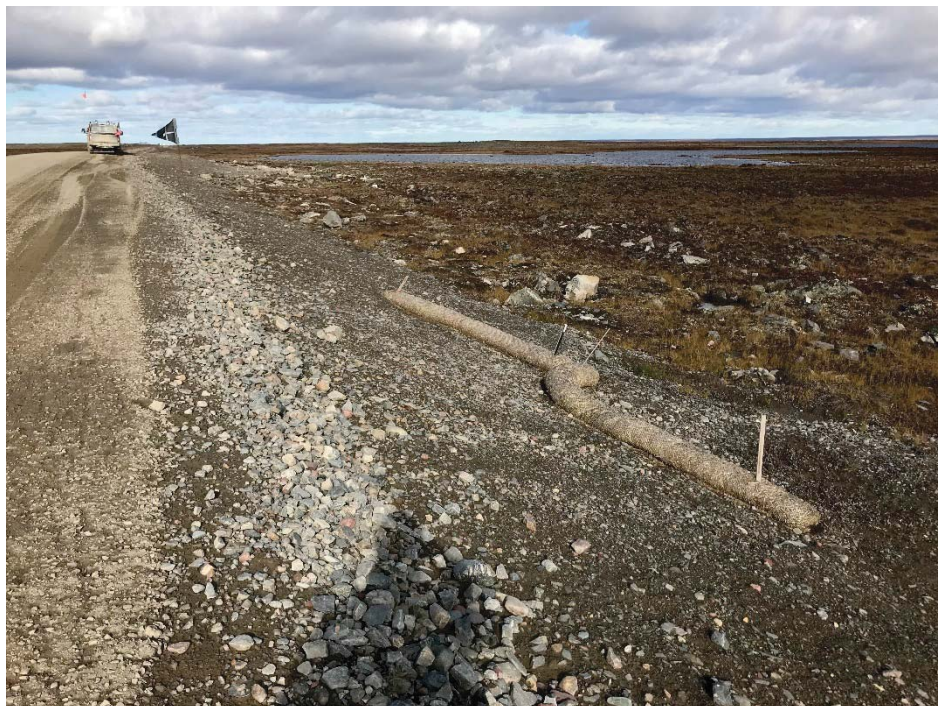
Photographs 78 to 80 were taken at KM21.2 where water is ponding on the west side of the AWAR. There are no culverts present at this location. Water flowed over the road at this location during freshet. A straw log has been placed on the east side of the road to manage erosion. It is recommended that a culvert be installed at this location.

Photograph 79: View of the east side of the AWAR at KM21.2 where water is ponding on the west side of the road, looking south. (14 September 2018)

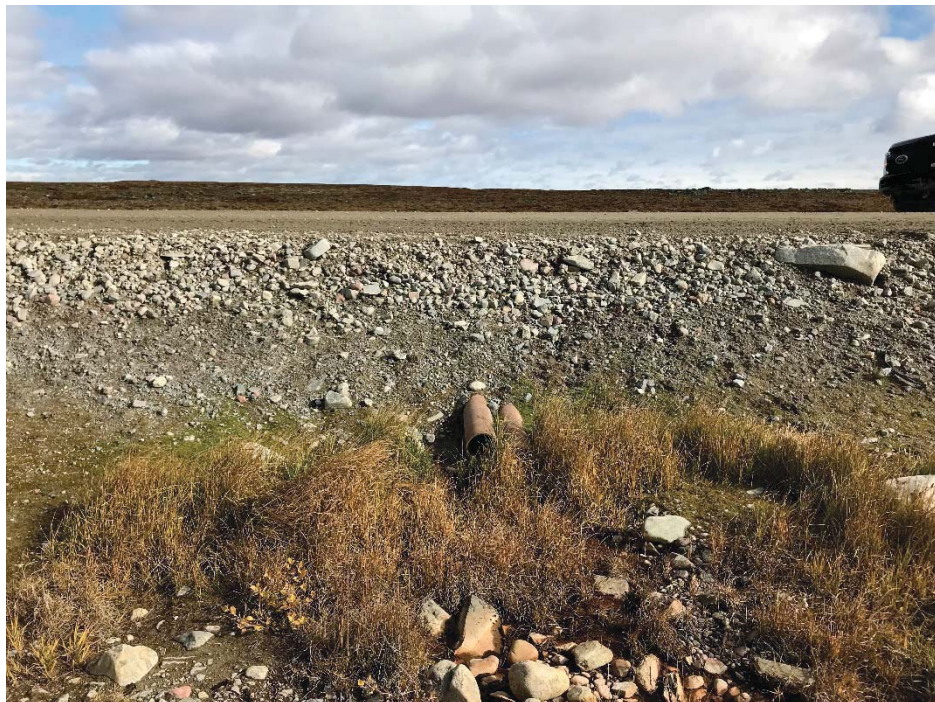
Photographs 81 to 84 were taken at KM21.7. There are two 170 mm outside \varnothing pipes, vertically offset. Mine personnel reports that the road was excavated at this location this spring to allow water to drain. The capacity of the pipes may be inadequate, or pipes could have been frozen/blocked causing water to backup. Installation of larger diameter culvert should be considered at this location.

Photograph 82: At KM21.7, view of the upstream ends of two steel pipes, looking north (14 September 2018).

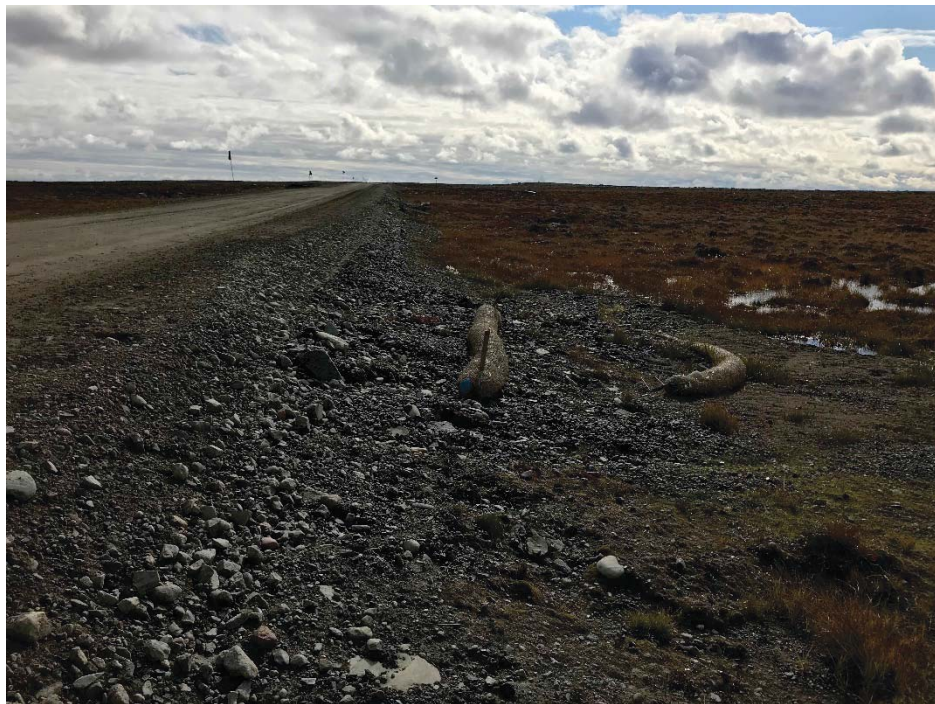
Photograph 83: Downstream ends of two 170 mm Ø steel pipes at KM21.7 (14 September 2018)

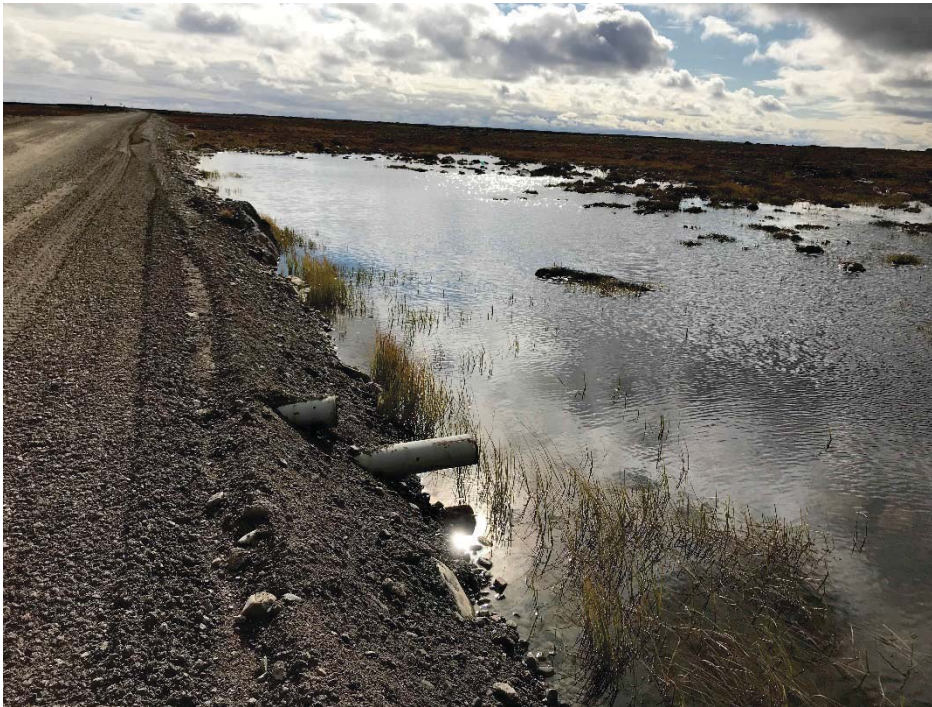
Photograph 84: Straw logs placed on west side of the road, south of the steel pipes at KM21.7 (14 September 2018)

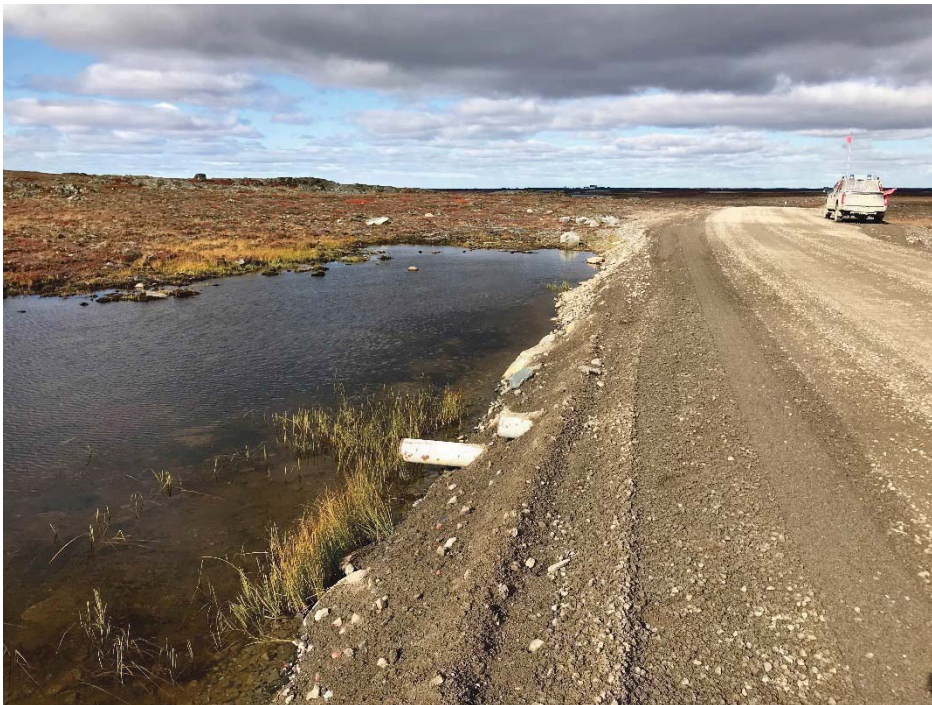
Photographs 85 to 88 were taken at KM22.3. There are two 160 mm Ø steel pipes that are vertically offset. Both pipes were clear with no flow. Water is ponding on the upstream (west) side of the road. Inverts of culverts are elevated above the ponded water. Consider lowering the culverts to reduce ponding.

Photograph 85: At KM22.3, upstream ends of two 160 mm Ø steel pipes that are vertically offset. Water is ponded on the upstream side (14 September 2018)

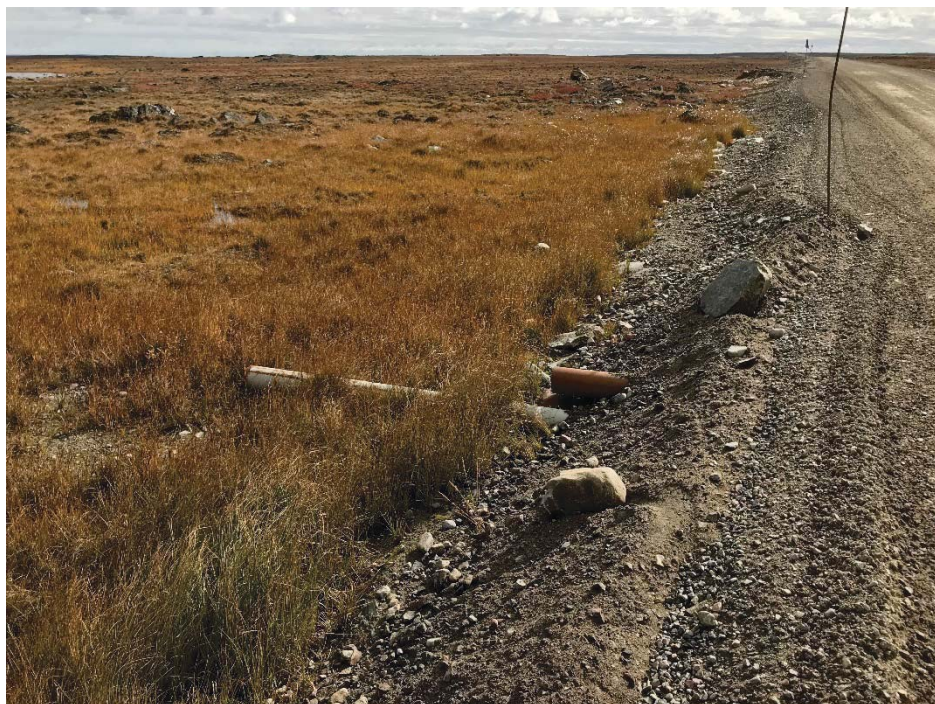
Photograph 86: Upstream ends of two steel pipes at KM22.3, looking north (14 September 2018)

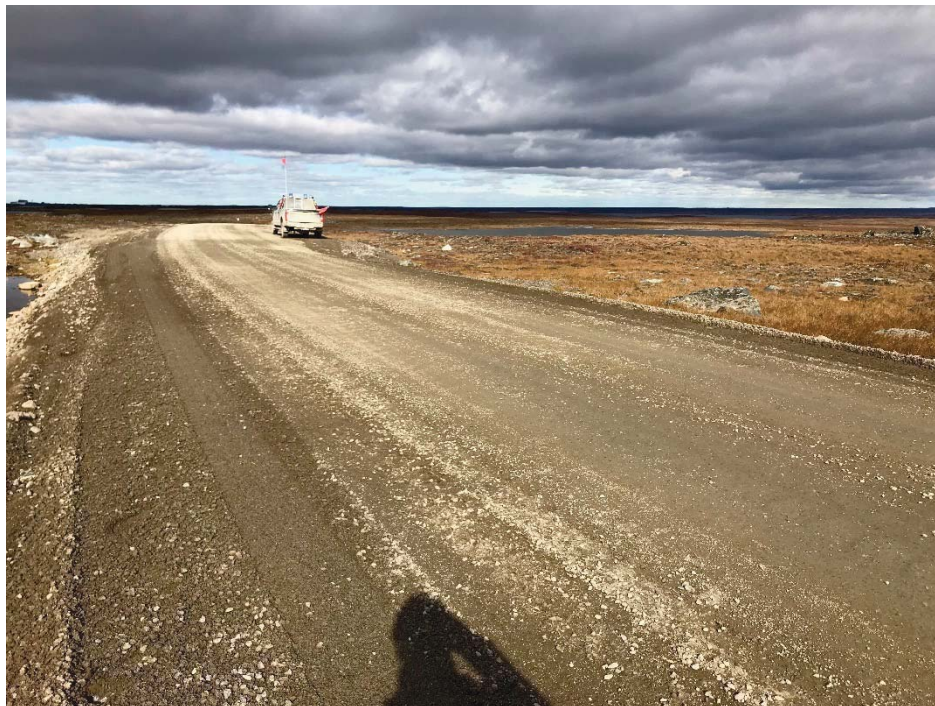
Photograph 87: Downstream ends of two steel culverts at KM22.3 looking south (14 September 2018)

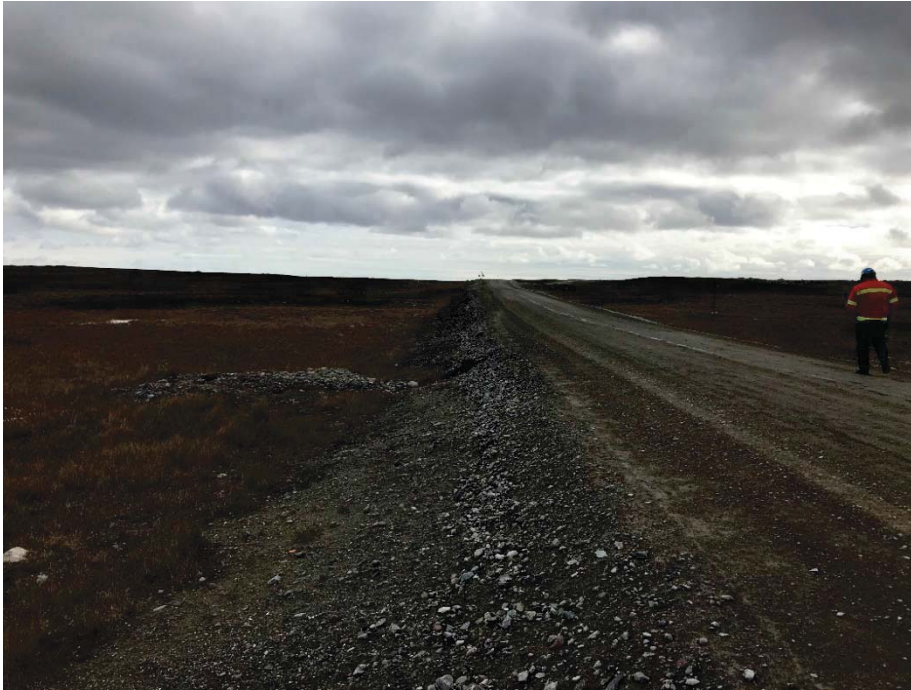
Photographs 91 through 93 were taken at KM25.8 where there is a single HDPE corrugated 600 mm Ø culvert. Some damage and granular material partially blocking the inlet of the culvert. Culvert should be cleaned out to re-establish capacity.

Photograph 92: Downstream end of corrugated 600 mm Ø HDPE culvert at KM25.8 (14 September 2018)

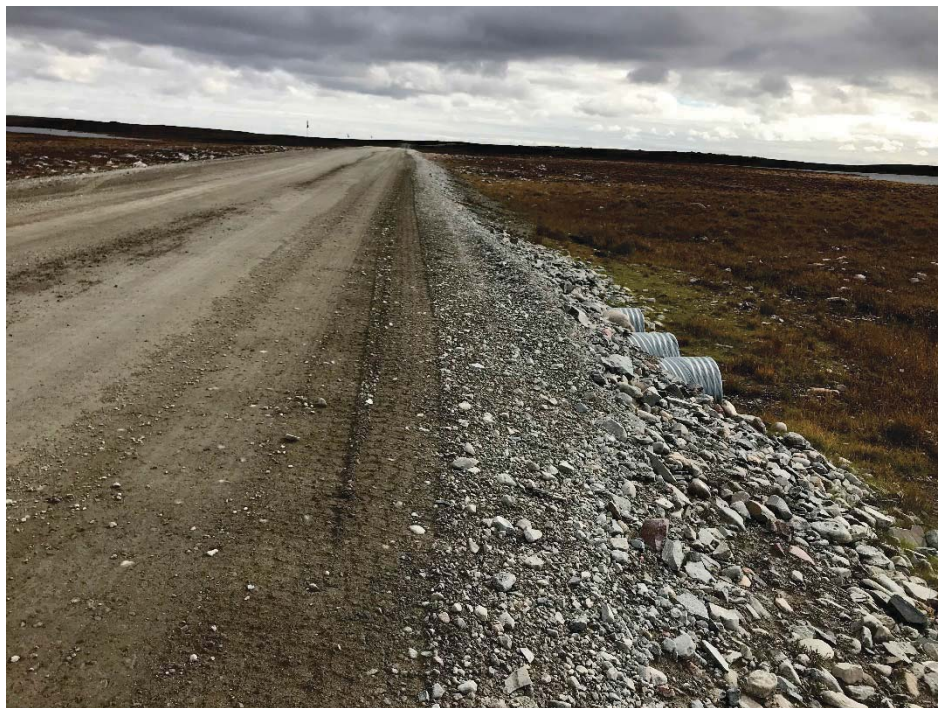
Photographs 96 through 100 are at KM26.5 where there are three 700mm Ø CSP culverts installed at about equal elevation. Small dents in culverts, minor deformation observed under the road. Minor sediment buildup observed in the culverts, riprap and embankments are in good condition.

Photograph 97: Downstream ends of three CSP culverts at KM26.5. Riprap and embankments are in good condition (14 September 2018).

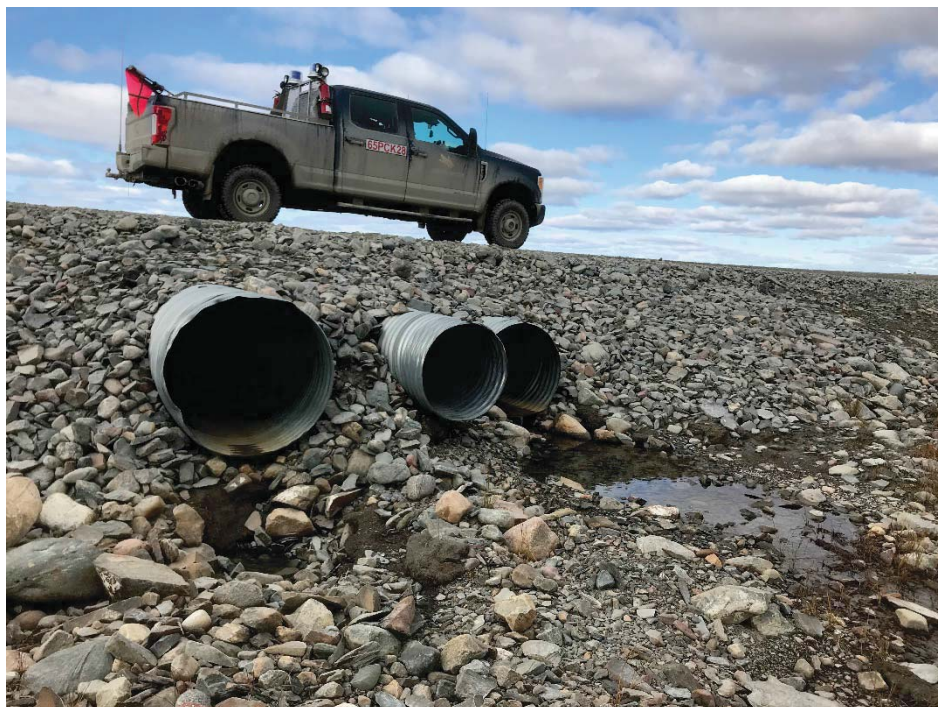
Photographs 105 through 108 are at KM27.1 where there are 3 CSP culverts installed: 900 mm, 700 mm, and 1000 mm ø. Some minor sloughing of riprap observed around the culvert inlets. Some erosion/deposition observed under culvert outlets. Otherwise embankment slope is generally in good condition.

Photograph 106: Downstream ends of three CSP culverts at KM27.1. From left to right, 1000 mm, 700 mm, and 900 mm ø. (14 September 2018)

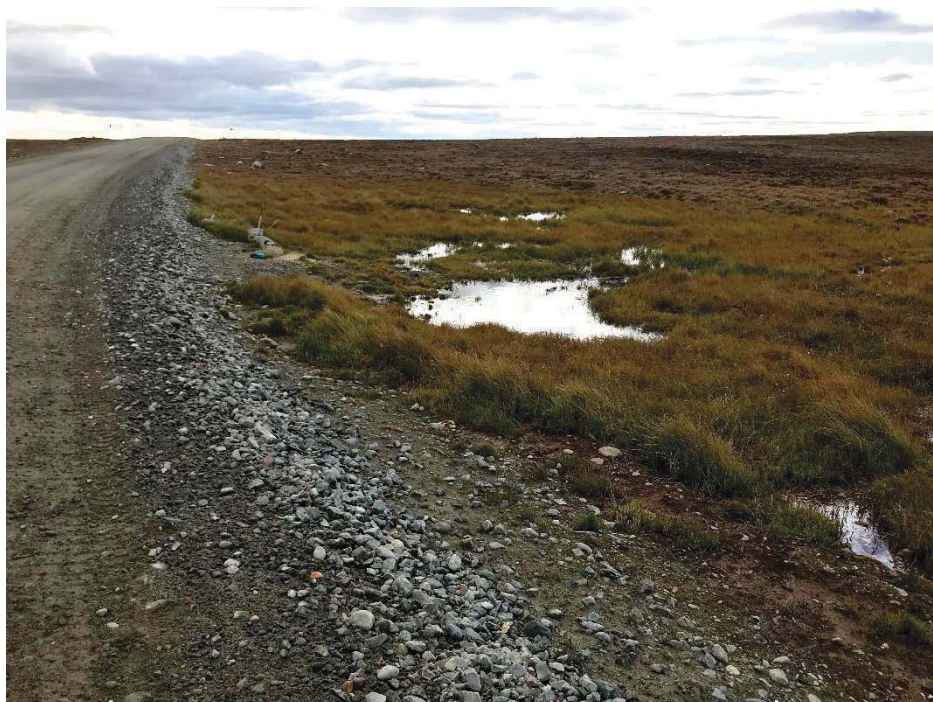
Photographs 109 and 110 are at KM28.7 where water is ponding on the east side of the AWAR. Mine personnel report that water flowed over the road in the spring. Consider installing culvert.

Photograph 109: At KM28.7 where water is ponding on the east side of the AWAR. Mine personnel report that water flowed over the road in the spring. Consider installing a culvert at this location (14 September 2018).

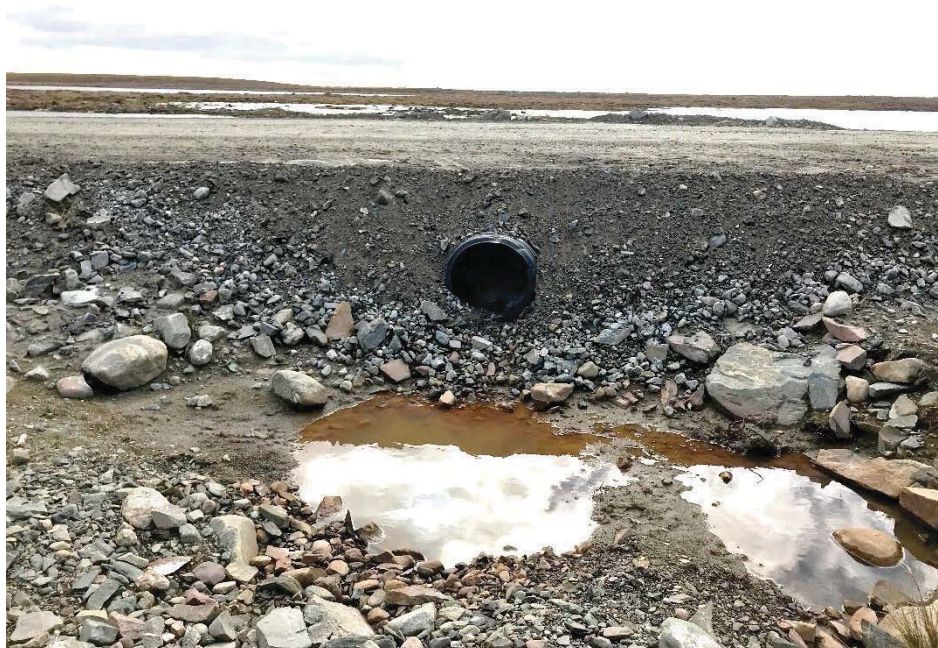
Photographs 111 through 114 are at KM29.6 where a single 500 mm Ø corrugated HDPE culvert is installed. Ponding water observed on the west side of road. Culvert inlet is partially blocked by road fill and riprap and is elevated above level of ponded water. Move riprap from in front of inlet and recommend lowering culvert invert to reduce ponding adjacent to road.

Photograph 112: View of water ponded upstream of 500mm Ø corrugated HDPE culvert at KM29.6 (14 September 2018).
