APPENDIX B

All Weather Access Road
Photographs

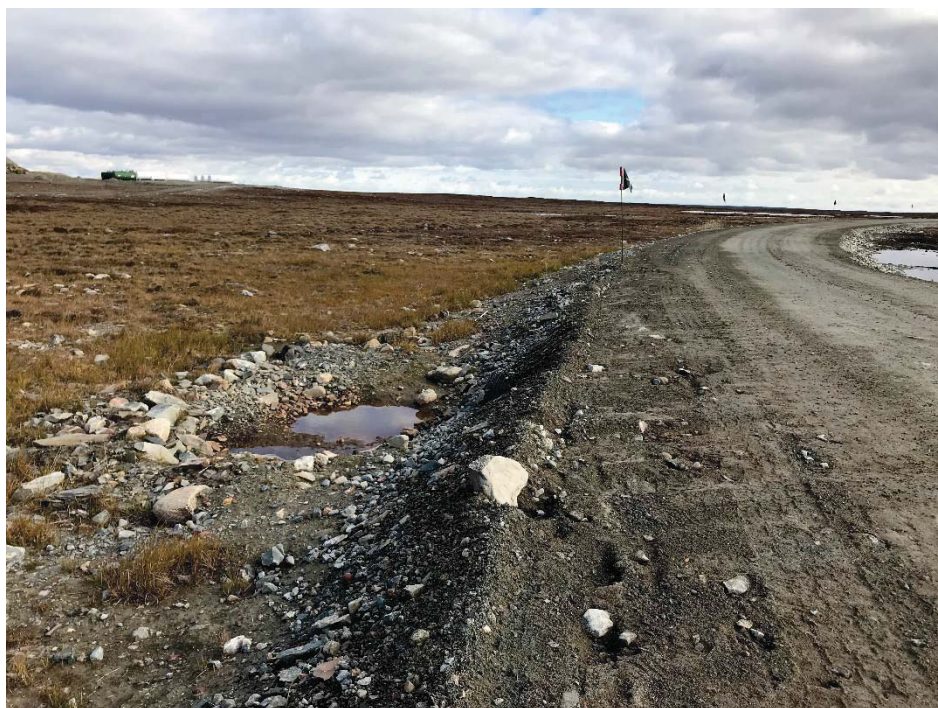
Photographs 111 through 114 are at KM29.6 where a single 500 mm Ø corrugated HDPE culvert is installed. Ponding water observed on the west side of road. Culvert inlet is partially blocked by road fill and riprap and is elevated above level of ponded water. Move riprap from in front of inlet and recommend lowering culvert invert to reduce ponding adjacent to road.

Photograph 113: Downstream end of 500 mm Ø corrugated HDPE culvert at KM29.6 (14 September 2018).
