CLIENT  
AGNICO-EAGLE MINES LIMITED  
MELIADINE GOLD PROJECT  
NUNAVUT

CONSULTANT  
GOLDER

PROJECT  
Meliadine Gold Project  
Rankin Inlet, Nunavut

**Itivia Fuel Storage, Laydown, and  
By-Pass Road Photographs**

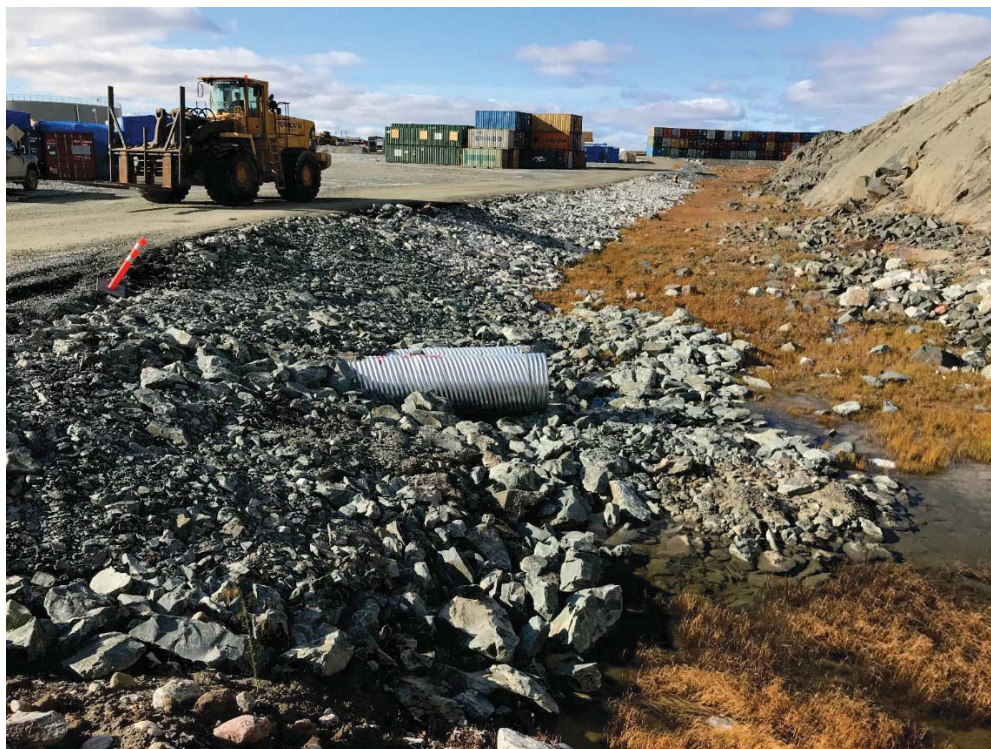
**Photograph 1: Inlets of Culverts at Entrance to Itivia Fuel and Laydown Area, Looking Southwest (14 September 2018).**

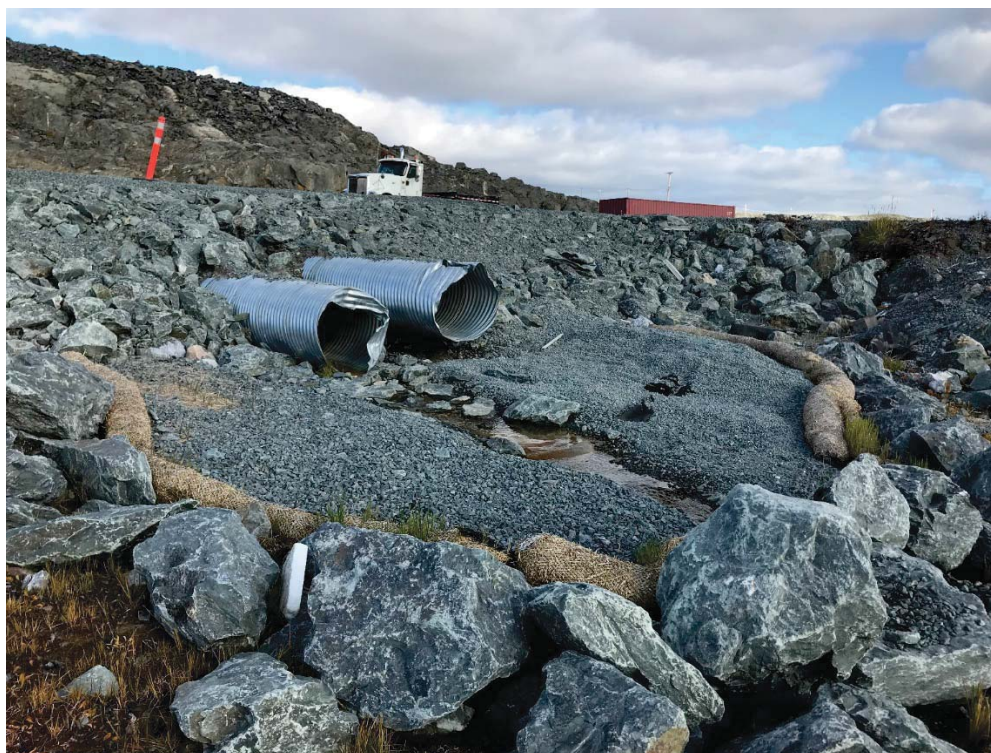
**Photograph 2: Outlets of Culverts at Entrance to Itivia Fuel and Laydown Area, Looking North (14 September 2018).**

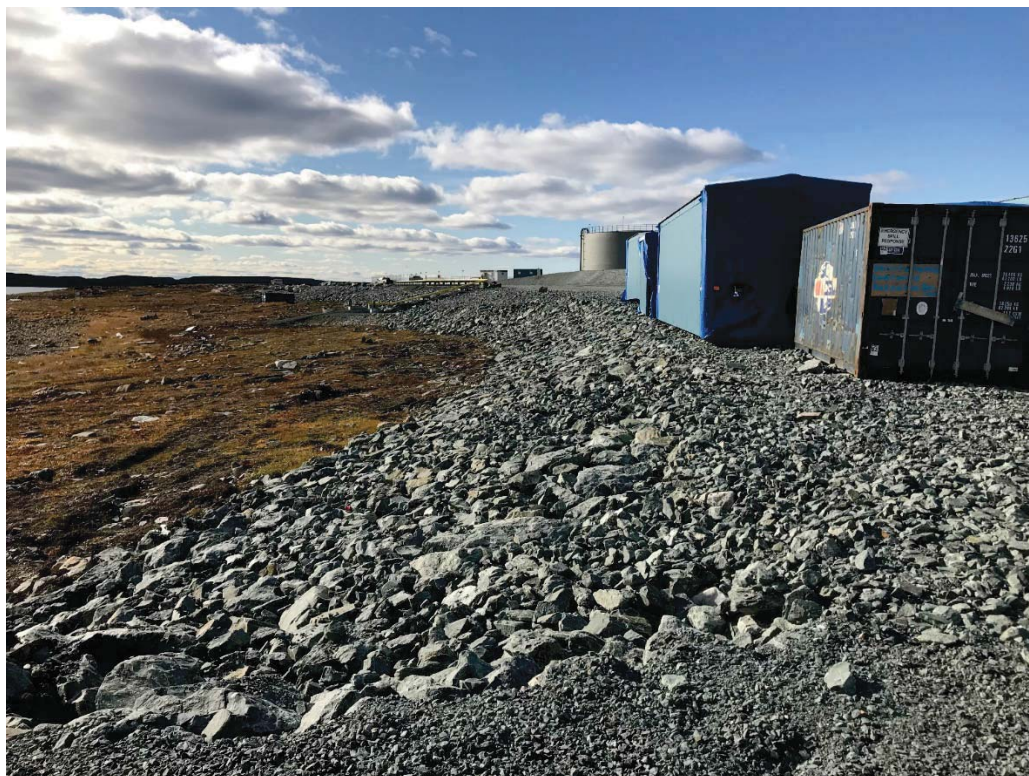
**Photograph 3: Itivia Fuel and Laydown Area, South Slope, Looking West (14 September 2018).**

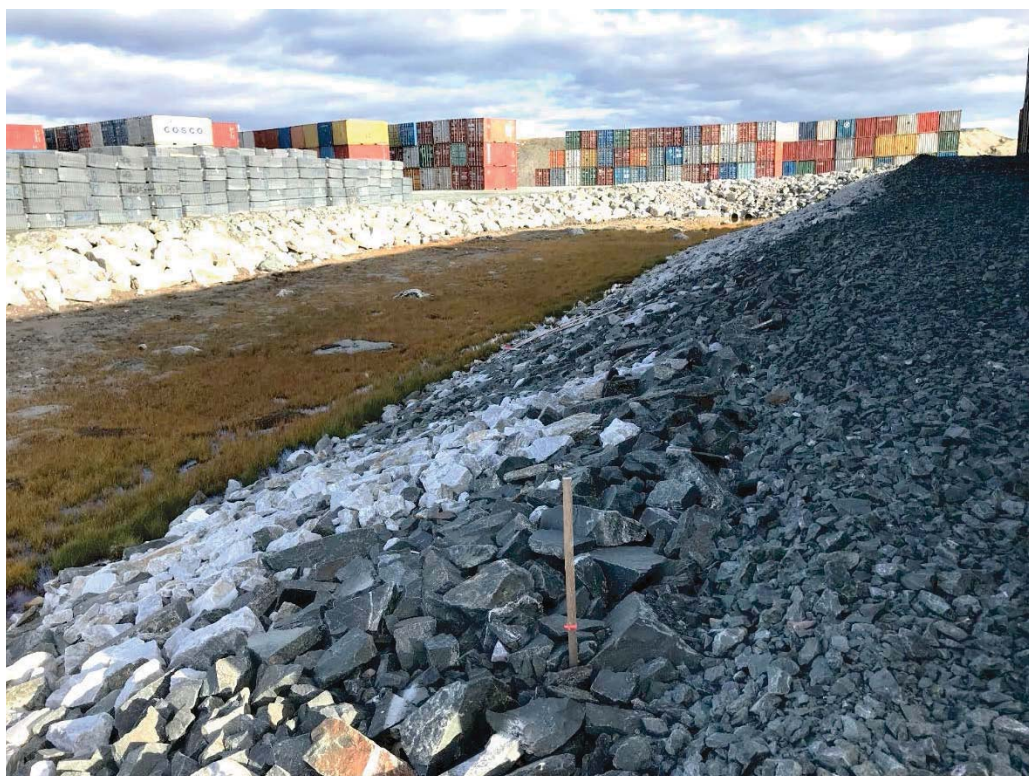
**Photograph 4: Itivia Fuel and Laydown Area, Pad Slopes on West End of Facility, Looking North (14 September 2018).**

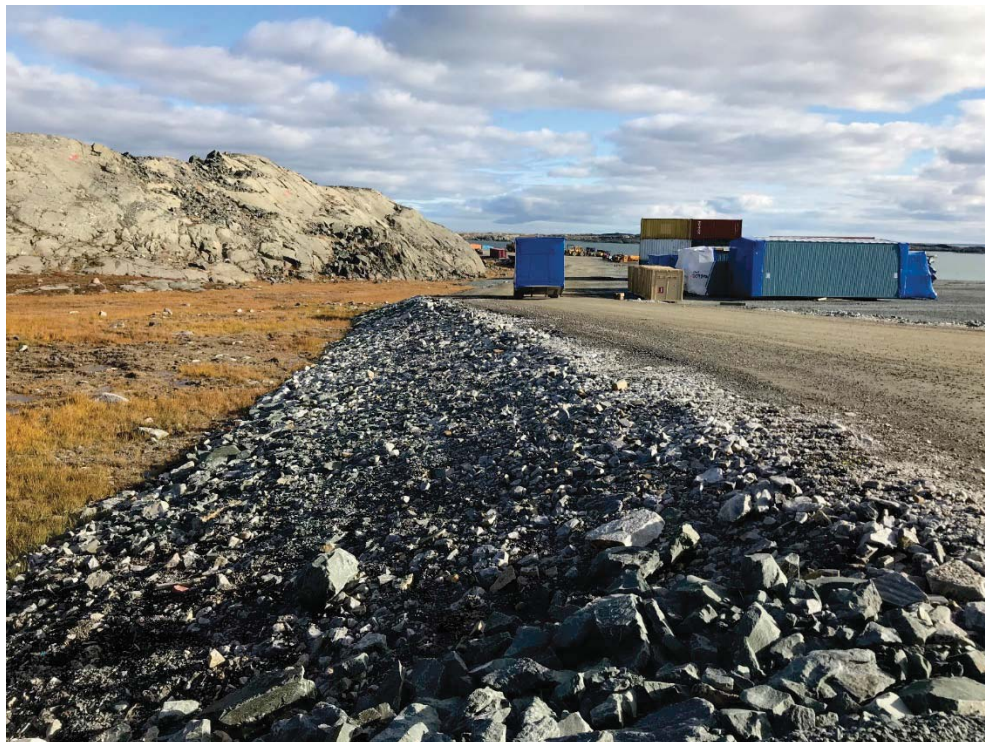
**Photograph 5: Itivia Fuel and Laydown Area, Pad Slope on North Boundary of Facility, Looking East (14 September 2018).**

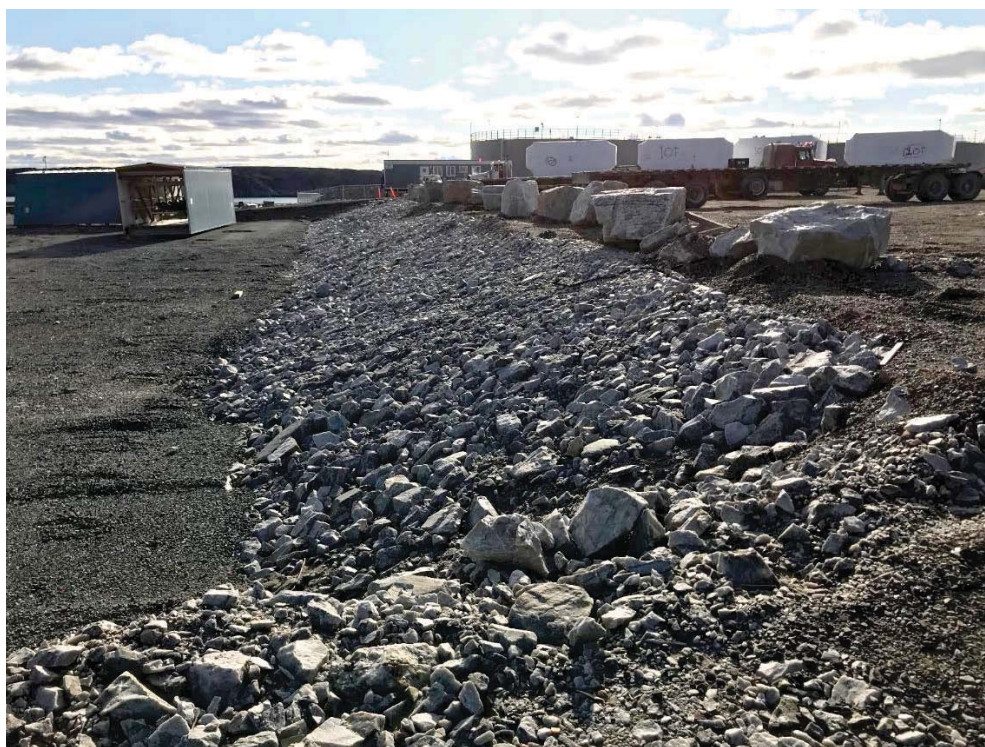
**Photograph 6: Itivia Fuel and Laydown Area, Interior Slope, Looking South (14 September 2018).**

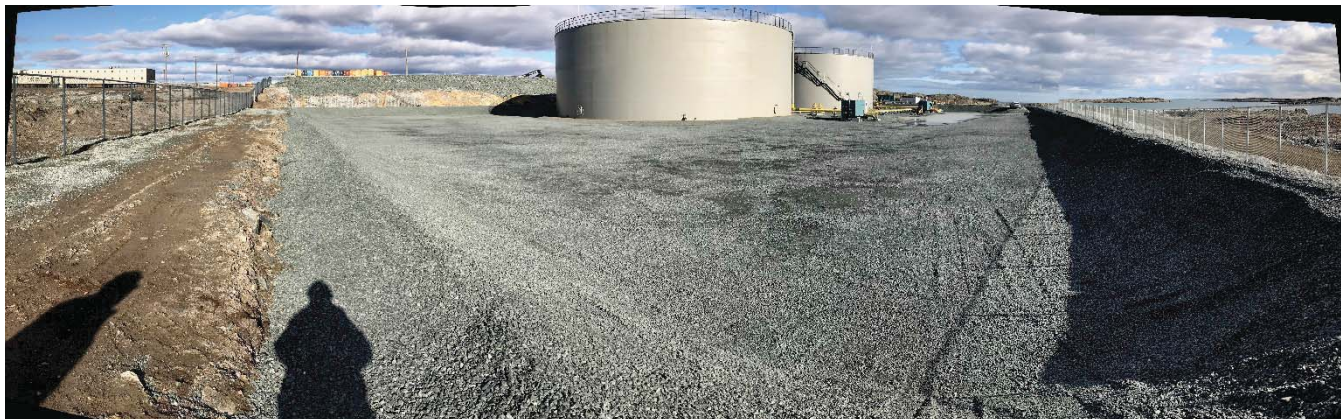
**Photograph 7: Itivia Fuel and Laydown Area, Overview of Interior of Fuel Storage Area, Looking Northeast from Southwest Corner. (14 September 2018).**

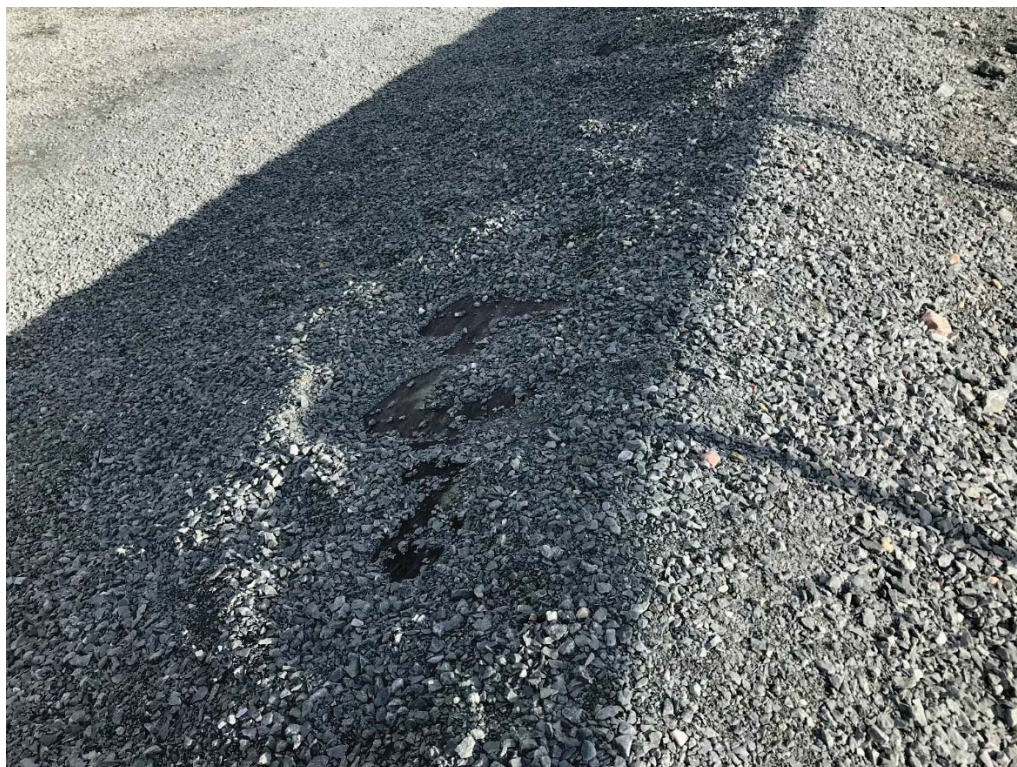
Photograph 9: Itivia Fuel and Laydown Area, Liner Exposed on Interior Slope of South Berm. (14 September 2018).

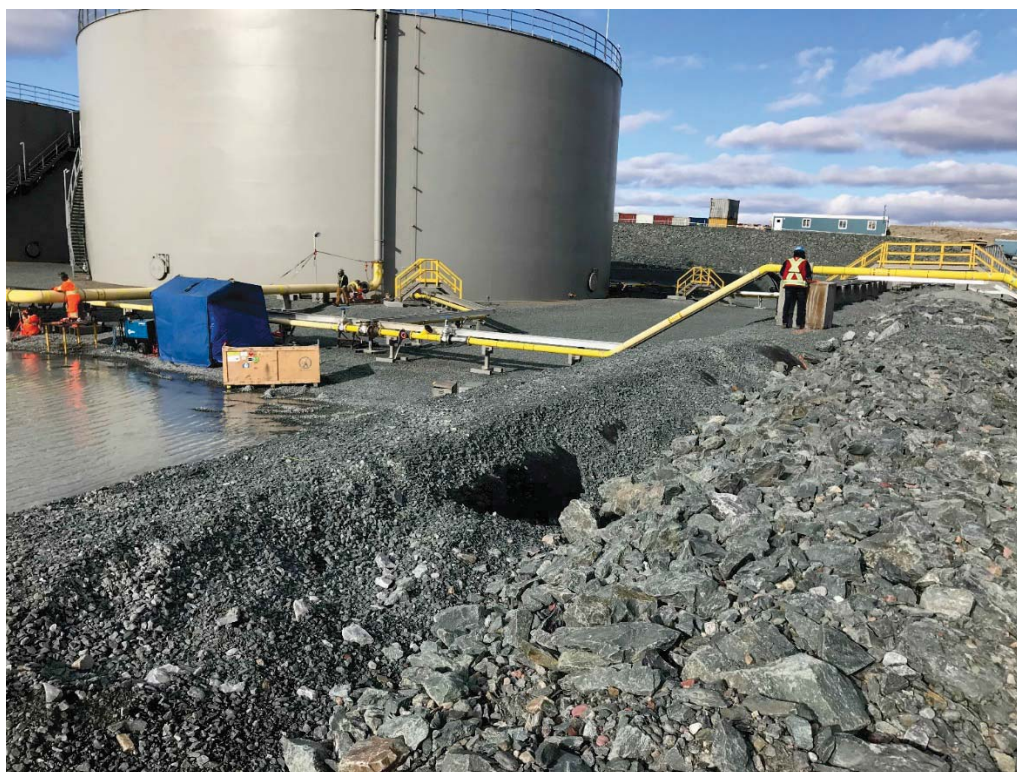
Photograph 10: Itivia Fuel and Laydown Area, Liner Exposed on Crest of East Berm. (14 September 2018).

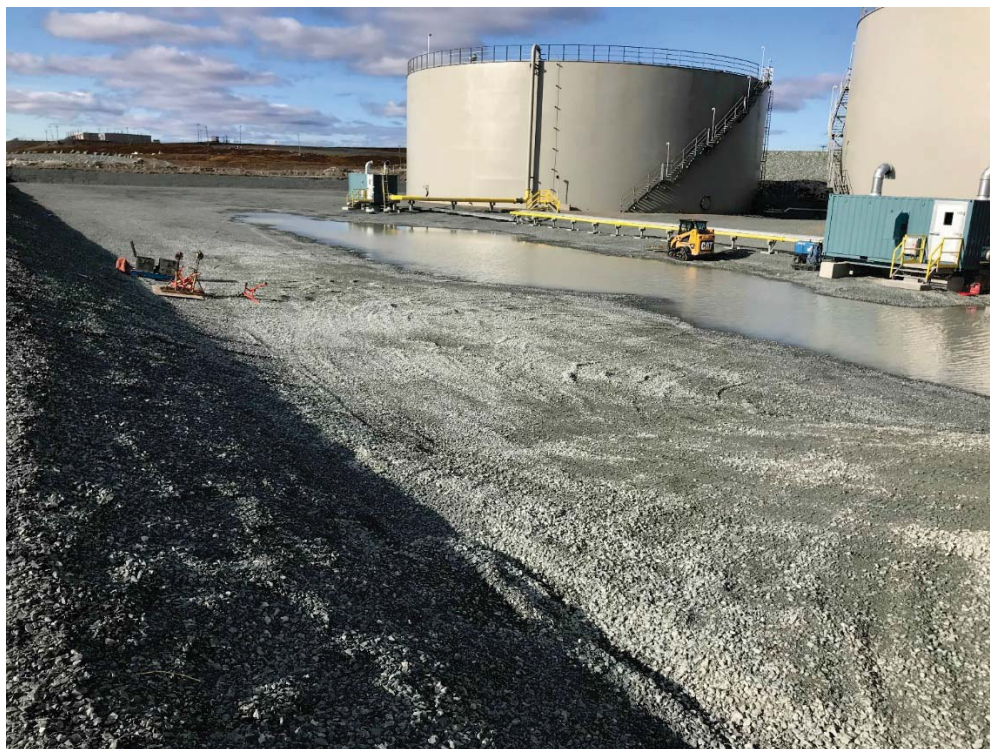
**Photograph 11: Itivia Fuel and Laydown Area, Water Poned on South Side of Tanks, actively being pumped at time of inspection, Looking Northwest. (14 September 2018).**

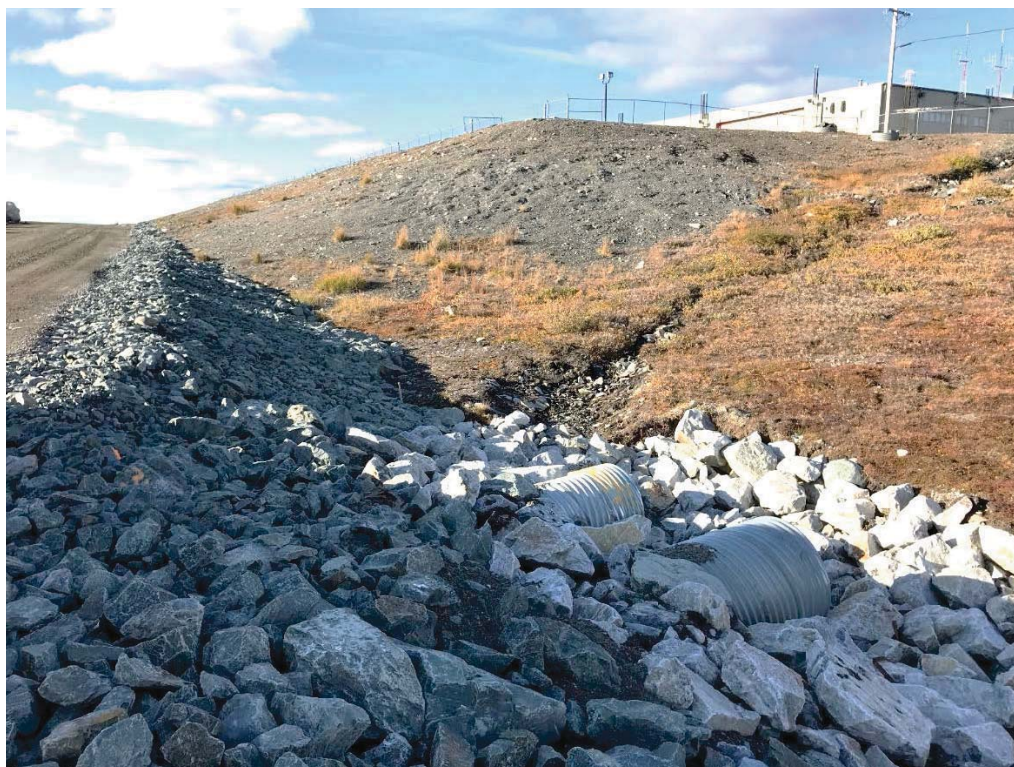
**Photograph 14: Inlets for Culvert C03, Looking North. Upstream Channel Erosion (14 September 2018)**

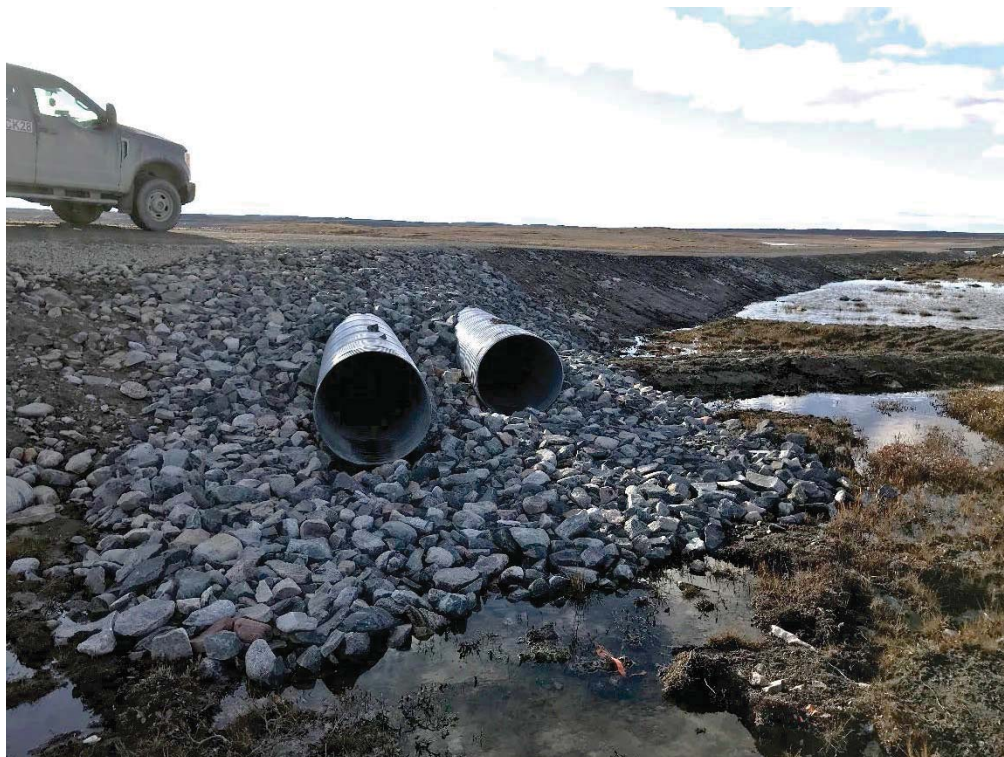
**Photograph 21: Inlets for Culvert C06, Looking Northwest. Water Ponded Adjacent to Road Near Inlets (14 September 2018)**

| | <p>Ponding of water adjacent to roads should be avoided. Disturbed areas from road construction should be recontoured to promote drainage away from the road and adjacent areas. This was most notable along the Emulsion Plant and Wearing Borrow access roads.</p> | <p>Medium</p> | <p>Already implemented</p> | <p>Ponding has been noted to be ephemeral in most areas adjacent to roadways and thus permafrost degradation is not a concern when ponds only exist following rain events. The design team has been consulted and agreed that the potential for TSS transport and road washout, AEM agrees that ponded areas should not be allowed to overtop during heavy rainfall.</p> | <p>AEM will continue to monitor roadways to identify locations of long-term ponding and plan to install catch basins to reduce ponding and potential for road wash outs.</p> | <p>Environment</p> | <p>Freshet/Open water season 2019</p> |

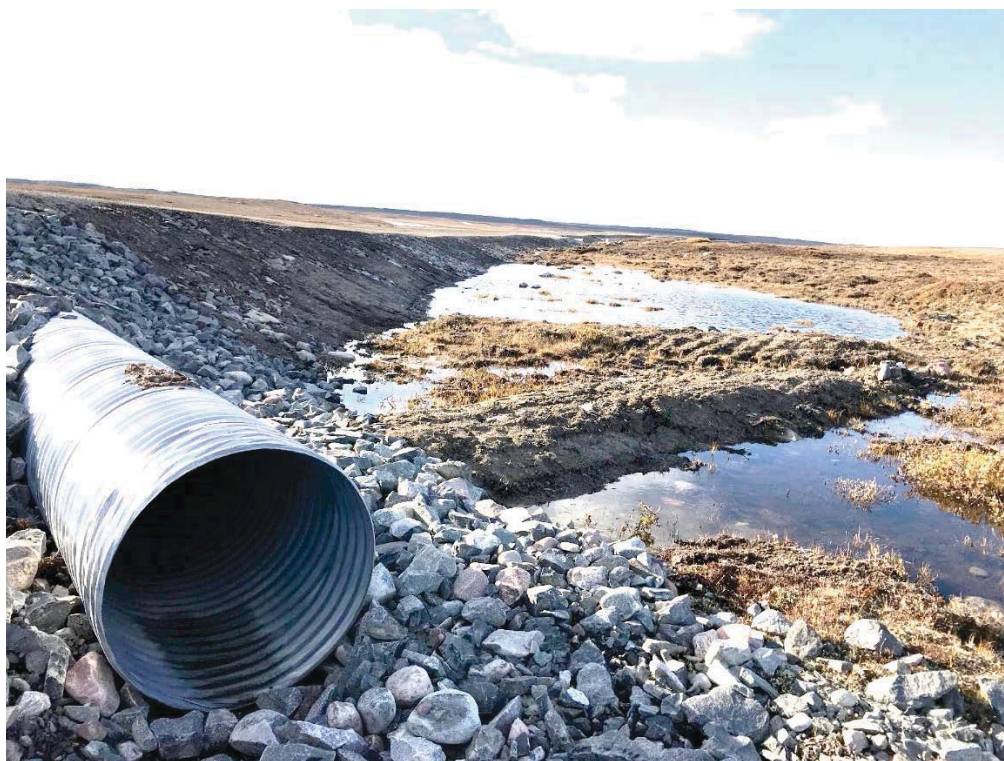
**Photograph 22: Diversion Berm West of Culvert C06. Water Ponded Adjacent to Road. Looking Northwest (14 September 2018)**

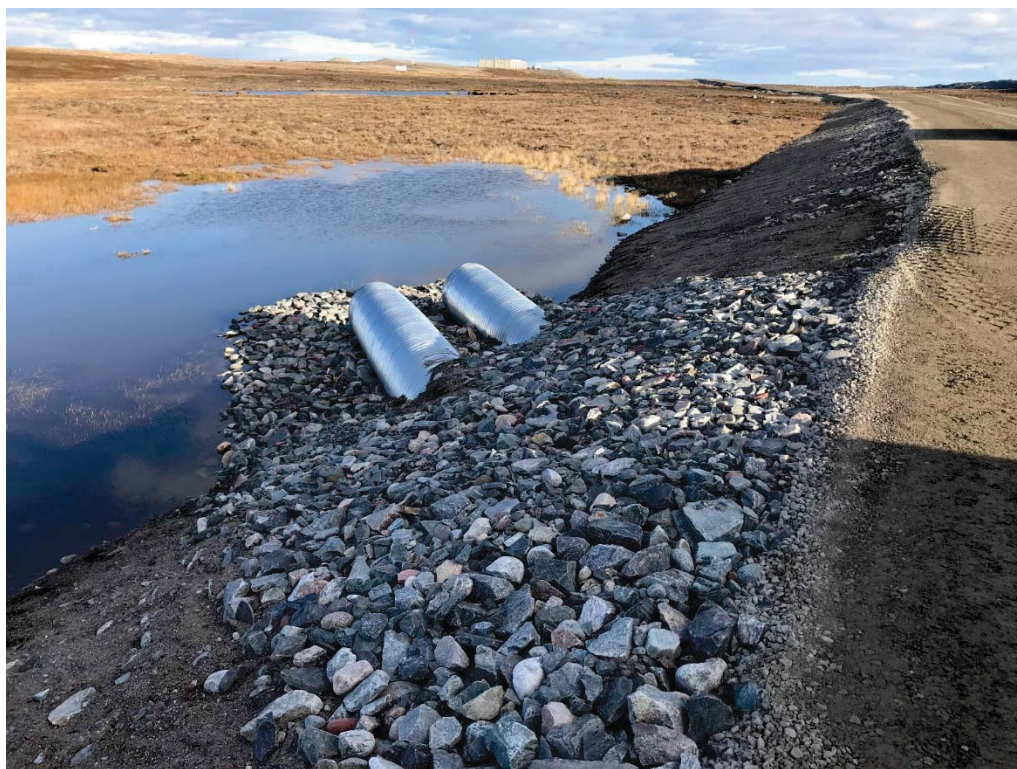
**Photograph 26: Inlets and Upstream Poned Water at Culvert C07a, Looking East (14 September 2018)**

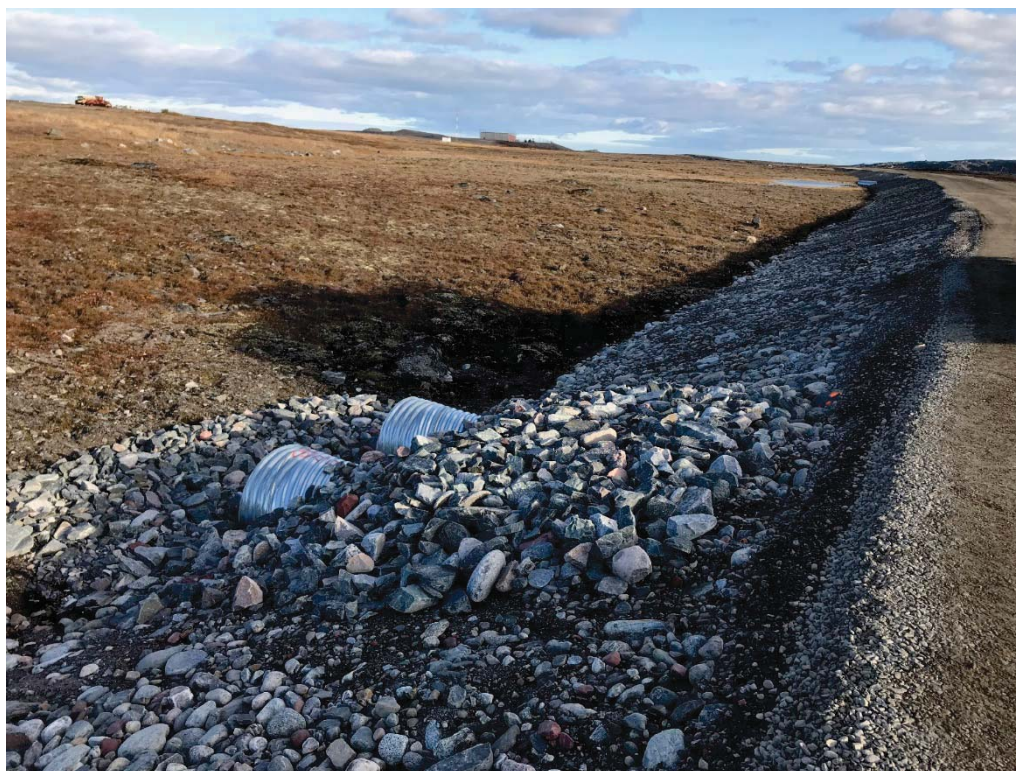
**Photograph 27: Outlets of Culvert C07a, Looking West (14 September 2018)**

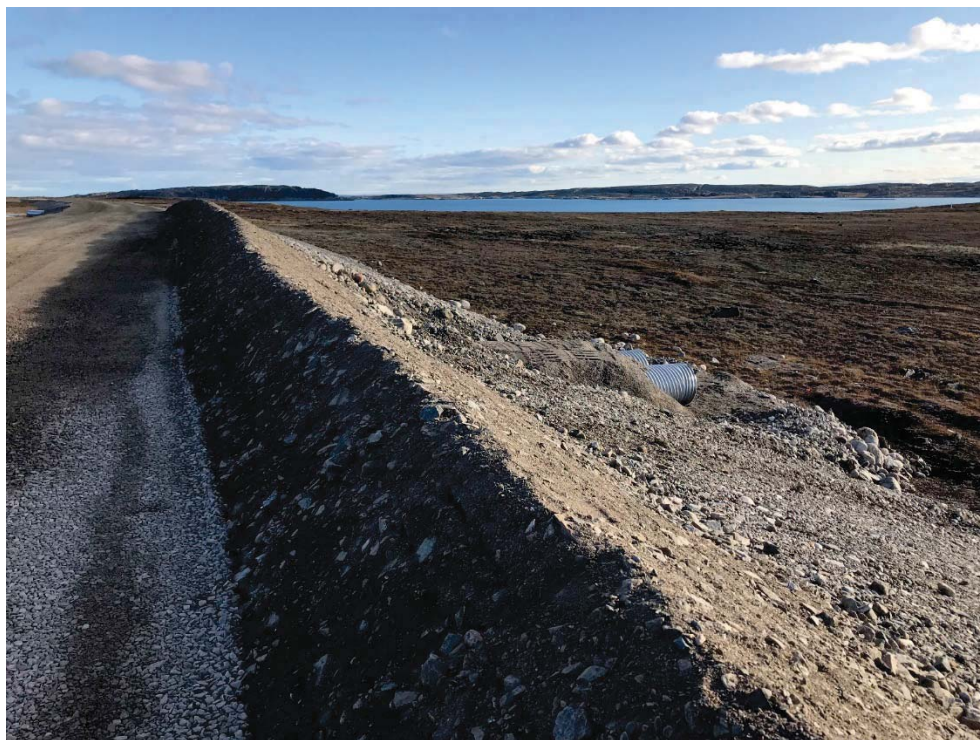
**Photograph 28: Inlets of Culvert C07b, Looking East (14 September 2018)**

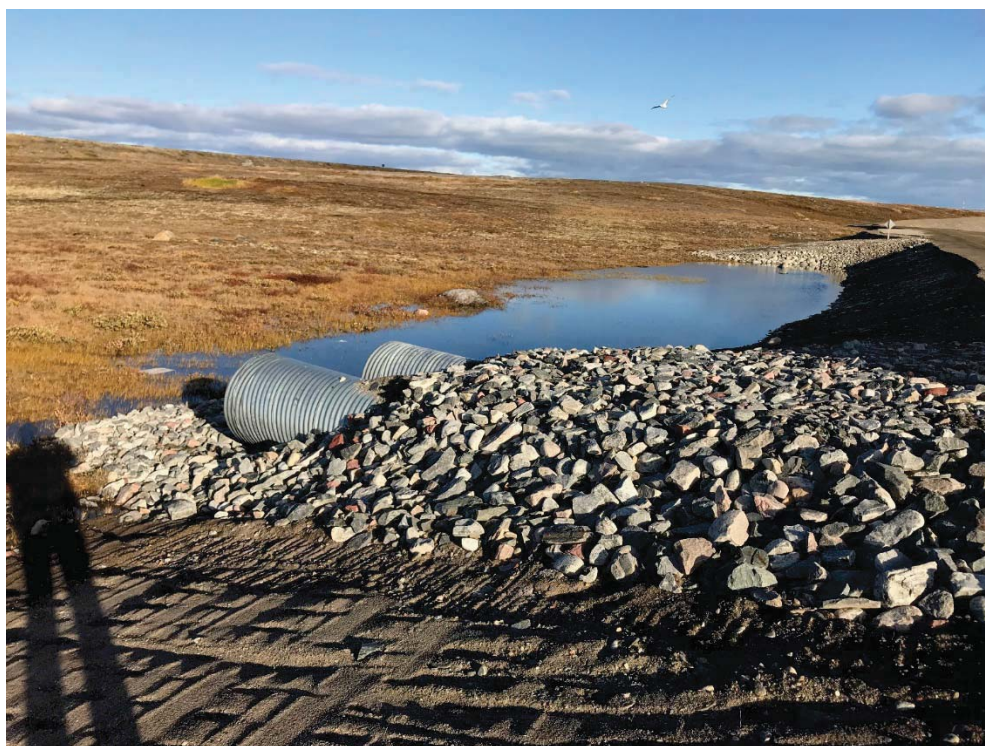
**Photograph 29: Safety Berm and Embankment Slope over Culvert C07b Outlets, Looking Southeast (14 September 2018)**

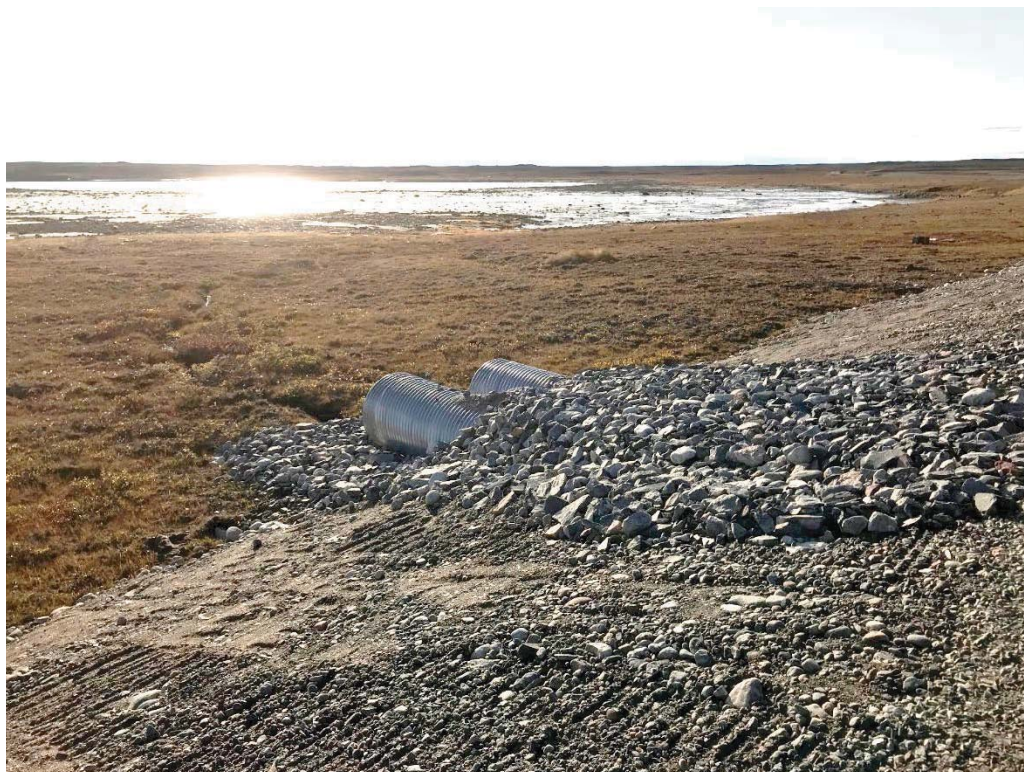
**Photograph 30: Ponded Water to the East of Inlet for Culvert C09, Looking East (14 September 2018)**

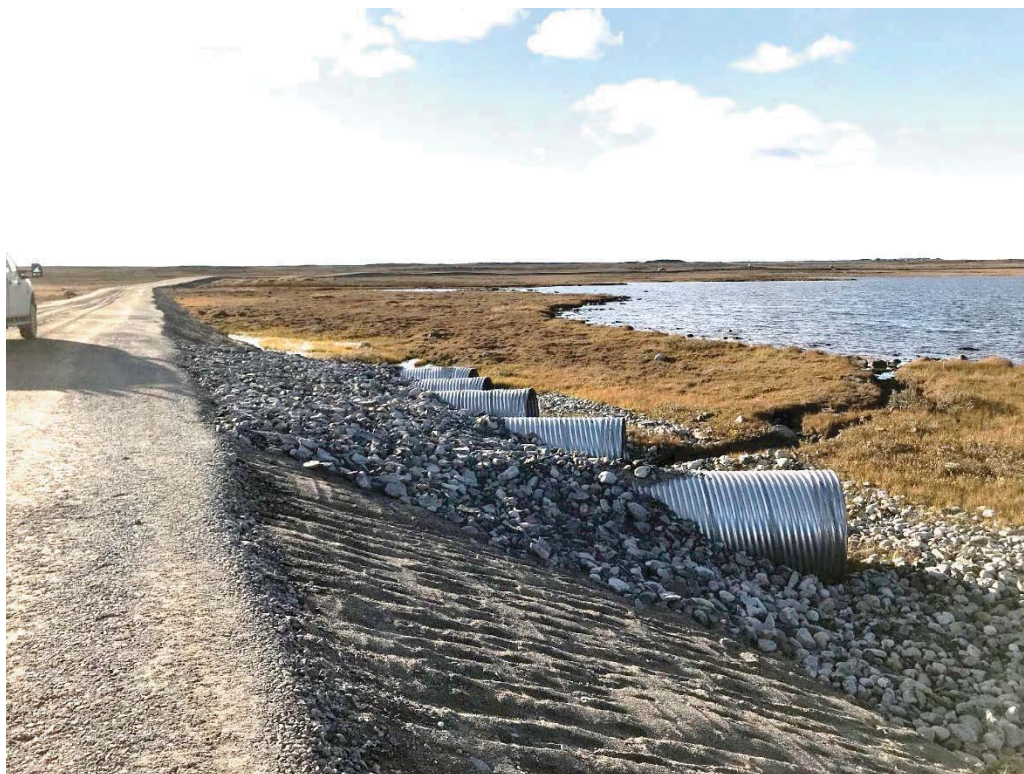
**Photograph 31: Road Embankment and Outlets for Culvert C09, Looking West (14 September 2018)**

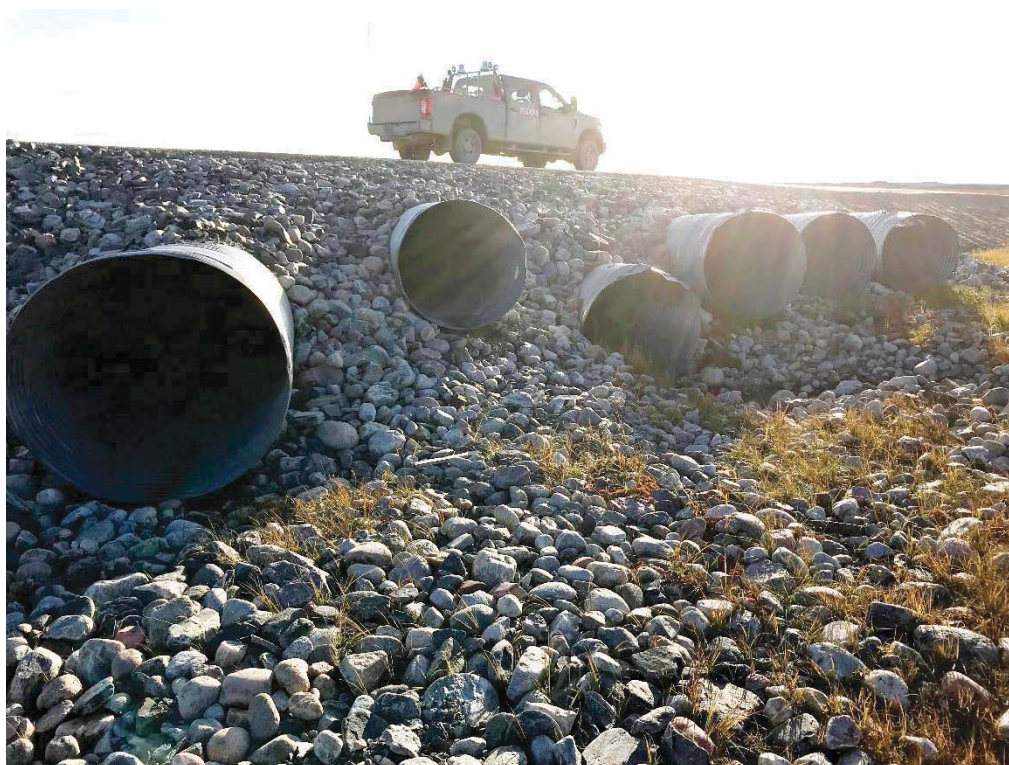
**Photograph 32: Inlets for Culvert C10, Looking East (14 September 2018)**

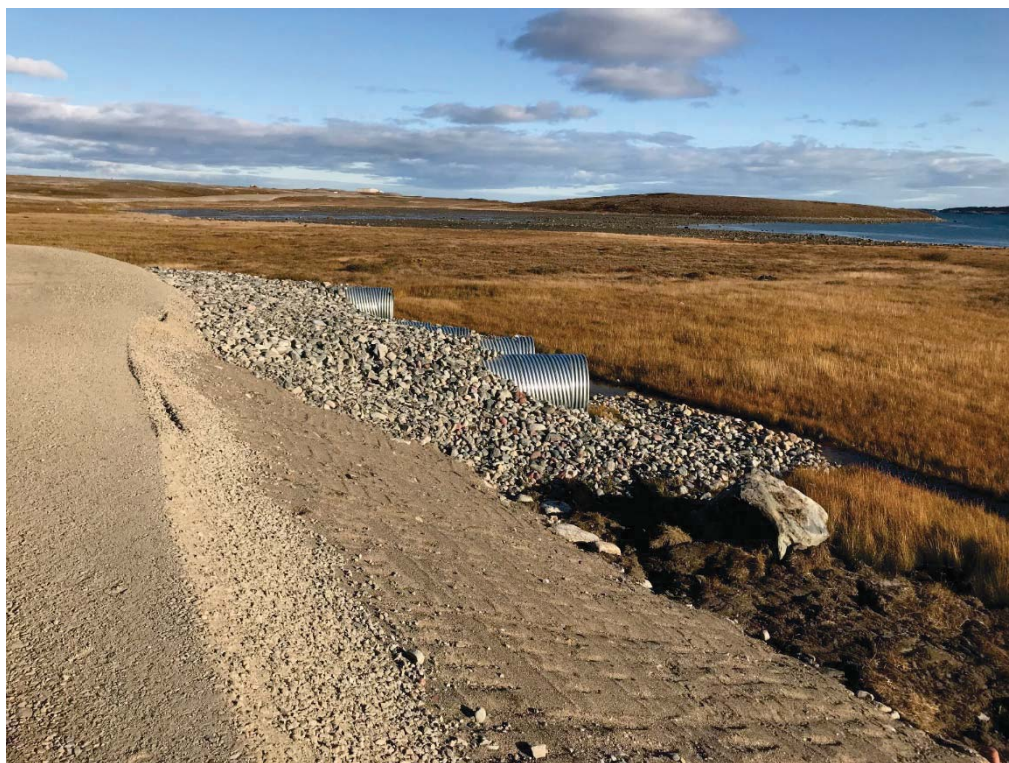
**Photograph 33: Inlets for Culvert C10, Looking South (14 September 2018)**

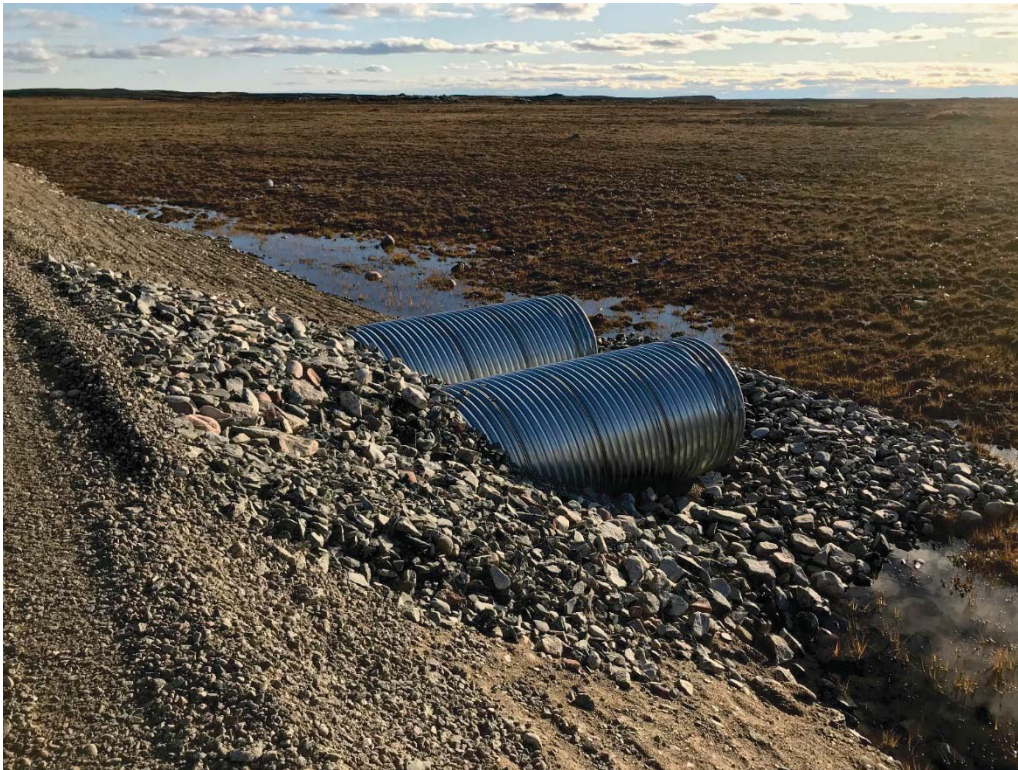
**Photograph 34: Outlets for Culvert C10, Looking Southeast (14 September 2018)**

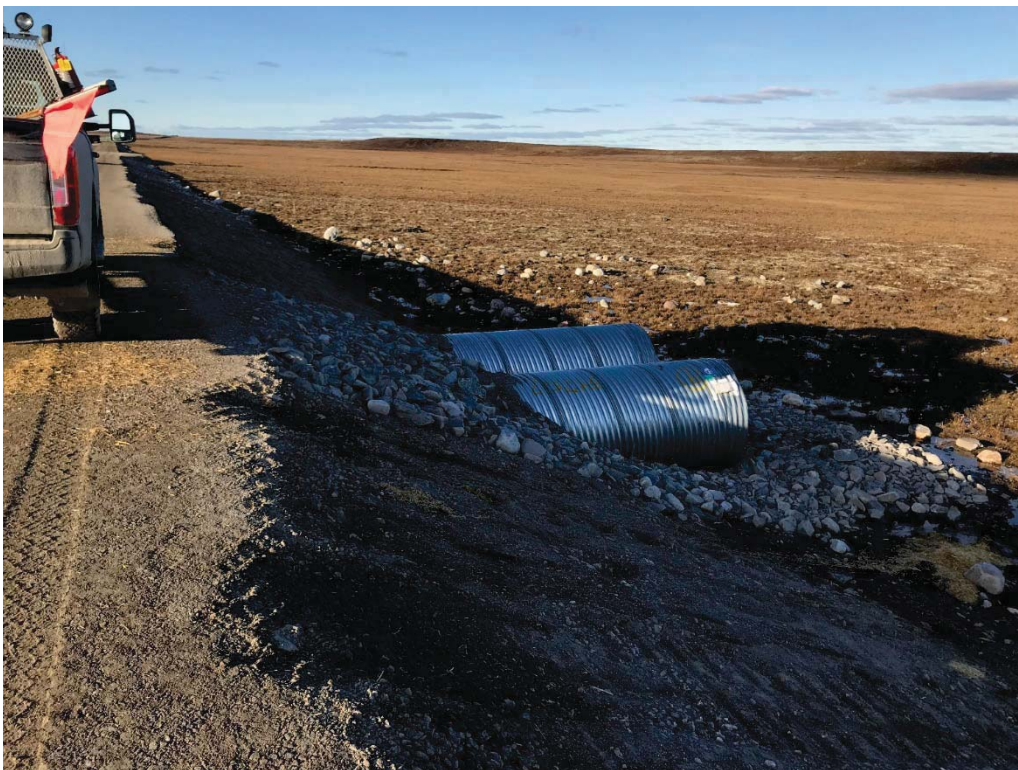
Photograph 35: Inlets of Culvert C11a, Looking Southwest (14 September 2018)

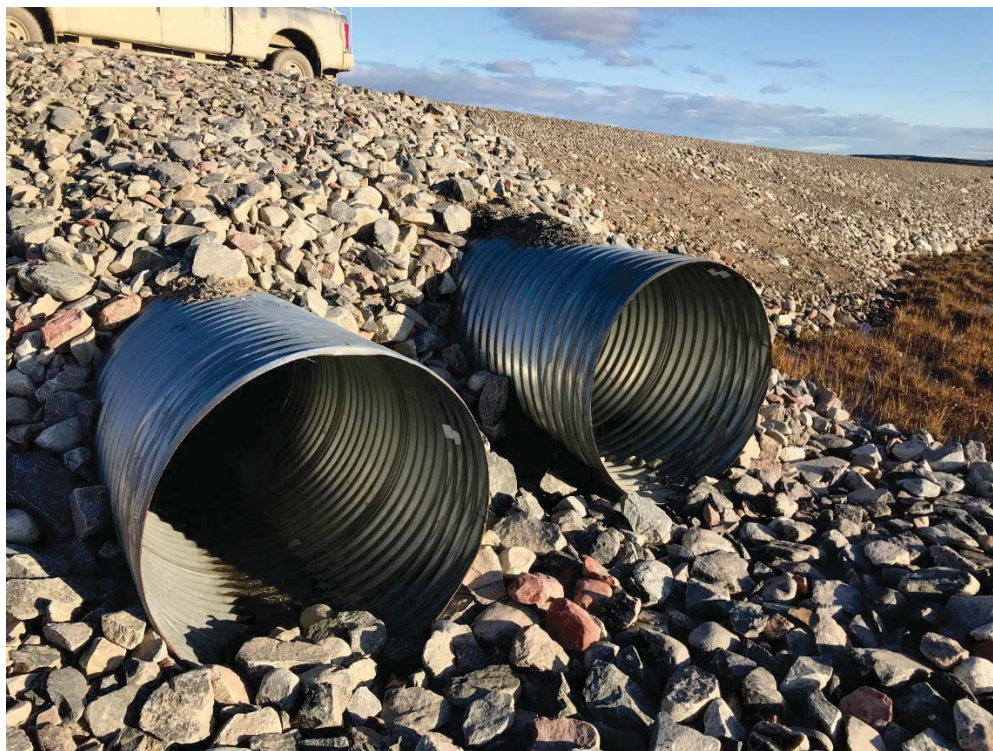
Photograph 36: Outlets of Culvert C11a, Looking North (14 September 2018)

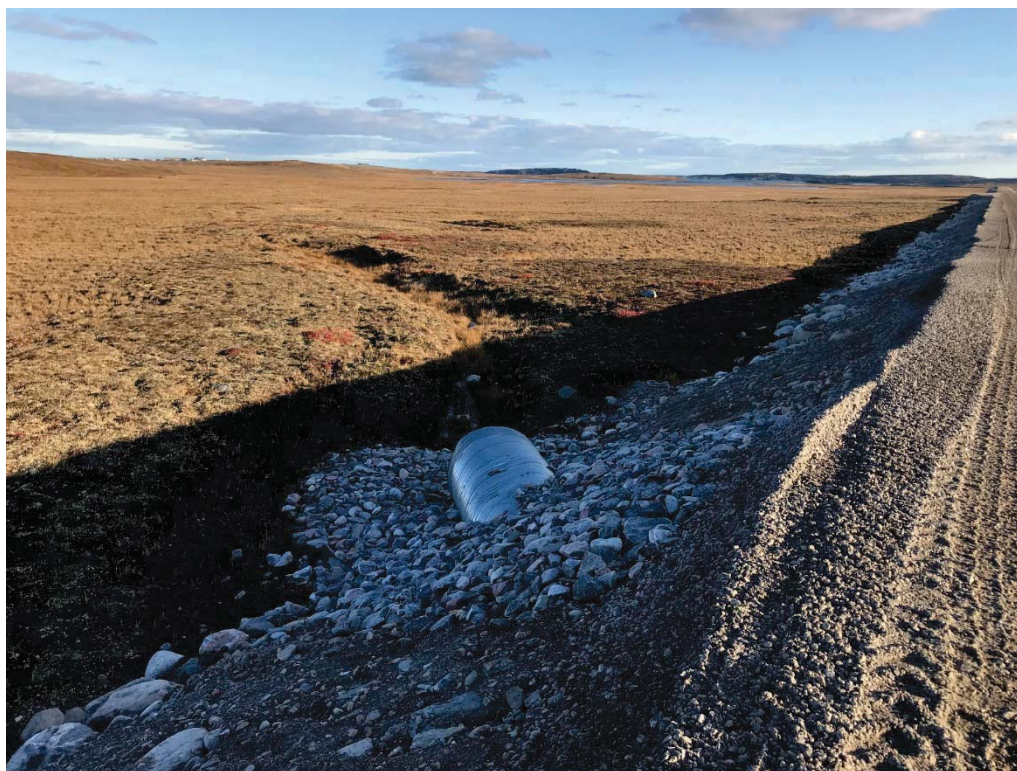
**Photograph 39: Upstream Natural Drainage Path and Culvert C11b-1 Inlet, Looking West (14 September 2018)**

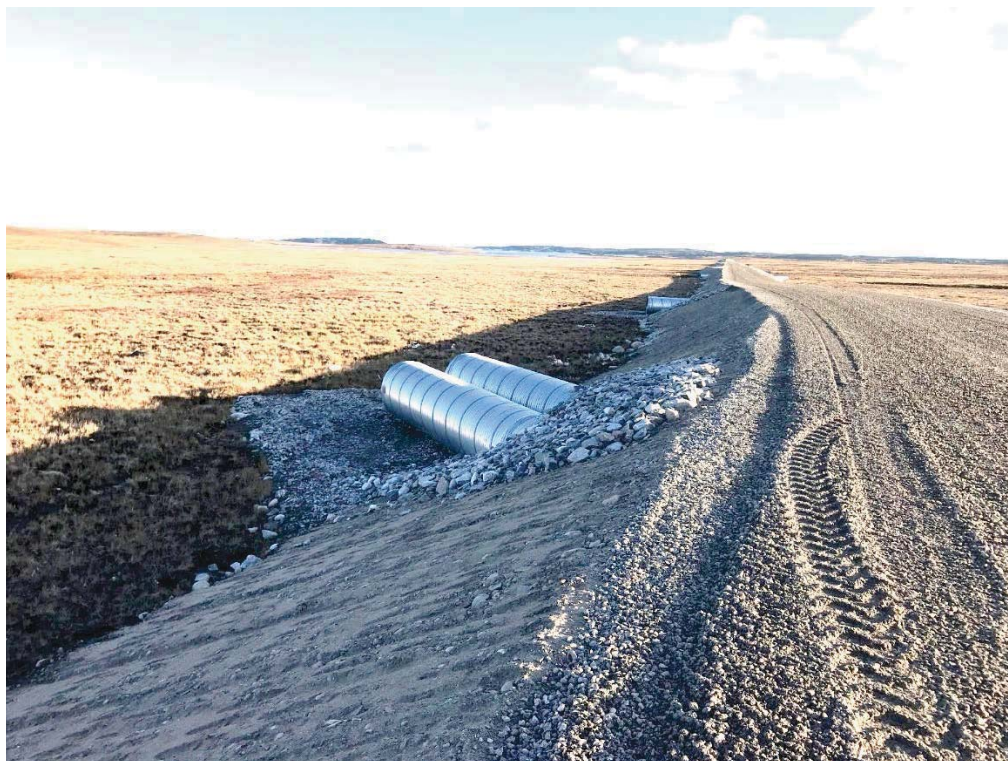
**Photograph 44: Culvert 12a Outlet, Looking North (14 September 2018)**

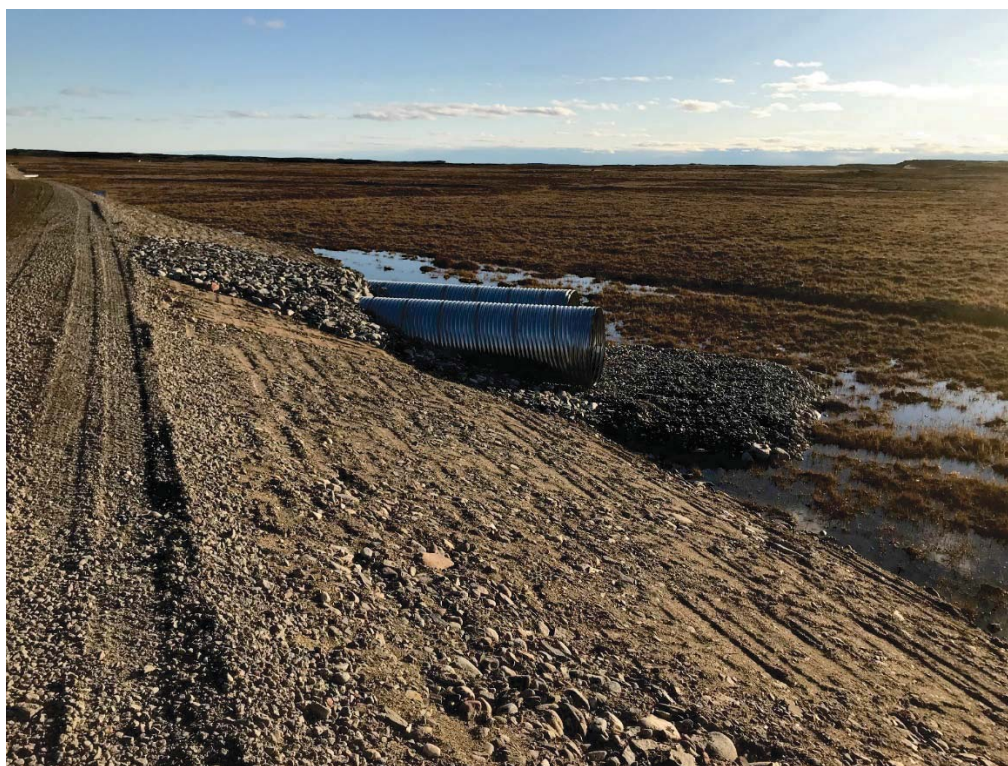
**Photograph 45: Culvert 12b Inlets, Looking Southeast (14 September 2018)**

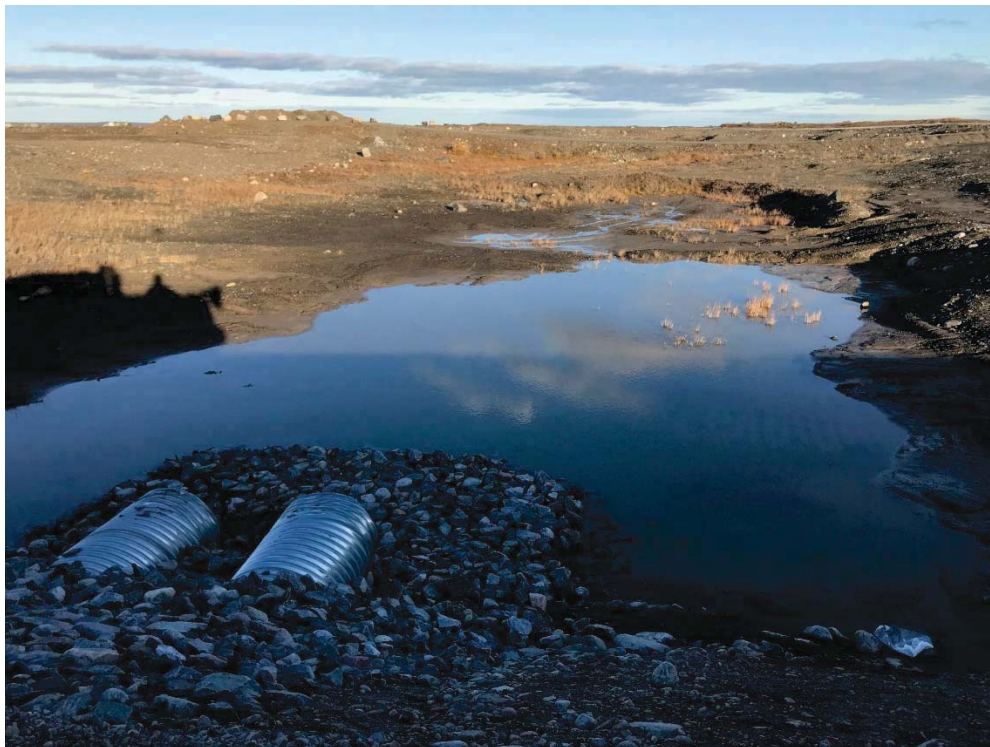
**Photograph 46: Culvert 12b Outlets, Ponded Water Below the Inverts and Against Road Embankment Toe, Looking South (14 September 2018)**

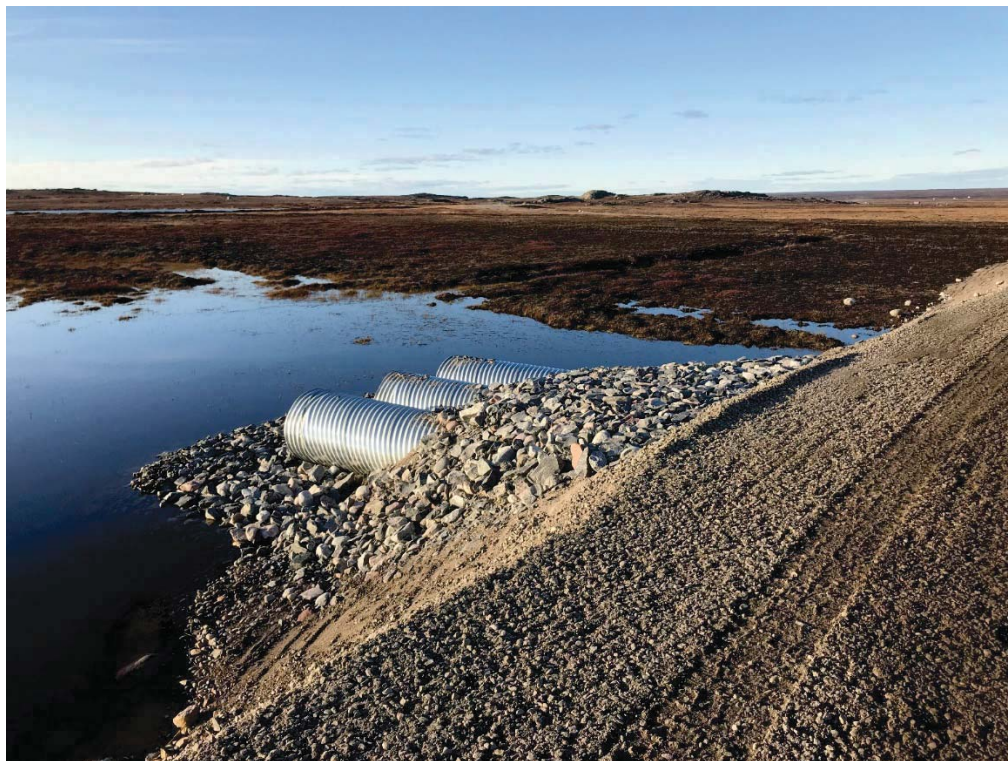
**Photograph 49: Culvert 14 Inlets, Ponded Water Upstream and Below Inverts, Looking Northeast (14 September 2018)**
