APPENDIX 15 2024 REPORTABLE SPILLS

Re: Follow-up Report Spill #2024-001 – Release of 150 L of Sewage at the Meliadine Gold Mine

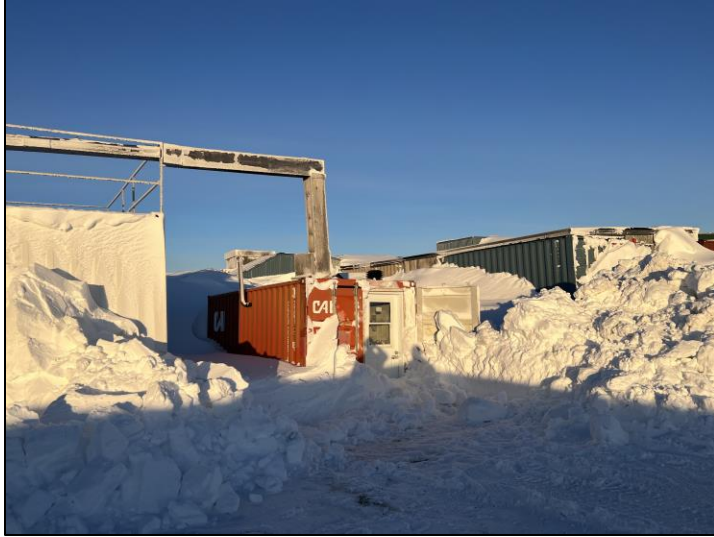
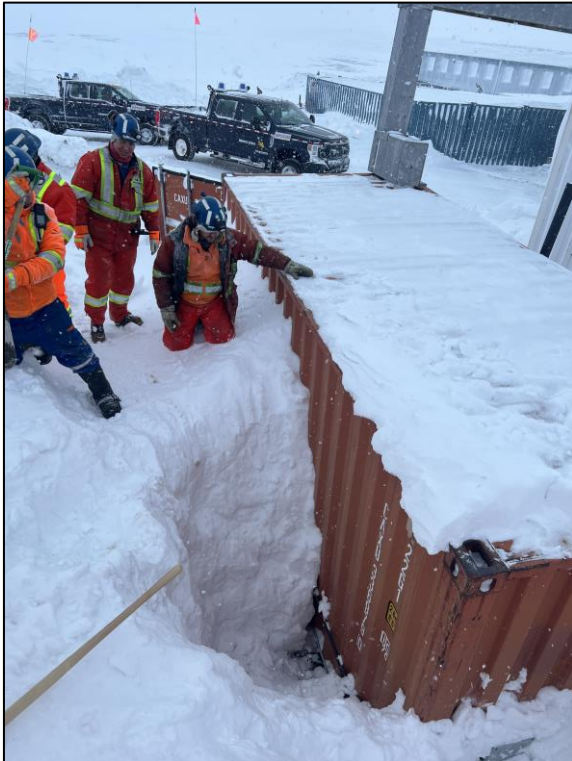
On January 10th, 2024, at approximately 15:00, an estimated 1m³ of sewage was spilled onto the ground at a lift station between the exploration camp sewage holding tank and an accommodation wing. The spill was discovered when a sewage truck operator found the exploration camp sewage holding tank was empty. The employee notified their supervisor, who subsequently inspected the sewage system. During the inspection it was found that the lift station between the camp sewage holding tank and the accommodation wing was not activated during the temporary reopening of the exploration camp. As a result, this lift station did not convey sewage to the final holding tank and overflowed, resulting in an estimated 1m³ sewage spill.

Photos 1 and 2: Sewage spill location.

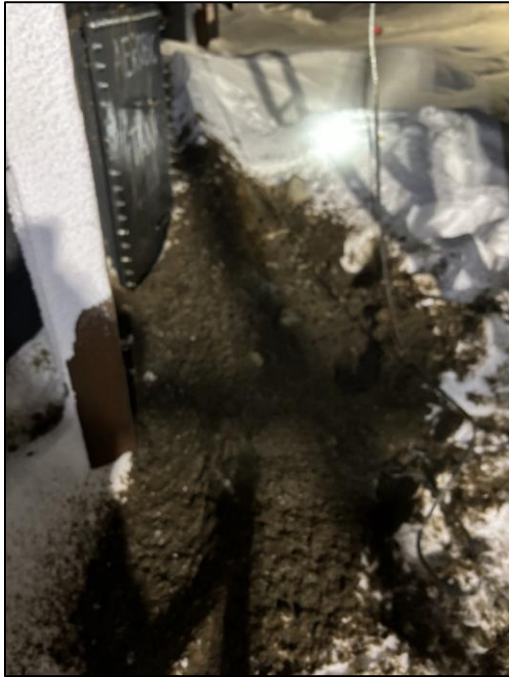
- An upset within the STP resulted in elevated MLSS and the creation of high amounts of foam within the aerobic tank. The upset condition was suspected to be due to a large volume of milk being disposed of from the kitchen, leading to an increase in MLSS and excessive foam generation.
- An accumulation of ice around the aerobic tank vents allowed pressure to build within the aerobic tank.
- An overflow device on the membrane filtration tank was blocked contributing to the spillover within the STP.

Photo 1: Sewage spill location.

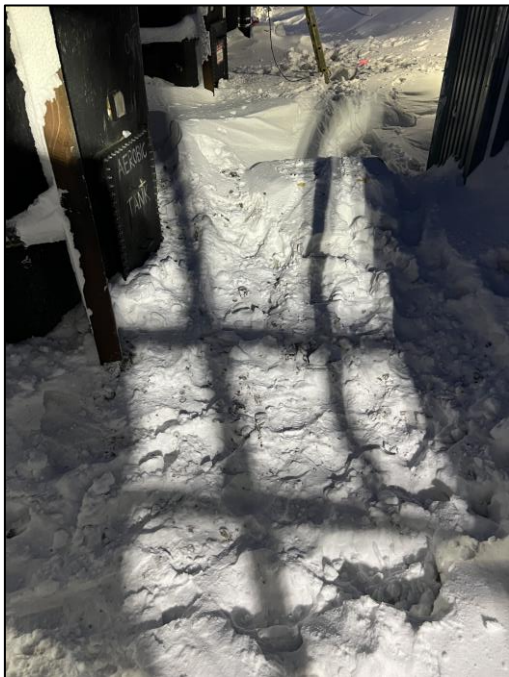
Photo 2: Spill location post remediation.

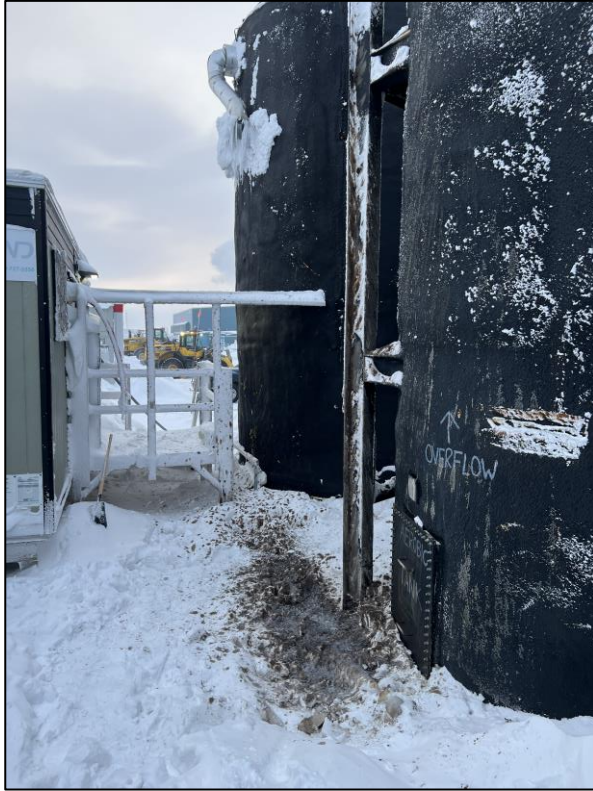
On January 13th, 2024, at approximately 10:00, an estimated 15 L of sewage was spilled onto the industrial pad during maintenance work at the STP in response to the spill that occurred on January 10th. The aerobic tank was isolated from the STP to conduct inspection and maintenance work on the distribution line between the aerobic tank and the membrane filtration tank. The STP operator failed to shut down the blower in the aerobic tank while the maintenance was being conducted. The blower generated excessive foam, which escaped from the vent at the top of the tank, resulting in the spill.

Photo 3: Sewage spill location.

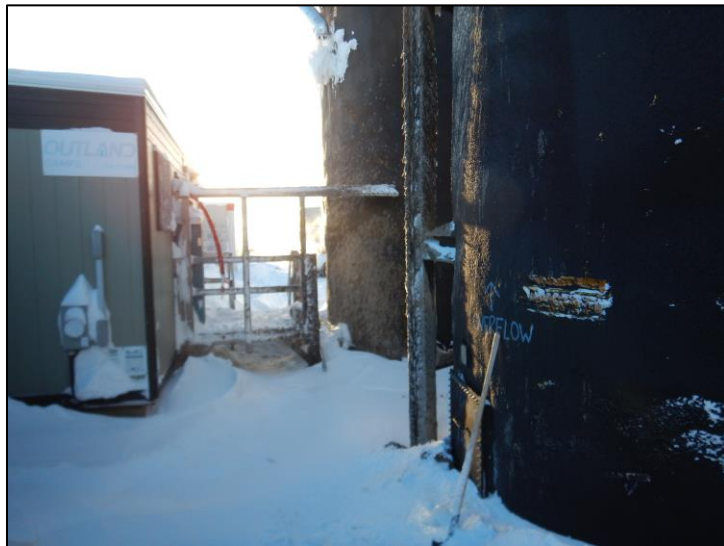
Photo 4: Spill location post remediation.

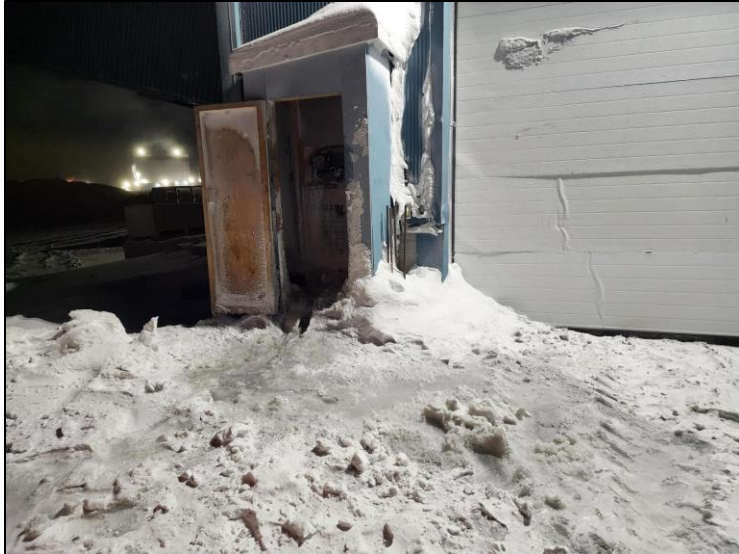
On January 22nd, 2024, at approximately 07:00, an estimated 30 L of sewage was spilled onto the industrial pad at the crusher water transfer outlets. A Sarliaq employee filled the crusher lavatory's freshwater tank using a water truck. While he was refilling the water tank, sewage released out of the sewage tank outlet causing the spill.

Photo 1: Sewage Spill

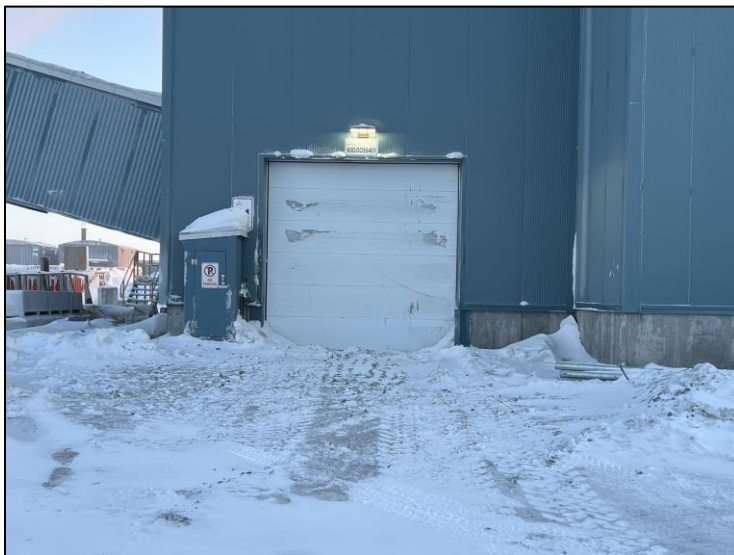
Photo 2: Post-Remediation

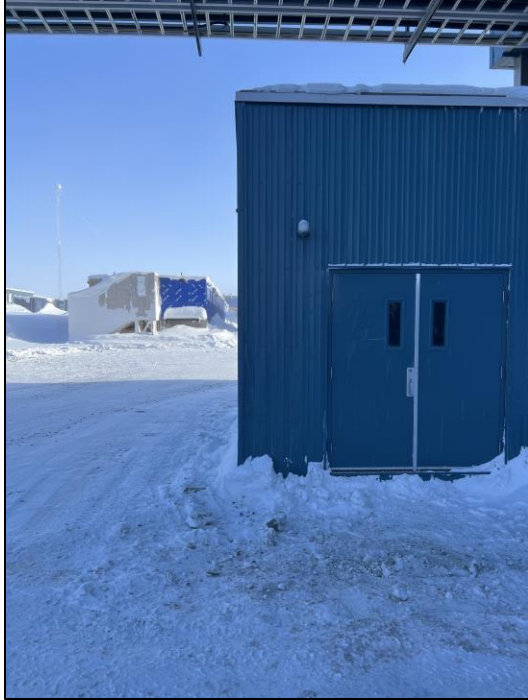
On February 28th, 2024, at approximately 16:30, an estimated 7 L of sewage was spilled onto the industrial pad at the MSB lift station. Following normal operation of the vacuum truck to offload sewage into the MSB lift station, the operator attempted to switch the truck's mode from discharge to vacuum function. However, the power take-off (PTO) mechanism was frozen, preventing the mode change. When the operator attempted to clear the residual sewage in the hose by vacuuming, the truck discharged instead, resulting in the spill.

Photo 1: Sewage spill location.

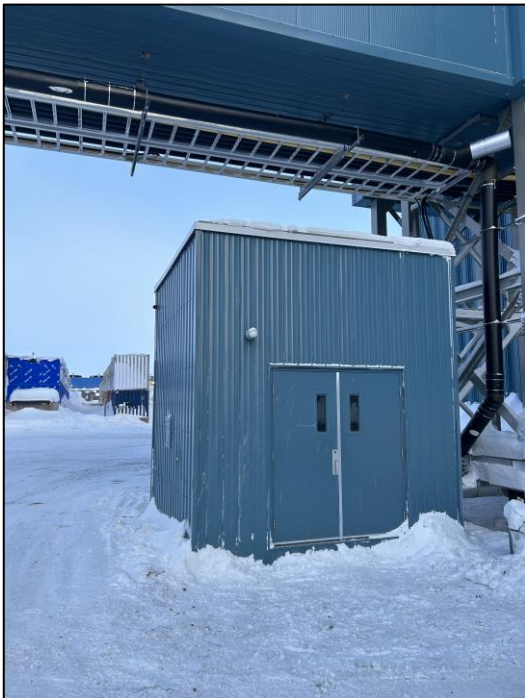
Photo 2: Spill location post remediation.

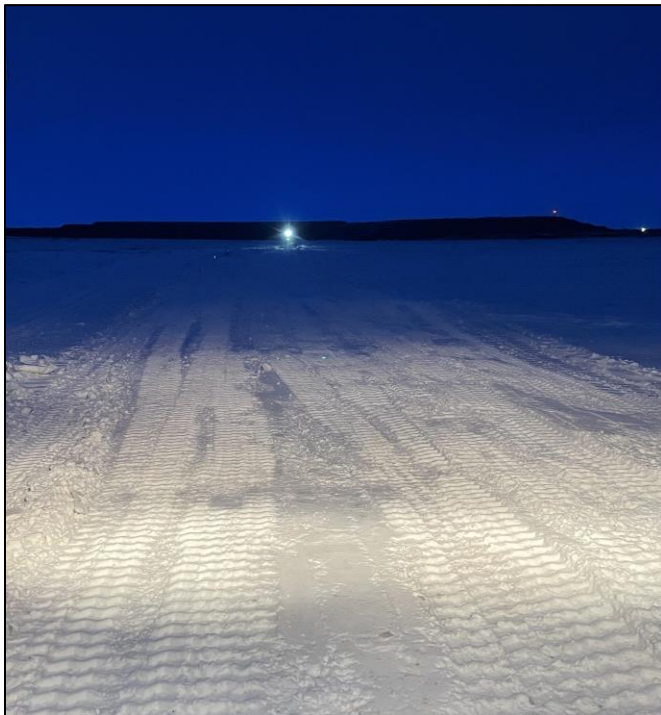
Photo 2: Spill area post remediation.

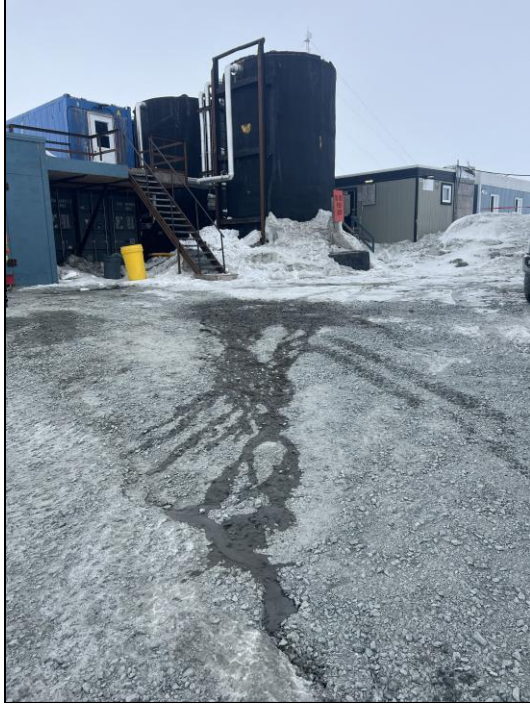
On May 3rd, 2024, at approximately 9:30 am, an estimated 30 L of sewage was spilled onto the industrial pad at the Sewage Treatment Plant (STP). During routine treated sewage collection at the STP, the vacuum truck was parked on a slope, resulting in the operator filling it over its capacity due to an inaccurate visual level check. Once over capacity, the function of the sewage truck vacuum pump could no longer vacuum sewage. Unaware of this, the sewage truck operator attempted to initiate the pump to remove the residual sewage in the vacuum hose, causing a pressure release and a spill of residual sewage in the vacuum hose.

Photo 1: Sewage spill location.

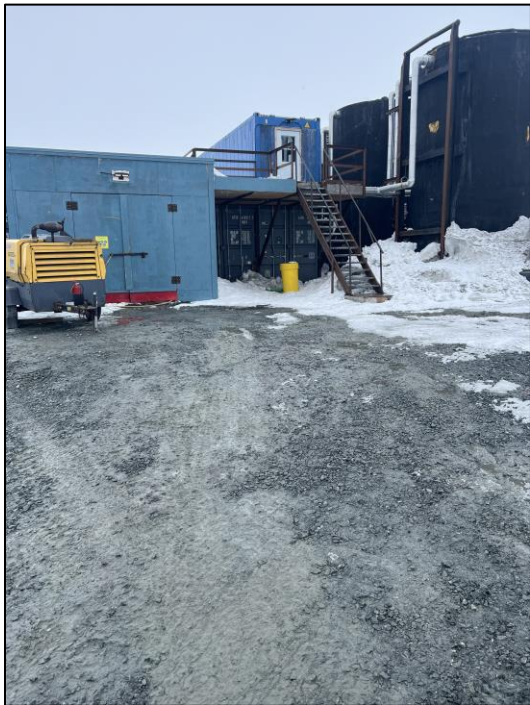
Photo 2: Spill location post remediation.

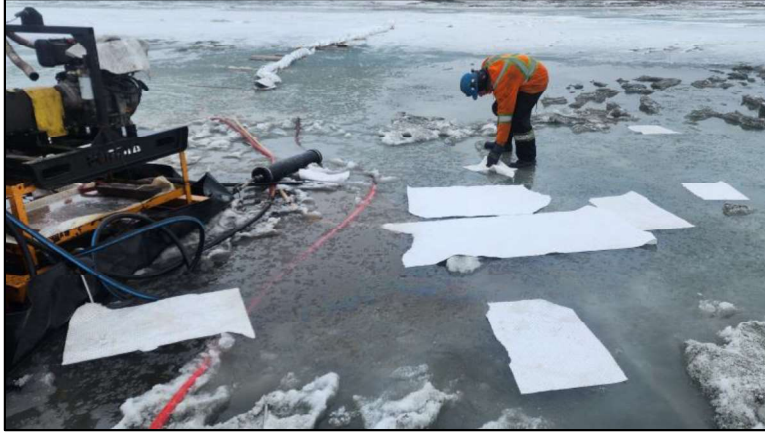
A drill helper filled the 2 L fuel tank for the freshwater pump the morning of the spill event. However, it was later discovered by the drill helper that the fuel cap was not completely secured, allowing the fuel tank to leak into the secondary containment. Much of the spilled fuel was absorbed by hydrocarbon absorbent pads that were in place beneath the pump within a small containment as a proactive measure. The secondary containment was compromised, allowing diesel-contaminated water to leak outside of the containment and onto the surface of Lake B59, which is known to be frequented by fish.

Photo 1: Spill location on Lake B59.

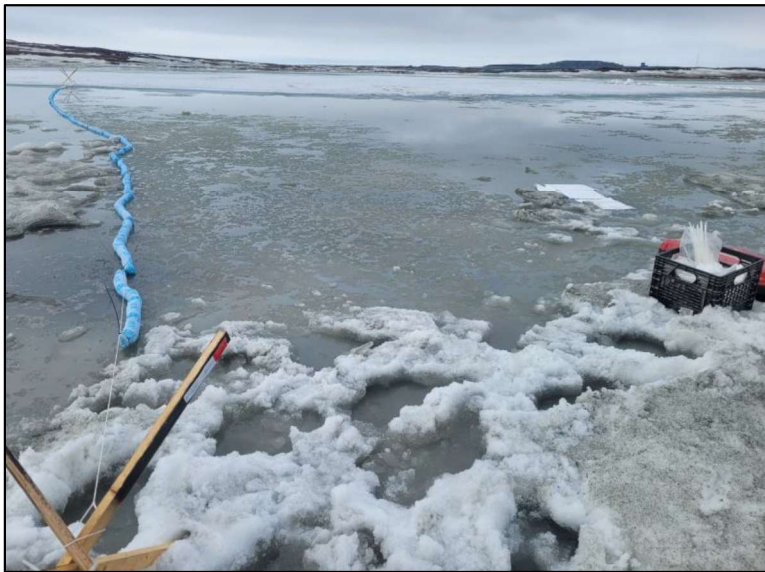
Photo 2: Spill remediation on Lake B59.

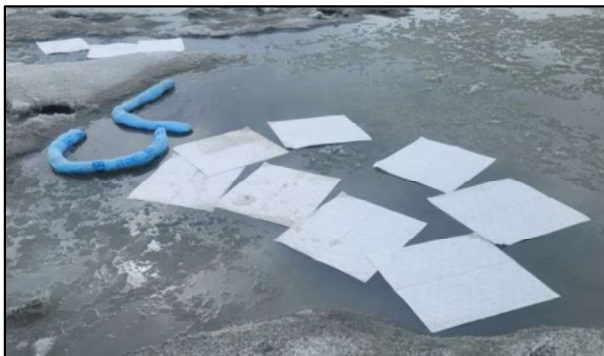
Photo 3: Spill remediation on Lake B59.

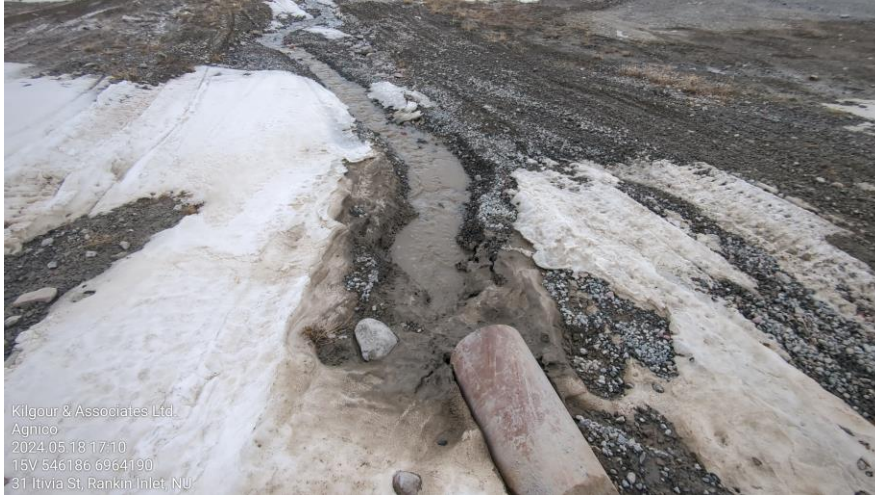
Photo 1. Downstream of Itivia Upstream West.

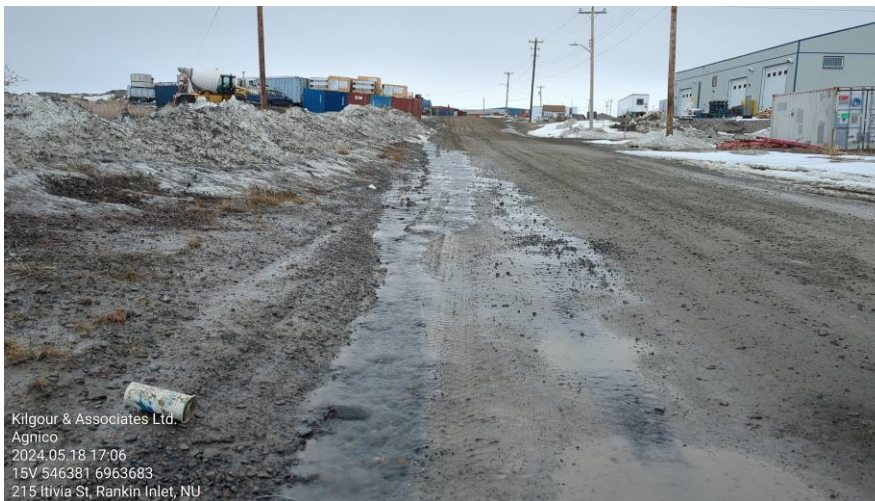
Photo 2. Upstream of Itivia Upstream East (past normal sampling location).

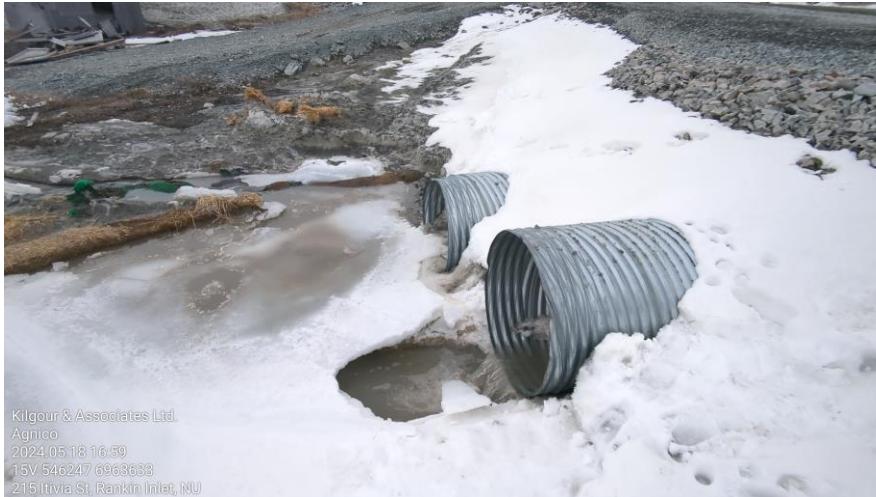
On May 18th, 2024, at approximately 16:00, surface runoff was observed at monitoring station MEL-SR-1, located at the south end of the Itivia site. Field turbidity measurements indicated a potential exceedance of the TSS effluent quality limits listed under Part D, Item 18 of the 2AM-MEL1631 Water Licence. Samples were collected at monitoring station MEL-SR-1 and sent to an external laboratory for analysis. Upstream monitoring indicated that sediment-laden runoff was entering the Itivia lease boundary and was not a result of the activities or infrastructure within the Itivia lease. Analytical results reported a concentration of 330 mg/L TSS, above the allowable TSS effluent quality limits listed under Part D, Item 18 of the 2AM-MEL1631 Water Licence.

Photo 3. Downstream of Itivia Culvert on 2024-05-18 (during exceedance).

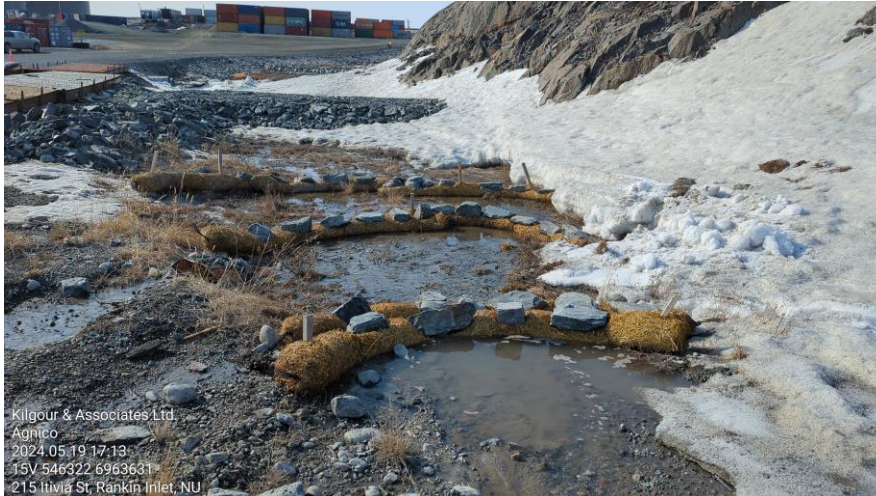
Photo 4. Straw logs placed between Itivia Upstream West and Itivia Culvert to mitigate the sediment loading.

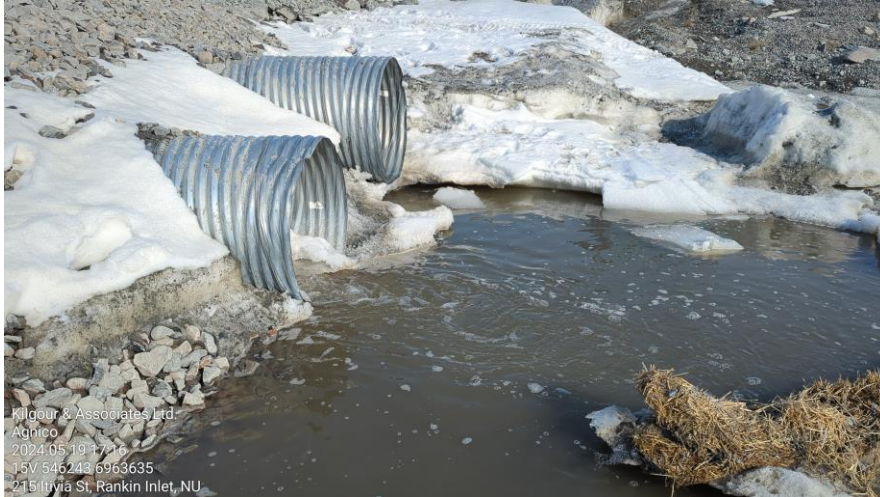
Photo 5. Downstream of Itivia Culvert on 2024-05-19 (after exceedance).

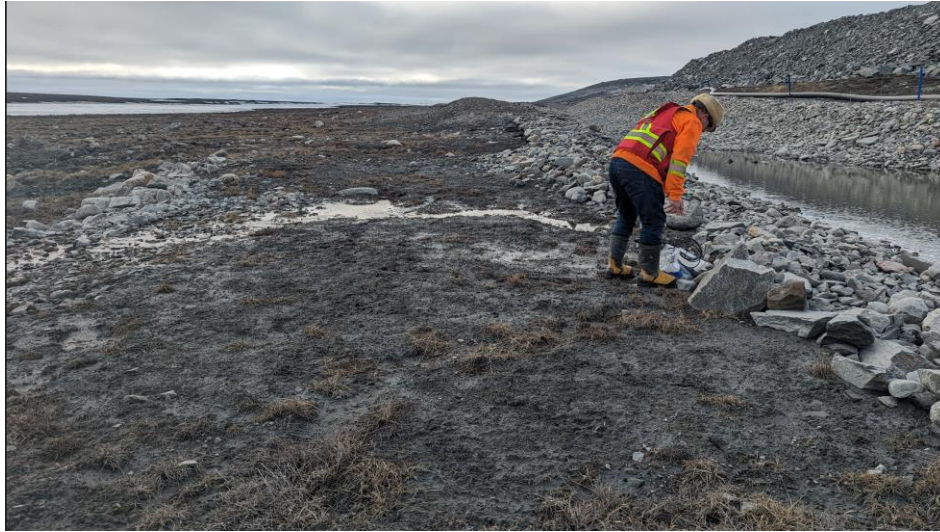
On May 21st, 2024, at approximately 5:00PM, it was noted during a routine inspection of water management infrastructure that water was overflowing the berm of Channel 4, releasing approximately 100 L of water onto the tundra. The incident was a result of accumulated snowmelt within Channel 4 during freshet.

Photo 1: Overflow location on May 21st, 2024.

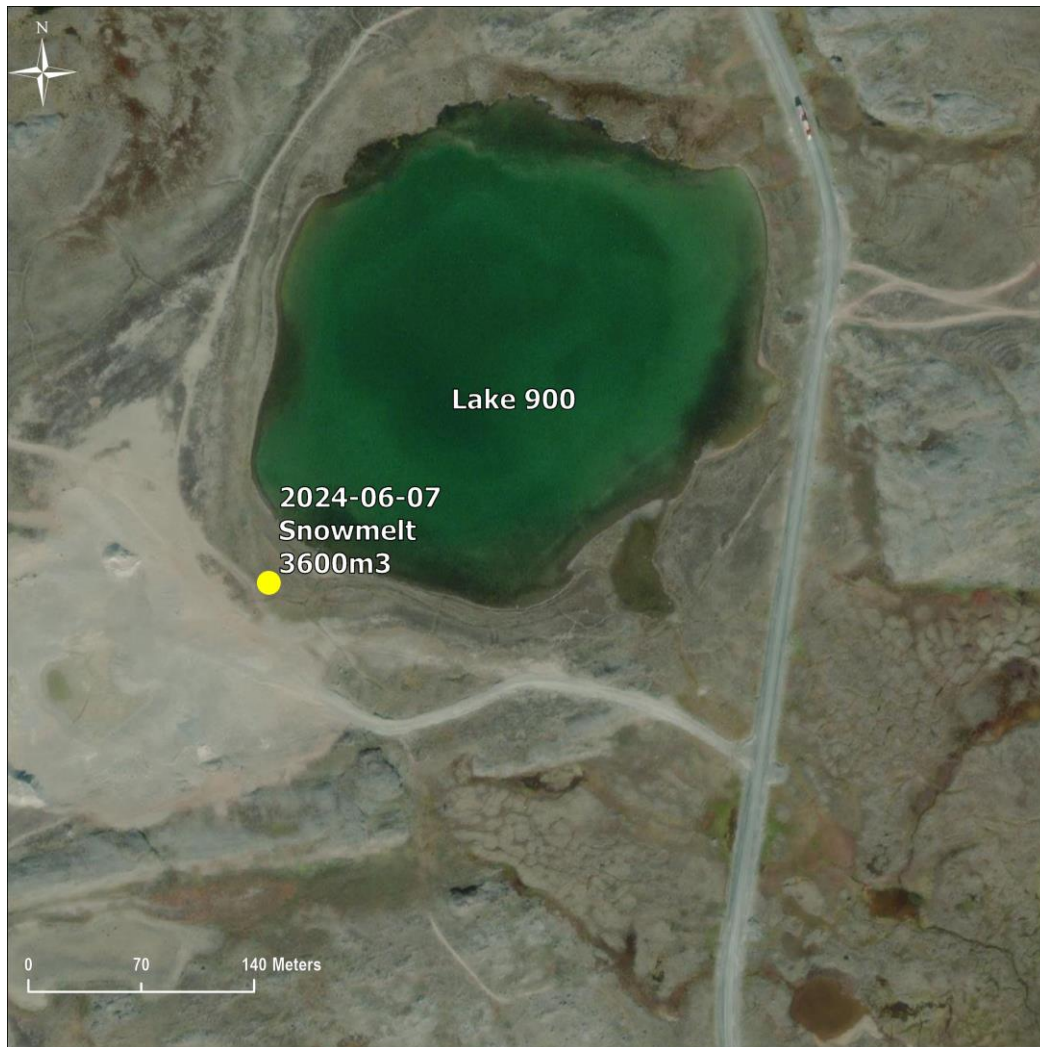
On June 7th, 2024, at approximately 16:00, an employee performing a surface runoff inspection at borrow pit B12 observed dewatering activities occurring within the borrow pit. Dewatering of borrow pits is typical after spring melt to prevent potential seepage, erosion and sedimentation from ponding water within the borrow pit, and to allow access to construction material located within or near the standing water. This planned discharge occurred one day before the end of the 10-day discharge notice issued to the Inspector and before the pre-discharge water quality results were received from an accredited laboratory.

No water bodies were affected by the spill. The closest water body, Lake 900, is approximately 45 meters northeast, as seen in Figure 1.

Figure 1: Location of the release of snowmelt water.

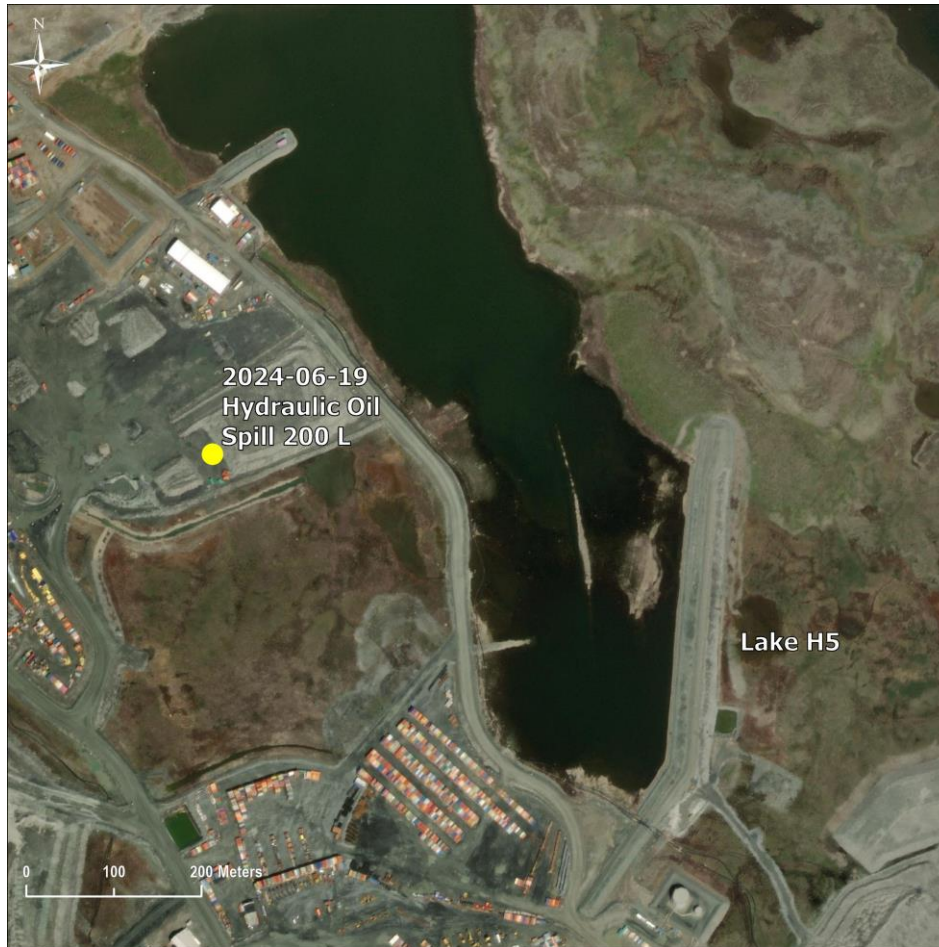
On June 19th, 2024, at approximately 8:00PM, a loader operator heard an unusual noise while working at the OP2 extension open pit marginal stockpile. Upon inspection, it was discovered that a hydraulic hose broke and a leak had occurred, resulting in the hydraulic tank being completely emptied on the ore pad.

No waterbodies were impacted by the spill. The closest water body (Lake H5) is approximately 618 meters southeast, as shown in Figure 1.

Figure 1: Location of the spill and proximity to waterbodies.

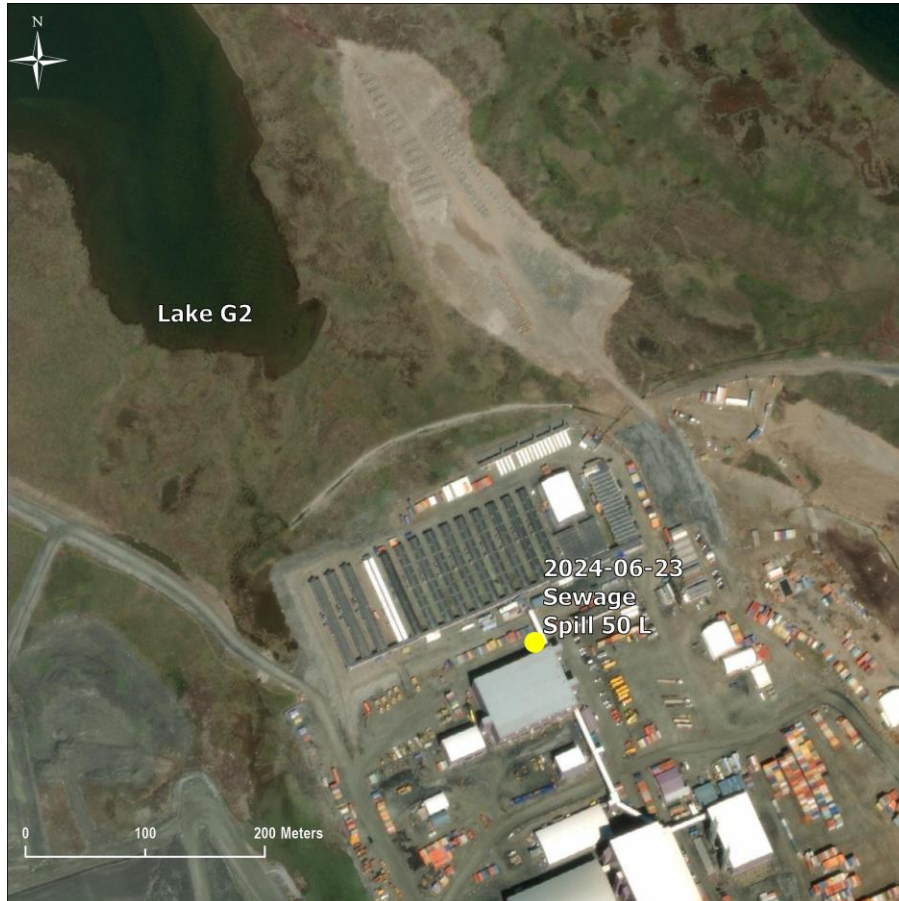
On June 23rd, 2024, at approximately 8:30 AM, an estimated 50 liters of sewage spilled onto the industrial pad at the Multi-Service Building (MSB) lift station. A brief power outage at the MSB caused the Variable Frequency Drives (VFDs) to malfunction, thus stopping the sump pumps. When the vacuum truck operators arrived to discharge sewage from the truck into the lift station, the tank overflowed from the inlet pipe, leading to the spill.

No water bodies were affected by the spill. The nearest water body, Lake G2, is approximately 325 meters northwest, as shown in Figure 1.

Figure 1: Location of the spill and proximity to waterbodies.

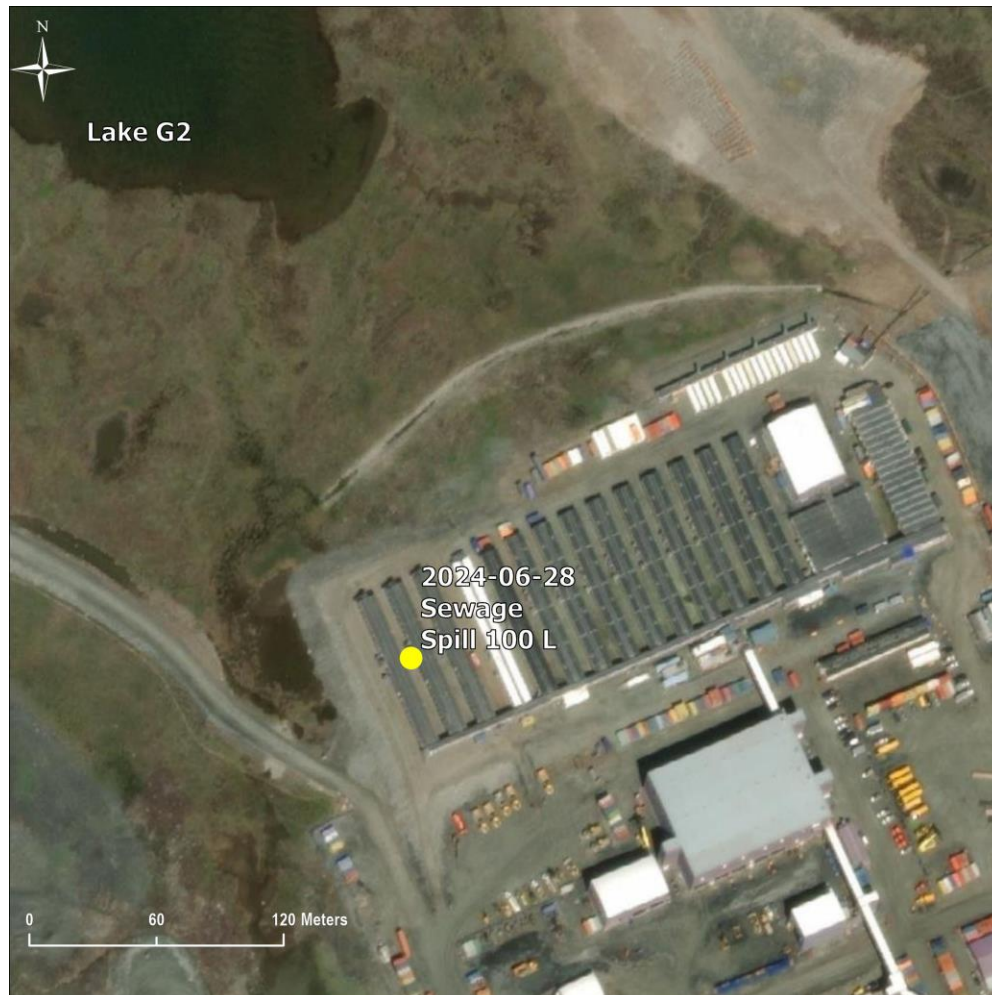
On June 28th, 2024, at approximately 6:30AM, an estimated 100 L of sewage was spilled onto the industrial pad at the Wing 13 lift station. The primary lift station pump became clogged with non-compliant material which caused the pump to fail. Subsequently, the lift station control box failed to initiate the lift station's secondary pump. Due to the primary pump failing and the secondary pump not initiating, the lift station overflowed, and sewage was spilled onto the industrial pad.

No waterbodies were impacted by the spill. The closest water body (Lake G2) is approximately 200 meters north, as seen in Figure 1.

Figure 1: Location of the spill and proximity to waterbodies.

- The primary lift station pump failed due to being clogged with non-compliant material that had been flushed down the toilet.
- The control box failed to initiate the secondary lift station pump when the primary pump had failed.

- The control box for the Wing 13 lift station was replaced on July 1st.
- An alarm system was installed on July 1st that will notify responsible personnel when a pump failure occurs through the Human Machine Interface (HMI) system. A radio and email notification will be sent.

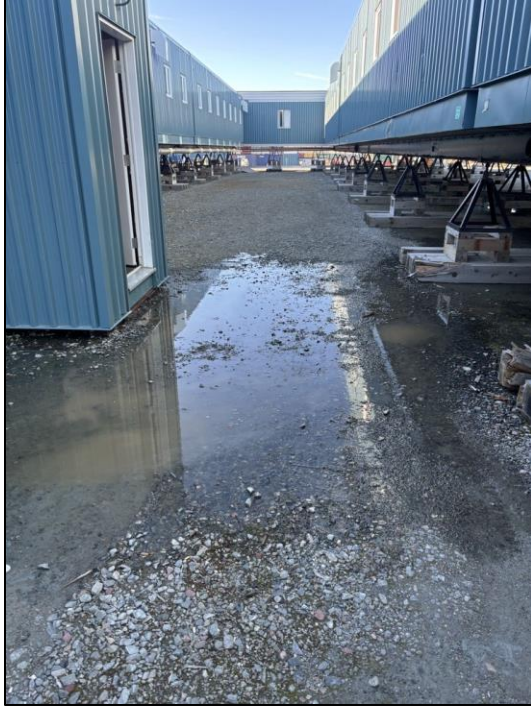
Photo 1: Spill location prior to remediation.

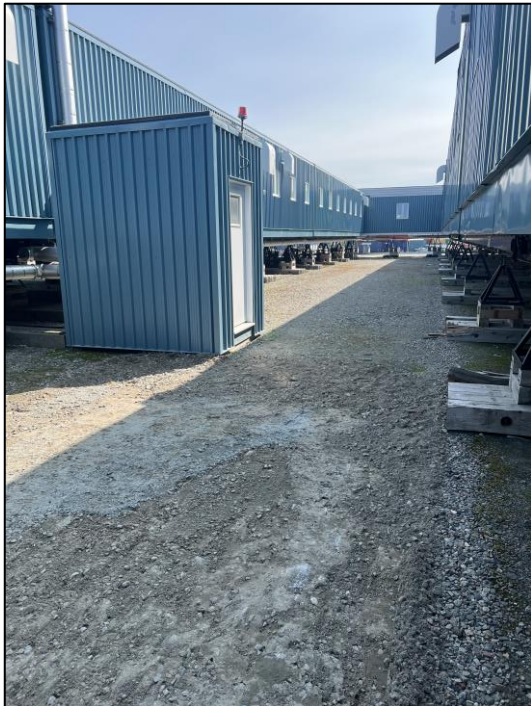
Photo 2: Spill location following remediation.

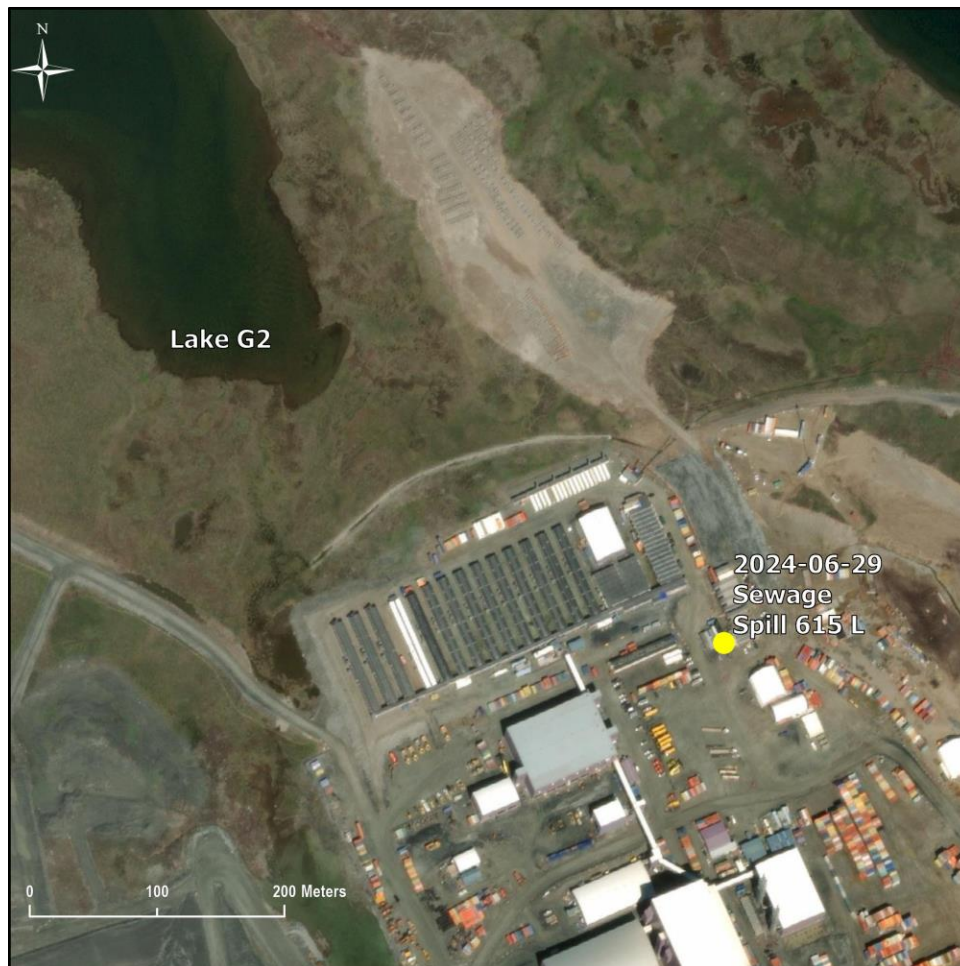
On June 29th, 2024, at approximately 23:00, membrane 3 in the Sewage Treatment Plant (STP) was triggered due to a shutdown which caused the aerobic tank 2 to overflow, releasing approximately 615 L sewage onto the industrial pad. High temperature coming from the blower on membrane 3 exceeded the maximum temperature threshold of the temperature sensor which caused membrane 3 to shut down, resulting in the overflow from aerobic tank 1.

The spill occurred within the site's water management infrastructure, and as such, no water bodies were impacted by the spill. The closest water body, Lake G2, is approximately 370 meters northwest, as seen in Figure 1.

Figure 1: Location of the spill and proximity to waterbodies.

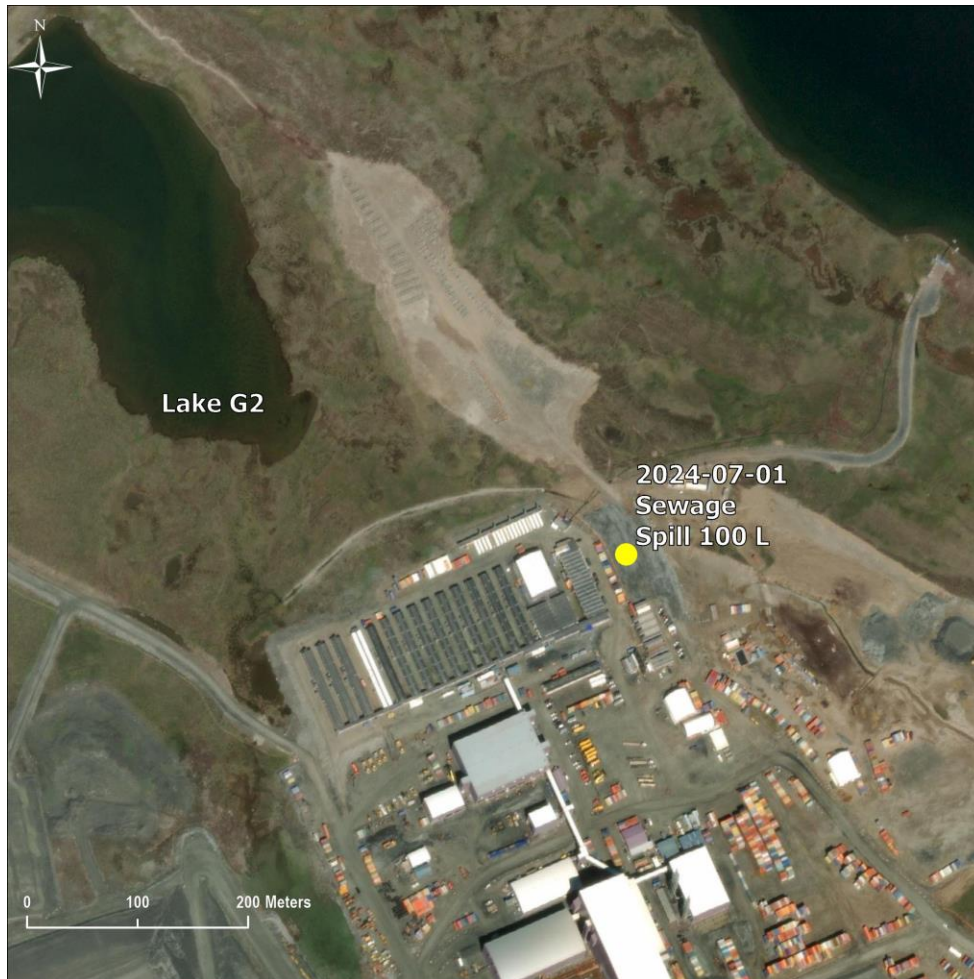
On July 1st, 2024, at approximately 18:30, an estimated 100 L of sewage was spilled onto the industrial pad at the Wing 16 lift station. Upon inspection of the lift station, it was discovered that the lift station pumps were not installed correctly inside the tank. The improper installation resulted in a lack of space between the impeller and the floor of the lift station tank, resulting in solids building up around the pump impeller and clogging the pumps. The lift station overflowed, resulting in the spill.

The spill occurred within the site's water management infrastructure, and as such, no waterbodies were impacted by the spill. The closest water body (Lake G2) is approximately 310 meters north, as seen in Figure 1.

Figure 1: Location of the spill and proximity to waterbodies.

- The Wing 16 lift station pumps were not installed correctly inside of tank causing the pumps to become clogged and fail.

- The blades on the lift station pumps were replaced and installed correctly inside of the tank.
- The development of a pre-commissioning checklist for new sewage management system installations is underway. This will include the verification of the proper installation of lift stations.

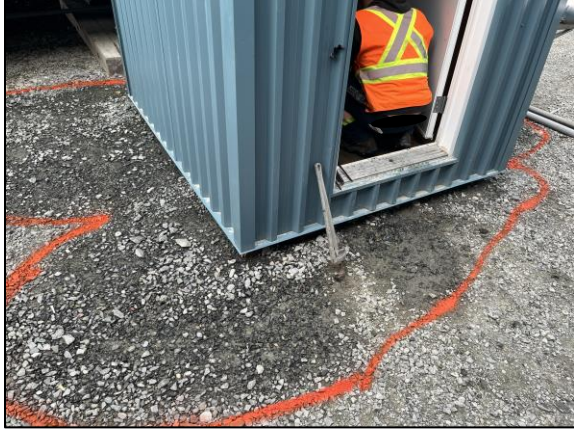
Photo 1: Sewage spill location

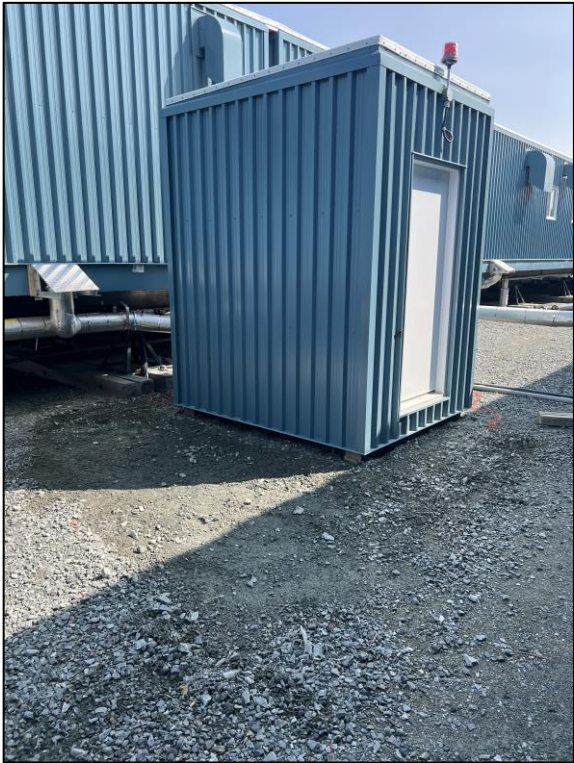
Photo 2: Spill location post remediation.

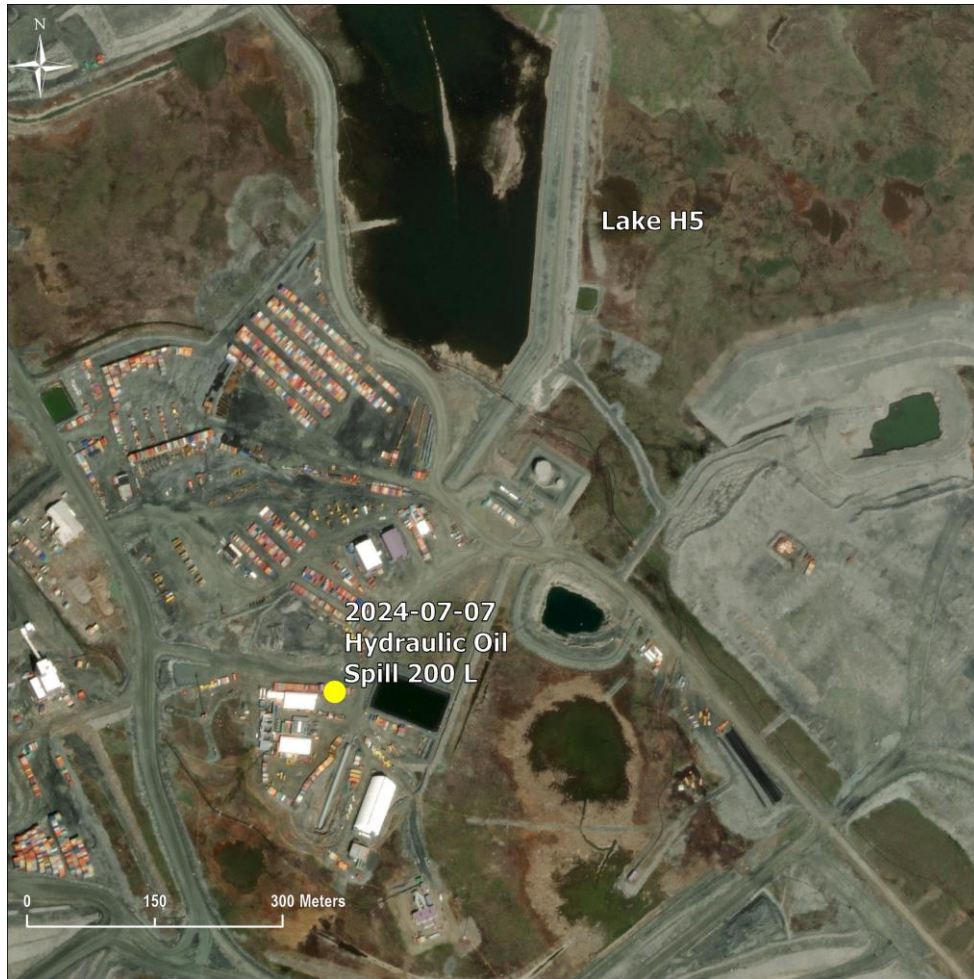
On July 7th, 2024, at approximately 13:30 200 L of hydraulic oil was spilled onto the industrial pad at Portal 1. An Underground Construction operator was transporting a 1,000 L tote of waste hydraulic oil using a telehandler. The operator observed another vehicle in their blind spot and made an abrupt stop. The tote slid off the forks of the telehandler and was tipped on its side, allowing waste hydraulic oil to spill from the fill hole on the top of the tote.

The spill occurred within the site's water management infrastructure, and as such, no waterbodies were impacted by the spill. The closest water body (Lake H5) is approximately 620 meters northeast, as seen in Figure 1.

Figure 1: Location of the spill and proximity to waterbodies.

- The tote was not strapped securely on the forks.
- The operator did not inspect the tote before moving it and the tote cap was found to be loose.
- The forks on the forklift were not widened and tilted while moving the tote.

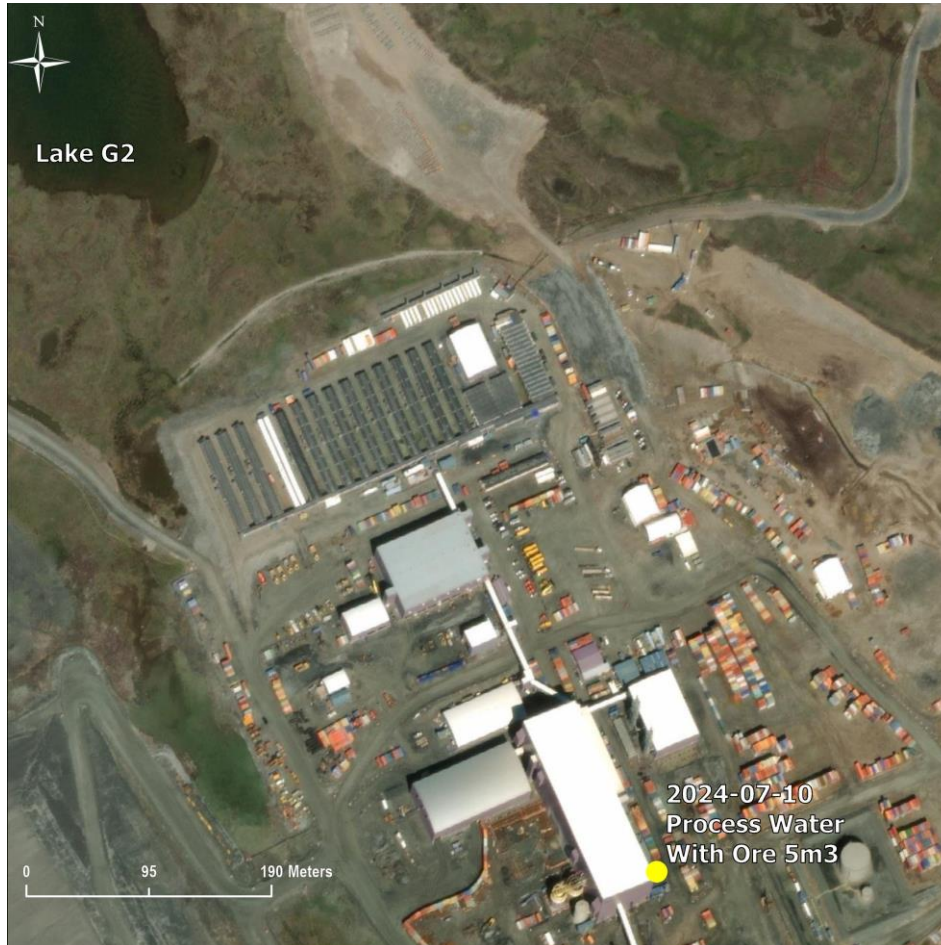
On July 10th, 2024, at approximately 14:00, an estimated 5m³ of process water was spilled outside of the Process Plant. The spill occurred during the preliminary tests of the newly commissioned Vertimill. A change in grain size during the trial caused the trash screens of the cyclone separator to be plugged. This created an overflow with volume too large to be contained by the grinding sump of the Process Plant, which consequentially flowed through the doors of the Process Plant and into the garage bay.

The spill occurred within the site's water management infrastructure, and as such, no waterbodies were impacted by the spill. The closest water body (Lake G2) is approximately 635 meters northwest, as seen in Figure 1.

Figure 1: Location of the spill and proximity to waterbodies.

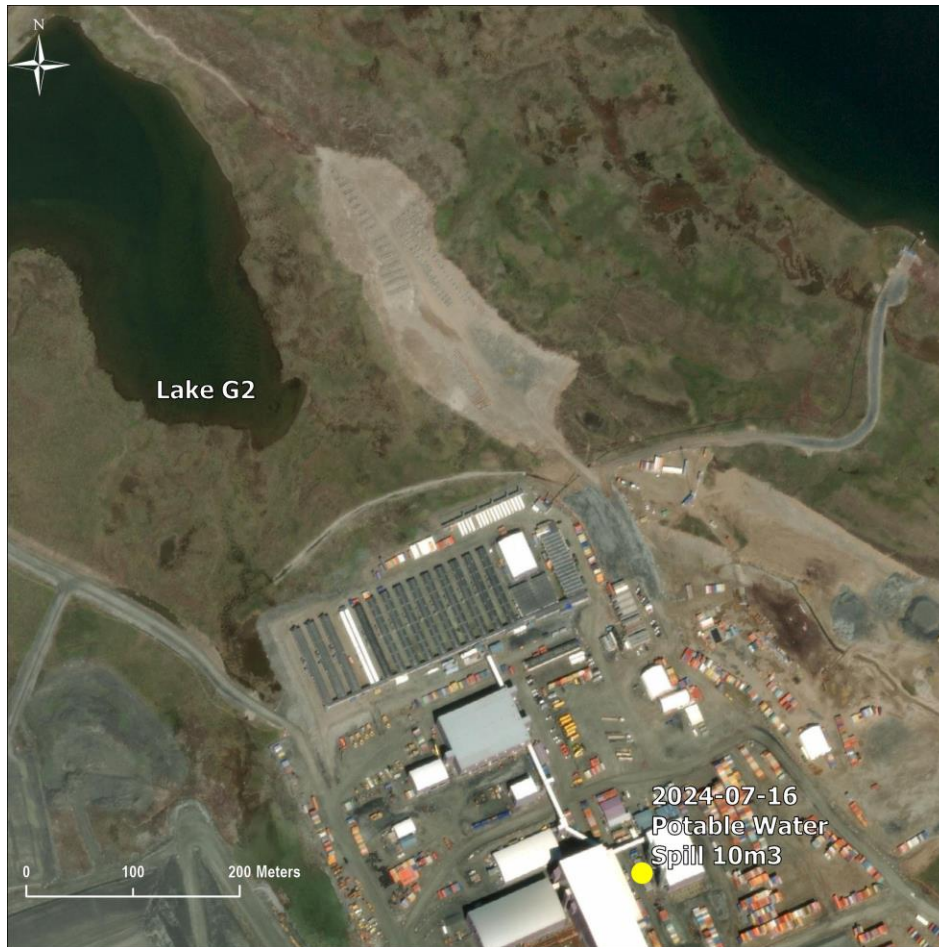
On July 16th, 2024, at 16:20, approximately 10 m³ of potable water spilled outside of the Power Plant. Due to the hot weather conditions, the Power Plant operator was concerned that radiator 3 would overheat. In response, the operator decided to connect a hose to the potable water system and begin showering water onto the radiator. The operator left the hose in place for an extended period before it was noticed. The potable water dripped off the radiator platform and onto the industrial pad, resulting in the spill.

The spill occurred within the site's water management infrastructure, and as such, no waterbodies were impacted by the spill. The closest water body (Lake G2) is approximately 550 meters northwest, as seen in Figure 1.

Figure 1: Location of the spill and proximity to waterbodies.
