APPENDIX 15 2024 REPORTABLE SPILLS

Re: Follow-up Report Spill #2024-001 – Release of 150 L of Sewage at the Meliadine Gold Mine

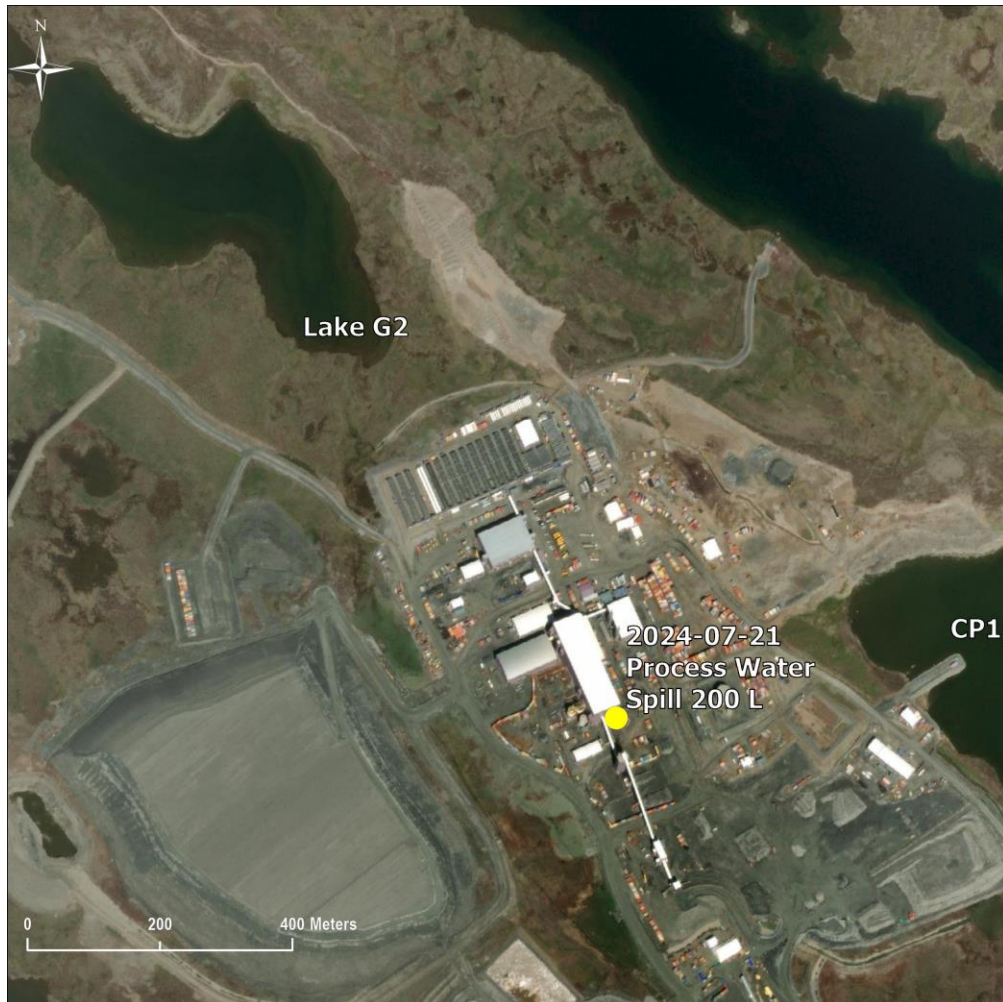
On July 21st, 2024, at approximately 05:30, an estimated 200 L of process water containing ore spilled at the Process Plant. A short-circuit on a solenoid caused the cyclone pump, the SAG Mill, and the SAG Mill conveyor to stop abruptly. This sudden stop caused an overflow of process water in the berm receiving the process water. The overflow was too large to be contained by the berm, which ended up spilling out of the Process Plant doors.

The spill occurred within the site's water management infrastructure, and as such, no waterbodies were impacted by the spill. The closest water body (Lake G2) is approximately 635 meters northwest, as seen in Figure 1.

Figure 1: Location of the spill and proximity to waterbodies.

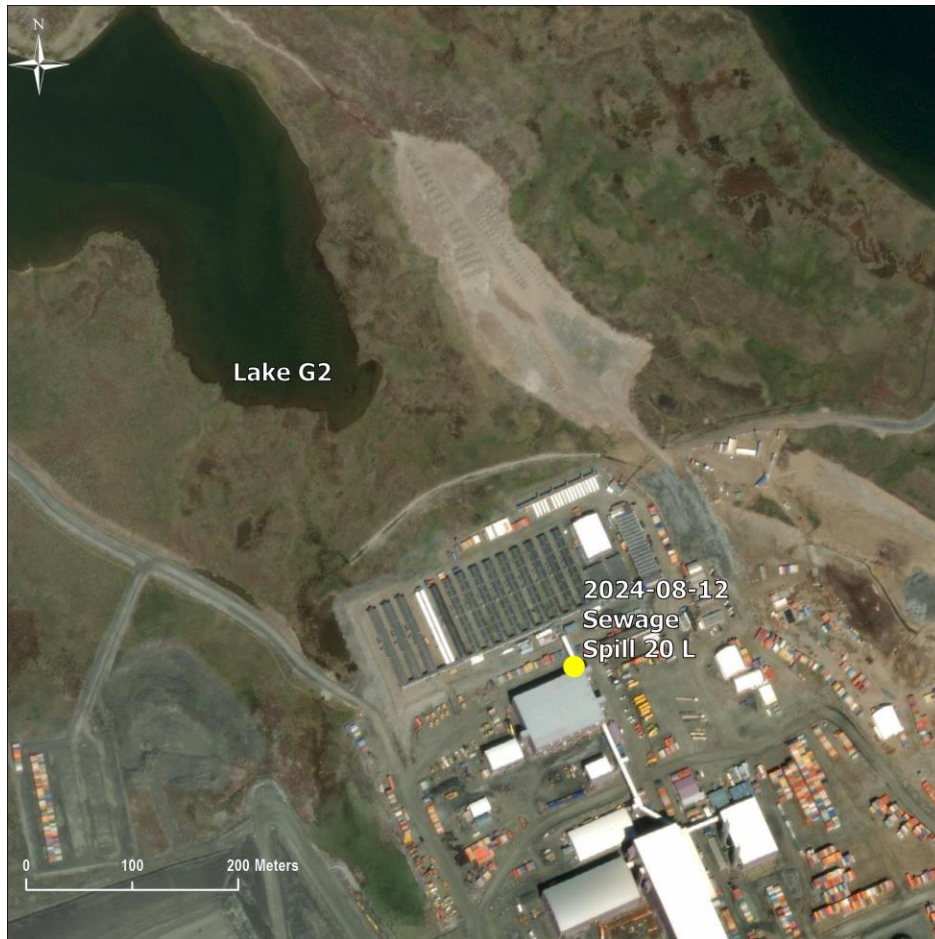
On August 12th, 2024, at approximately 09:00, an estimated 20 L of sewage spilled onto the industrial pad at the Multi-Service Building (MSB) lift station. During routine operation of the sewage vacuum truck, the operator was manipulating a transfer hose when they accidentally contacted the pump valve on the truck, inadvertently engaging the pump and resulting in 20 L of sewage being discharged from the hose onto the industrial pad.

The spill occurred within the site's water management infrastructure, and as such, no waterbodies were impacted by the spill. The nearest water body, Lake G2, is approximately 325 meters northwest, as shown in Figure 1.

Figure 1: Location of the spill and proximity to waterbodies.

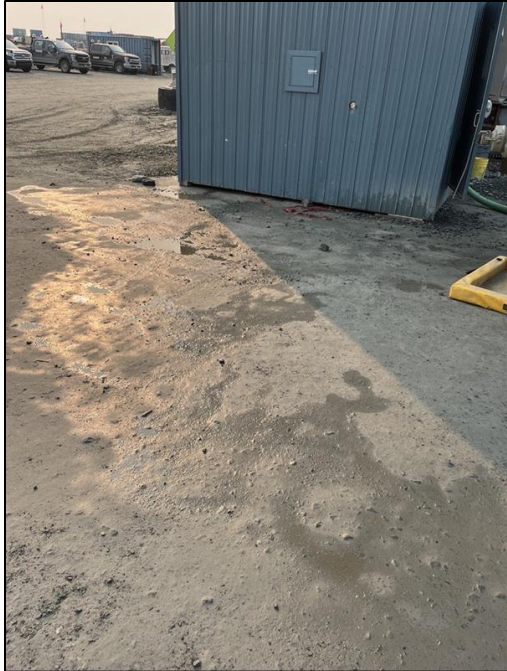
Photo 1: Spill location prior to remediation.

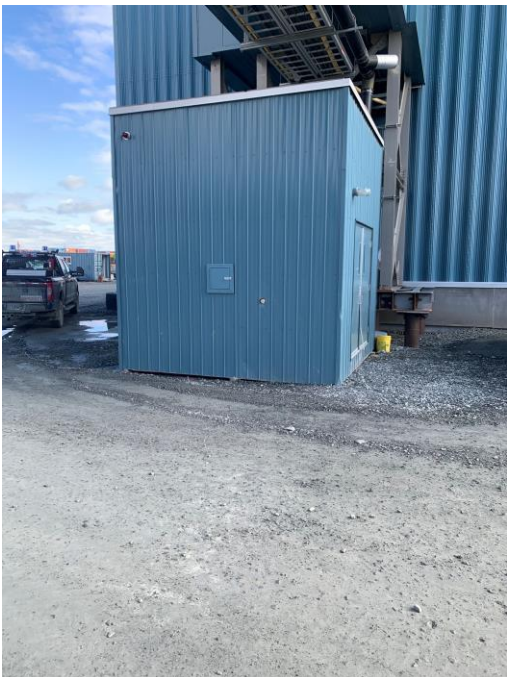
Photo 2: Spill location following remediation.

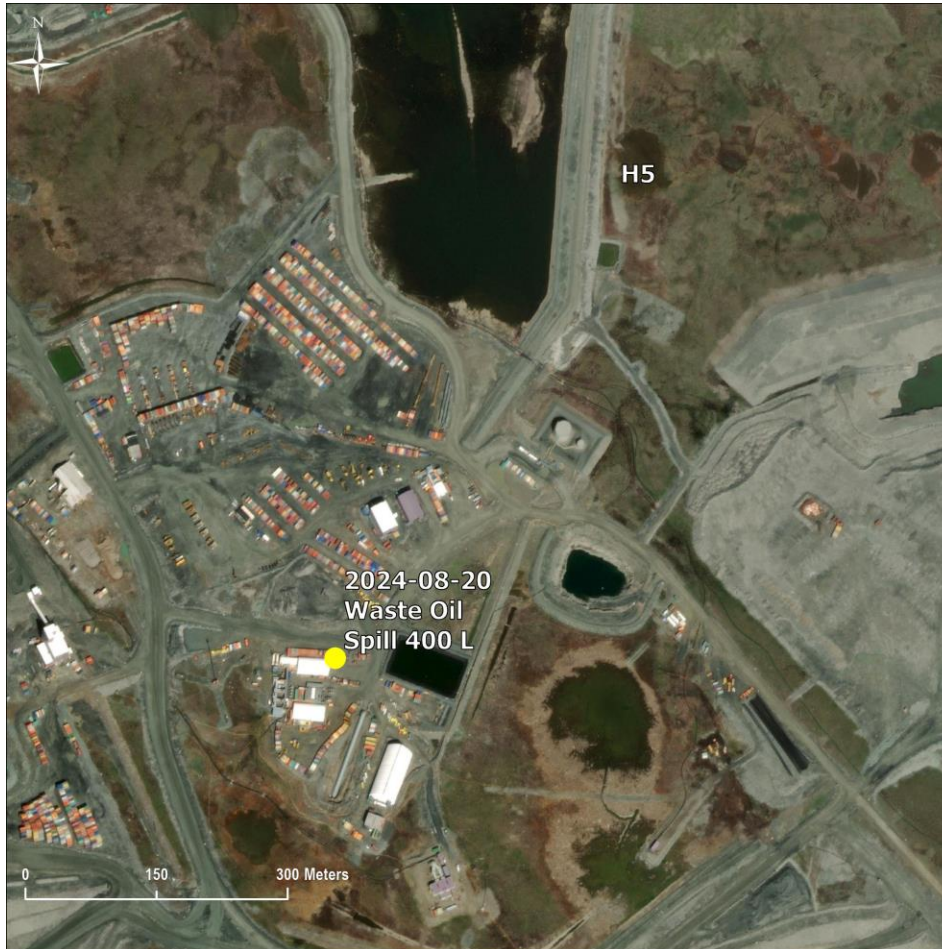
On August 20th, 2024, at approximately 17:00, a skid steer operator was moving a small bin of equipment when the forks inadvertently contacted a waste oil tote at Dome 3, Portal 1. The forks punctured the tote resulting in a release of 400 L of waste oil.

The spill occurred within the site's water management infrastructure, and as such, no waterbodies were impacted by the spill. The closest water body (H5) is approximately 616 meters northeast, as shown in Figure 1.

Figure 1: Location of the spill and proximity to waterbodies.

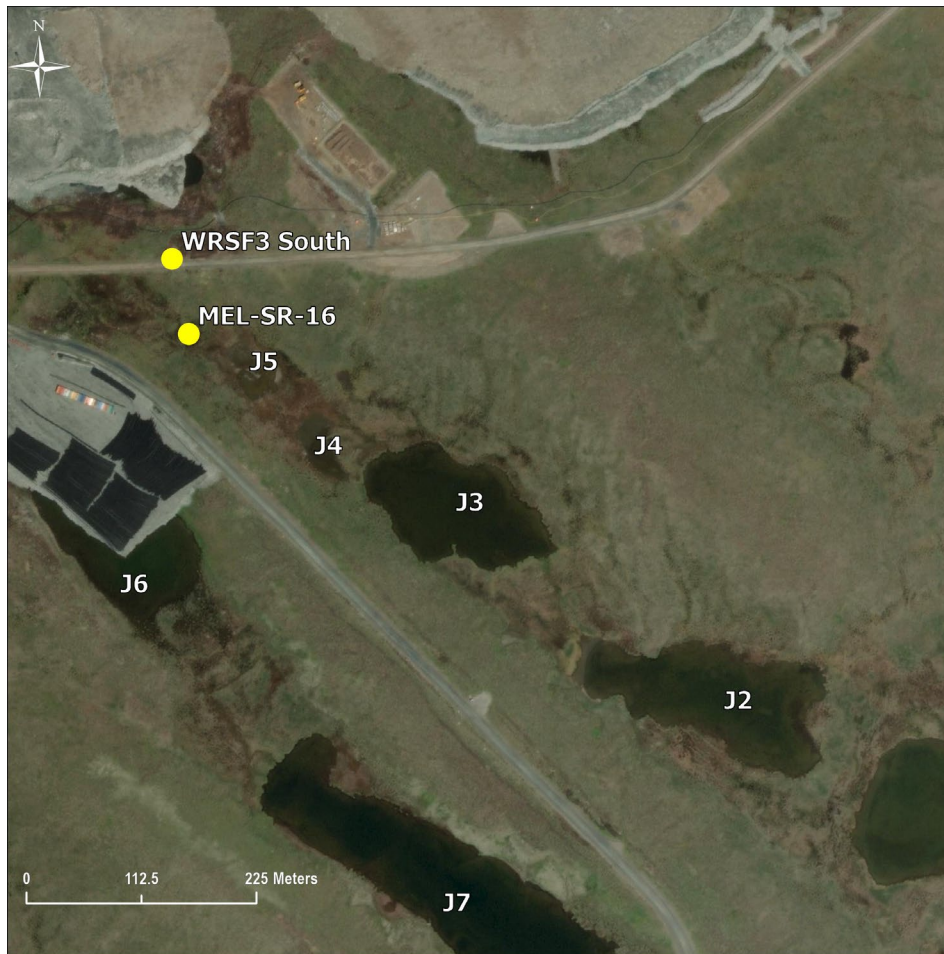
Water accumulation along the toe of WRSF3 is managed by pumping the water to the site water management ponds. During the period of heavy rainfall before the event, water levels in this area had been noted to be increasing, and as such, the existing pump was in place to draw down the ponded water. Due to the intensity of the rainfall event, it led to a rate of water accumulation higher than the pump could manage, which led to the overflow and release of contact water.

Upon further investigation following the initial spill report, the closest waterbody (J5) is approximately 90 m southeast, as seen in Figure 1.

Figure 1: Location of the release and proximity to waterbodies.

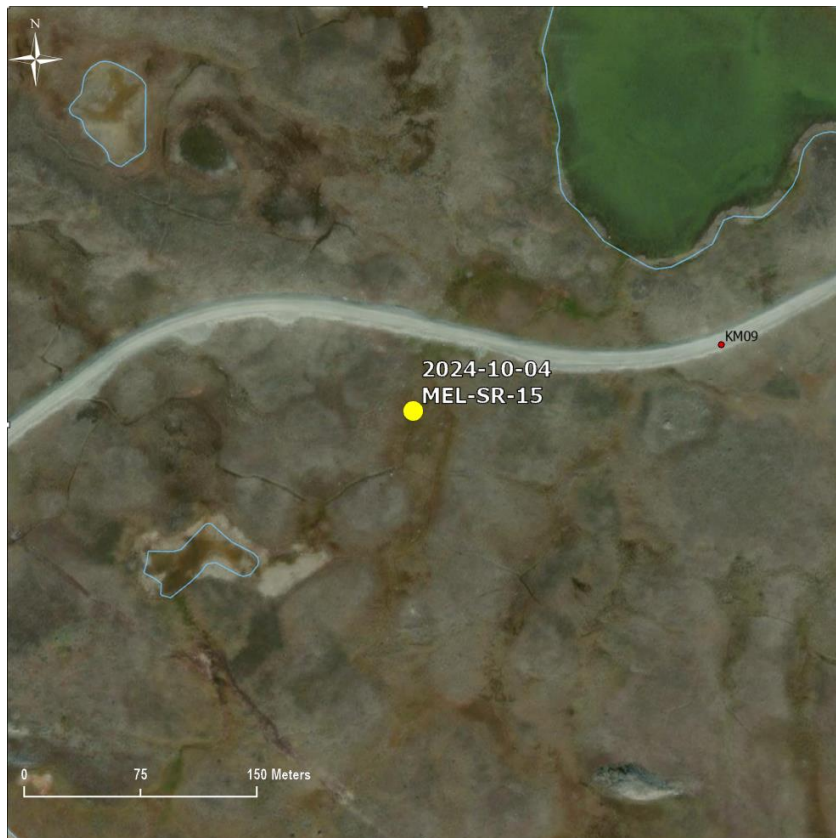
At approximately 10:00 p.m., surface runoff flowing downstream of the construction area was observed to be carrying sediment, which was confirmed by field turbidity measurements (Table 1) collected at 62°52'24.2"N 92°06'31.5"W (Fig.1).

Figure 1: Location of the surface runoff containing elevated total suspended solids and proximity to waterbodies.

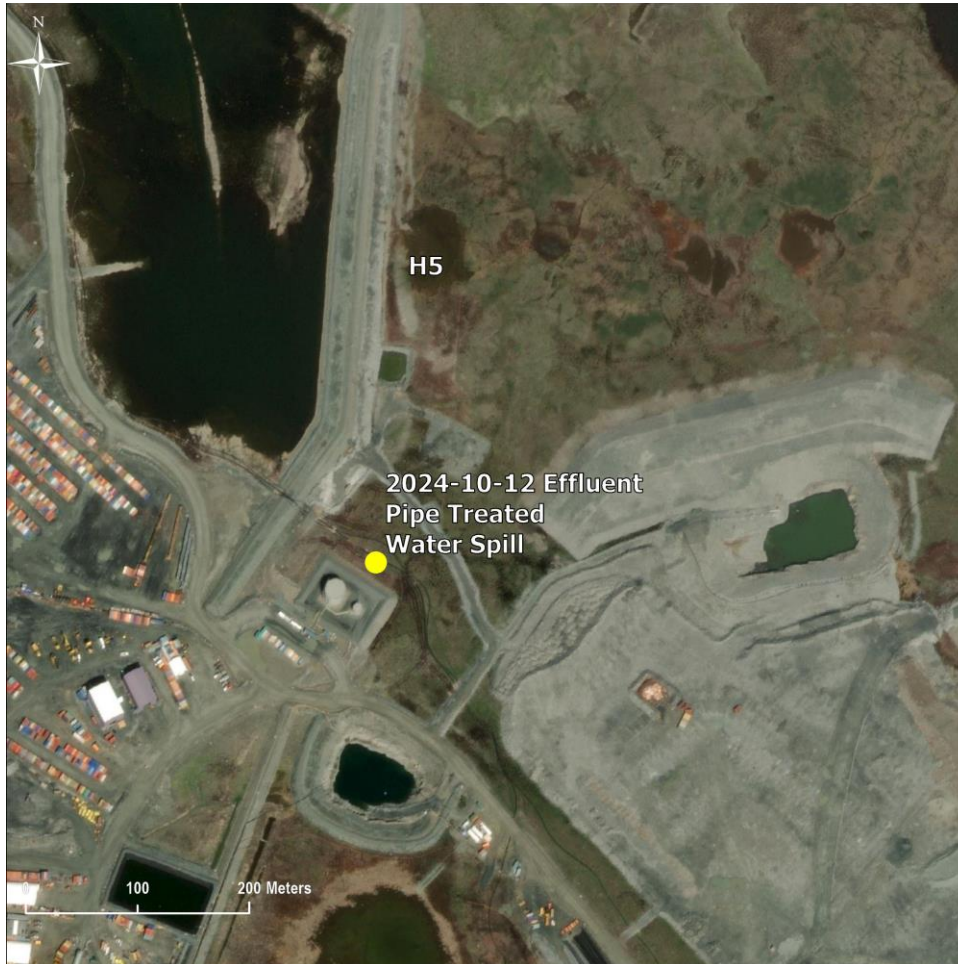
On October 12th, 2024, at approximately 10:45AM, it was noted during winterization of a nearby pipe, that treated water was leaking from the Meliadine Lake effluent pipe behind D-CP1. It was estimated that 200m³ of treated water was released into the tundra. This is the discharge pipe from the Effluent Water Treatment Plant (EWTP) to Meliadine Lake at monitoring station and Final Discharge Point (FDP) MEL-14. The incident was a result of a damaged tapping sleeve on the effluent pipe.

The closest water body (H5) is approximately 240 meters north, as seen in Figure 1.

Figure 1: Location of the spill and proximity to waterbodies.

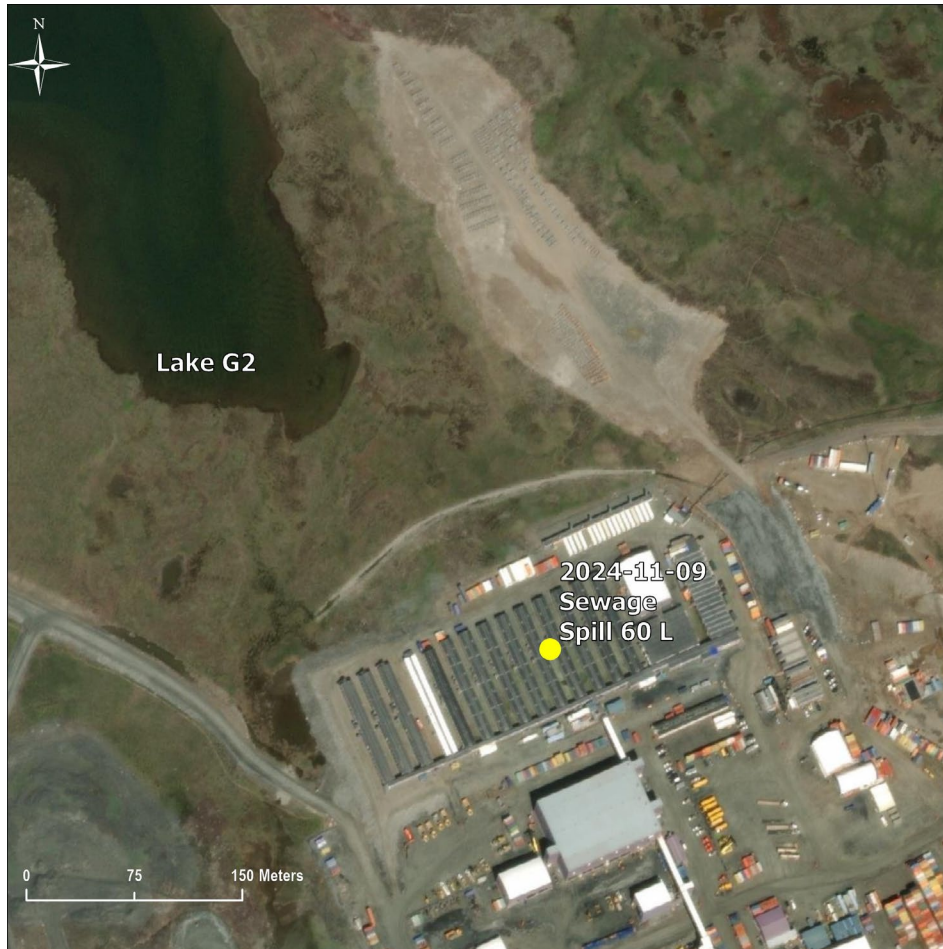
On November 9th, 2024, at approximately 20:00, E&I personnel responded to a high-level alarm at the Wing 4 lift station. Upon arrival, an estimated 60 L of sewage was observed to have spilled onto the industrial pad outside of the lift station.

The spill occurred within the site's water management infrastructure, and as such, no waterbodies were impacted by the spill. The closest water body (Lake G2) is approximately 220 meters northwest, as seen in Figure 1.

Figure 1: Location of the spill and proximity to waterbodies.

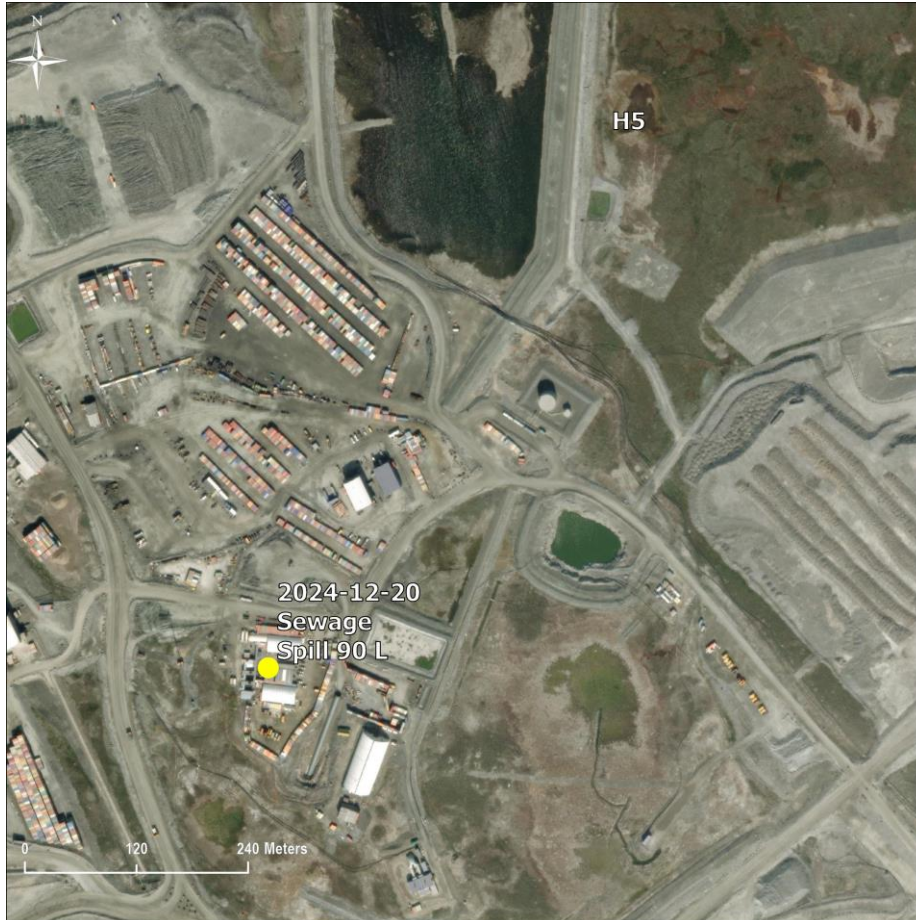
On December 20th, 2024, at approximately 06:00, Energy and Infrastructure (E&I) personnel were performing a routine inspection of lift stations around site. Upon arriving at the Orbit dome lift station (referred to as wash cart in the initial report), the employee noticed that sewage was leaking outside of the holding tank storage area. An estimated 90 L of sewage was frozen on the ground.

The spill occurred within the site's water management infrastructure, and as such, no waterbodies were impacted by the spill. The closest water body (Lake H5) is approximately 720 meters northeast, as seen in Figure 1.

Figure 1: Location of the spill and proximity to waterbodies.

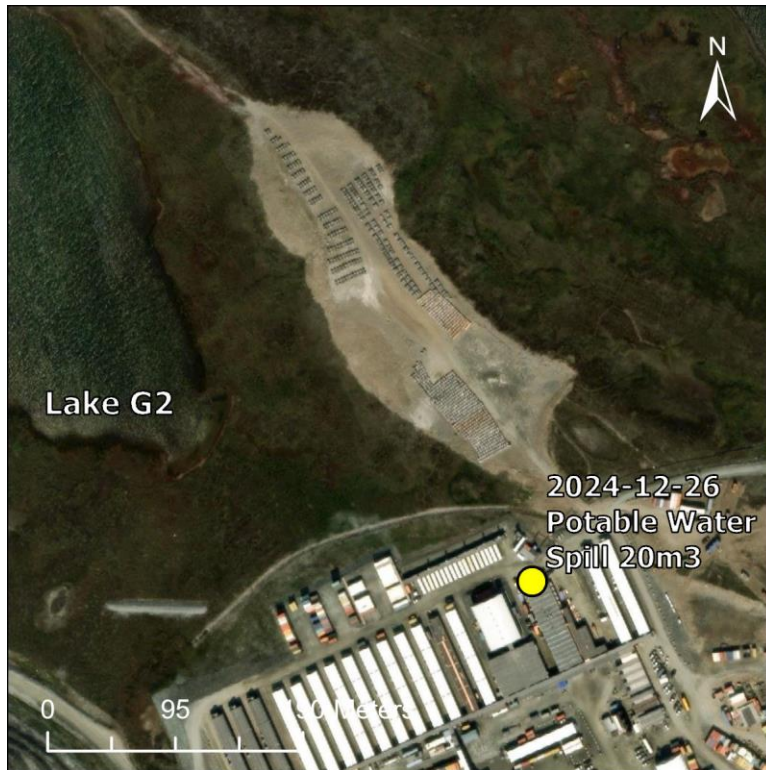
On December 26th, 2024, at approximately 9:00PM, Kitchen staff reported low pressure in the potable water system. Upon inspection, it was noted that potable water was leaking from the kitchen water supply line underneath the kitchen. Between the time the release was discovered and the supply line shut, it is estimated that 20m³ of water treated with chlorine (sodium hypochlorite) was spilled onto the industrial pad. The incident was a result of a rupture in the water line due to freezing.

No waterbodies were impacted by the spill. The closest water body (Lake G2) is approximately 275 meters northwest, as seen in Figure 1.

Figure 1: Location of the spill and proximity to waterbodies.

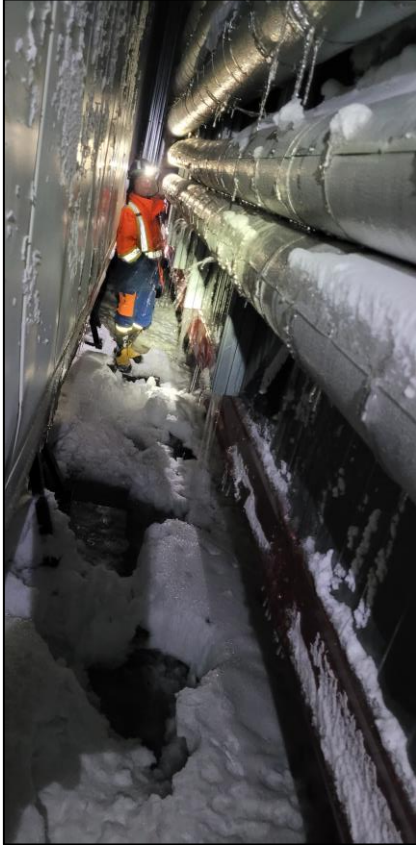
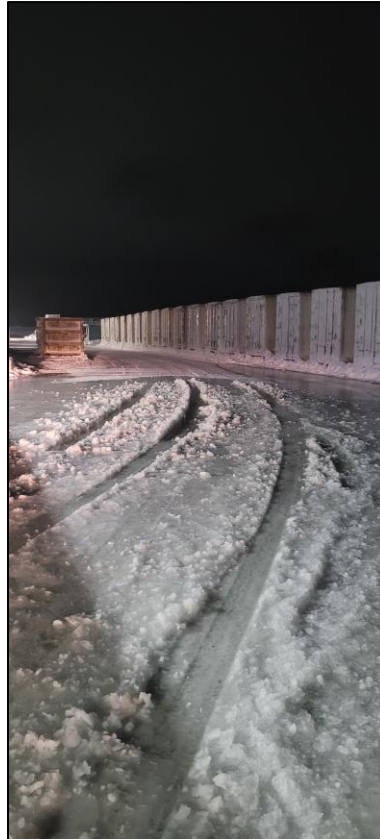
Photos 1 and 2: Unwanted release location and extent.

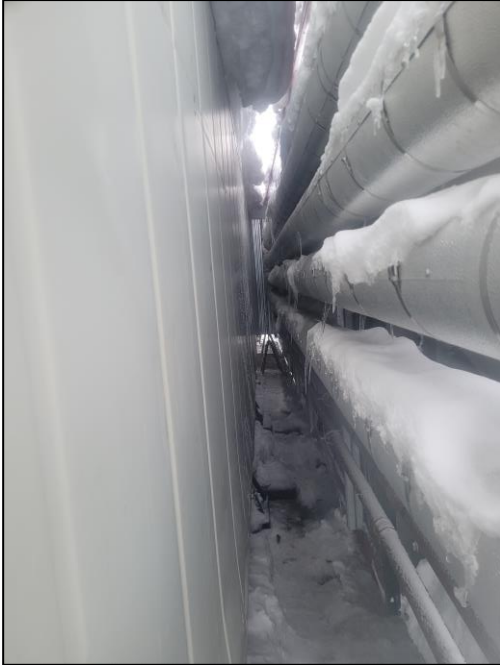
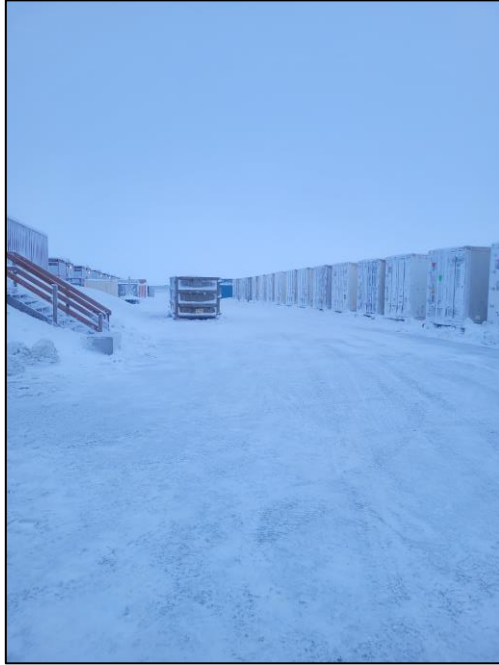
Photos 3 and 4: Unwanted release location post-remediation.

Upon discovering the leak, the kitchen potable water supply was shut down and the line was repaired on December 27th, 2024, in the early morning. Once the line was repaired, Energy and Infrastructure (E&I) personnel started remediation. Contaminated snow and ice were excavated with a loader and by personnel, and the contaminated material was brought to the contaminated snow cell as per the Spill Contingency Plan.

- The faulty breaker was replaced, and the kitchen water supply line was fixed and tested.
- E&I Maintenance will add a mandatory visit to the mechanical room to their PM inspection procedure for the kitchen water line, but also other mechanical rooms around site in early 2025. The procedure was also modified to include photo documentation of the inspection.
