Project Name / Nom de Projet: Rankin Inlet Tank Farm

Project No. / No. de Projet: C-15152

Rankin Inlet Fuel Farm

Photographs of corrective measures on piping under road, between Fuel Farm and Melvin Bay Shore
(Nov. 2018)

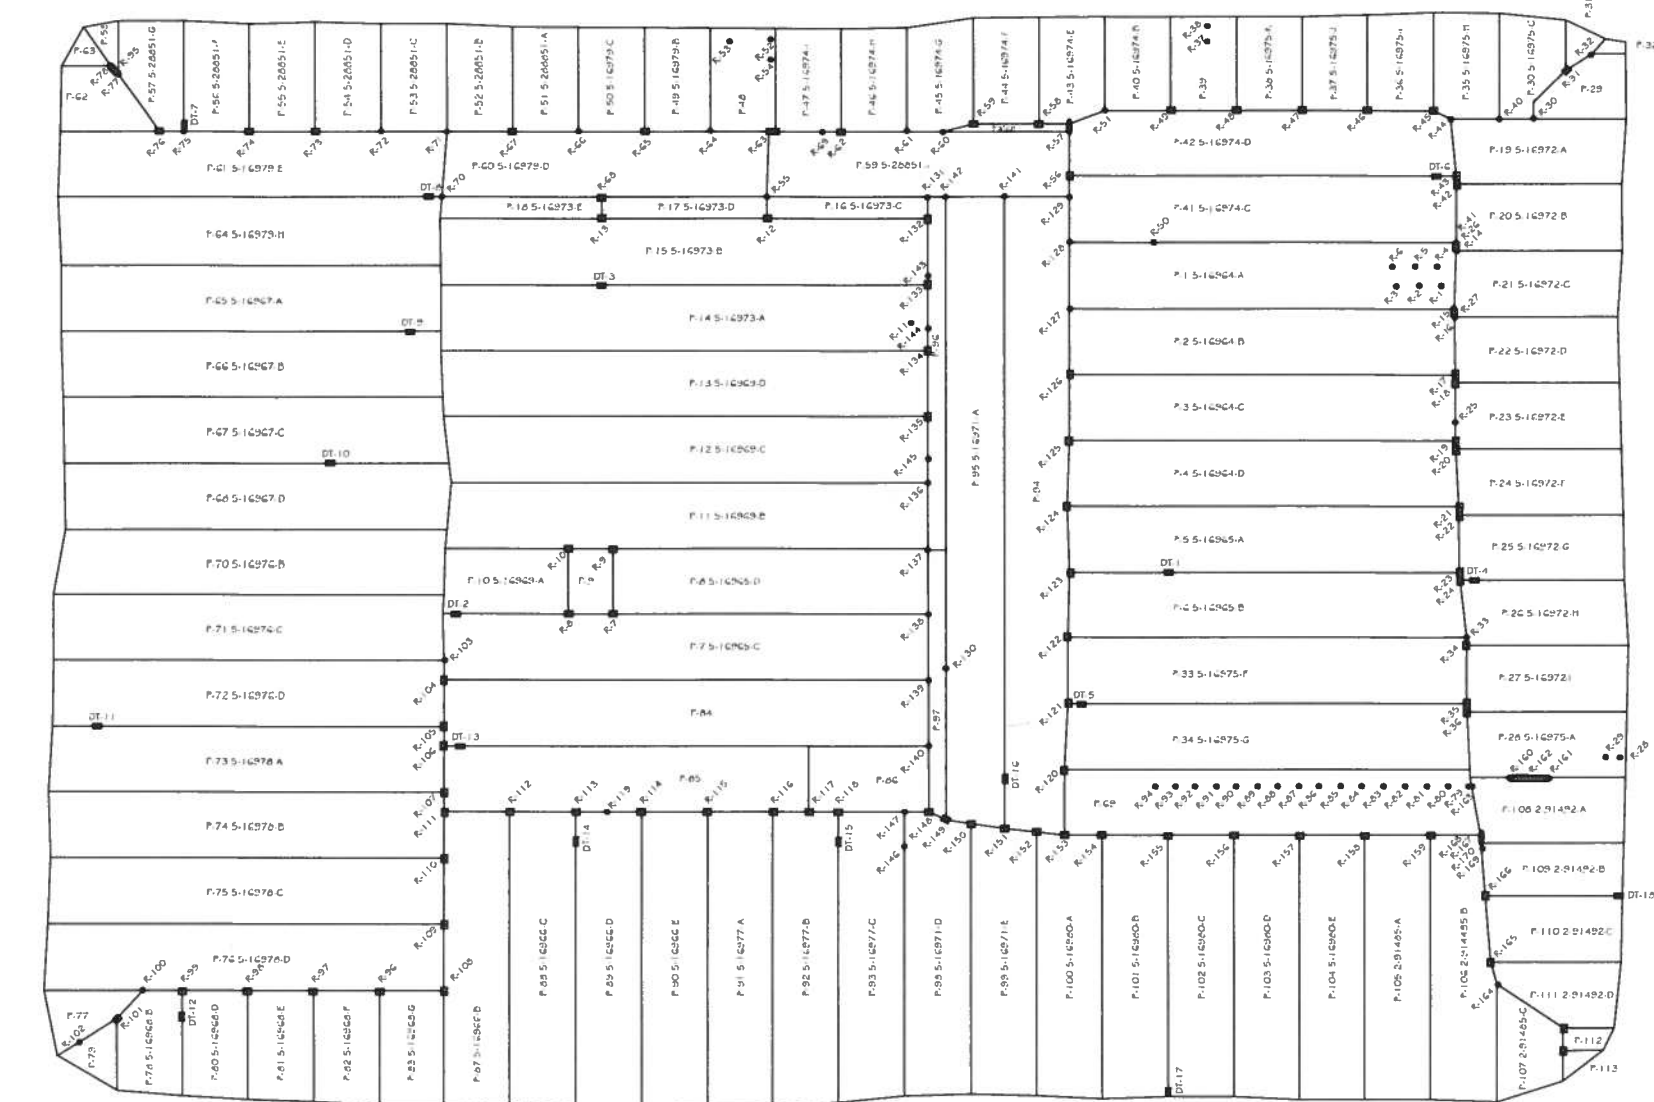
NO. PROJET / PROJECT NO. C-15154
FICHIER AUTOCAD: C-15152.mxd
AUTOCAD FILE:
DATE (dd-mm-yy): 14/11/17
DESSINÉ PAR / DRAWN BY: E.B.
VÉRIFIÉ PAR / CHECKED BY: E.B.
APPROUVÉ PAR / APPROVED BY: T.T.
ÉCHELLE / SCALE: 1/500
DESSIN NO. / DRAWING NO. 111

NO PANNEAU / PANEL NO.	ROULEAU NO / ROLL NO.	NO PANNEAU / PANEL NO.	ROULEAU NO / ROLL NO.	NO PANNEAU / PANEL NO.	ROULEAU NO / ROLL NO.	NO PANNEAU / PANEL NO.	ROULEAU NO / ROLL NO.	NO PANNEAU / PANEL NO.	ROULEAU NO / ROLL NO.	NO PANNEAU / PANEL NO.	ROULEAU NO / ROLL NO.
P-3	S-16294 E	P-32	S-16275 E	P-58	S-26051 H	P-68	S-16296 A	P-86	S-16294 A	P-97	S-16291 C
P-29	S-16275 B	P-39	S-16274 A	P-62	S-16279 F	P-77	S-16296 A	P-84	S-16277 D	P-112	S-291492 E
P-31	S-16275 D	P-48	S-16278 A	P-63	S-16279 G	P-79	S-16296 C	P-96	S-16291 B	P-113	S-291492 F
