TSF WEEKLY INSPECTION FORM

Date: November 13, 2019	Time: 12:30
Weather: -18.6C; 33 km/h NW; overcast	Inspected by: Jennifer Pyluk
Present: Alex Plasse

Placement Area: Center Cell

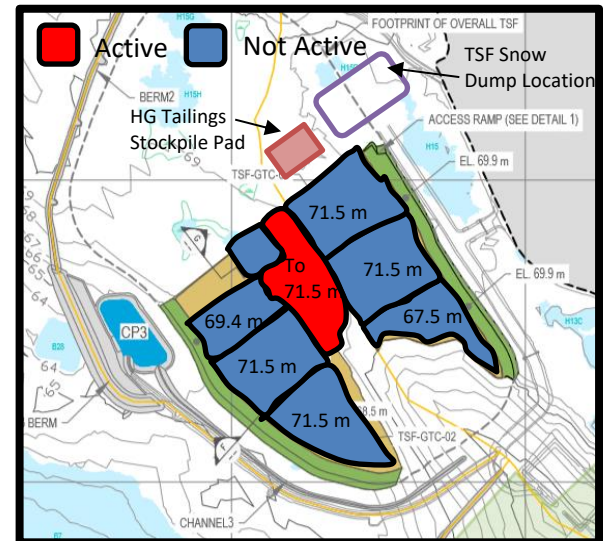
- Active tailings placement occurring over the past week in the center cell to approximate elevation 70.3 m.
- Considerable dust was observed to be generated from the surface of recently placed tailings material. This is expected to be due to the rough surface of the tailings material. At the time of inspection, tailings were being placed in a frozen or near-frozen condition and compaction was not occurring immediately after placement due to staffing issues. This resulted in a tracked surface only and dusty conditions.

- It was observed that compaction specifications were not being obtained, particularly in the top 4-6", due to the placement of tailings material in the frozen (and dried) condition. It is noted that placement of already frozen material in the center cell is preferable from a stability standpoint however.

- Dust generation was also observed on the surface of sub-cells 3 and 2, particularly in the area around the recently completed extension of the historical GTC. Track marks and tire tracks were clearly visible throughout this location and the remainder of these sub-cells.

- Snow removal was occurring from the side slopes of sub-cell 5, with mounds on sub-cell waiting collection and removal to the designated snow dump area in Cell 2. It was noticed that some snow had been placed on the west side of the LG stockpile, which is outside of the designated snow dump location.

- Sea cans with what are assumed to be unplaced filter cloths were seen on sub-cell 6, which appeared to have restricted the placement area.

- Placement should continue to focus on "filling in the holes" as issues regarding snow collection and removal will occur in these areas over the winter. These locations are the center cell, sub-cell 1 and between sub-cells 4/5. **Any excess snow/ice must be removed from trenches or the tailings/ground surface prior to placement.** No additional lifts are to be placed on sub-cells 2, 3, 4 or 5 at this time.

- Winter placement conditions must be followed in order to achieve proper compaction and reduce settlement in the summer months:
 - Tailings should be removed from the Church immediately** to avoid freezing of this material prior to placement. Stockpiling in the Church should only occur in extreme conditions.

- Compaction of tailings should also occur immediately following placement.** If compacted while unfrozen, the same number of passes (3 slow passes on high vibrate) applies. If frozen tailings material has to be placed, Engineering must be notified so that the least harmful placement location and compaction specifications can be chosen.

- There should be no vehicle traffic on the finished tailings surface.** Flash freezing of the surface will occur and erosion/dust generation will be at its peak. Traffic over snow will grind/compress the snow into the tailings surface and will make snow removal in these areas more difficult.

- Snow should not be placed/stockpile anywhere but the designated snow dump location in Cell 2.** The location of the snow dump was chosen based on experiences during freshet 2019.

5. **Filter cloths should be placed as soon as possible** to avoid additional work to separate the cloths prior to placement if they are all frozen together.
