Follow Up Report: #19-021

January 20, 2019 Boiler Recirculation Loop Leak

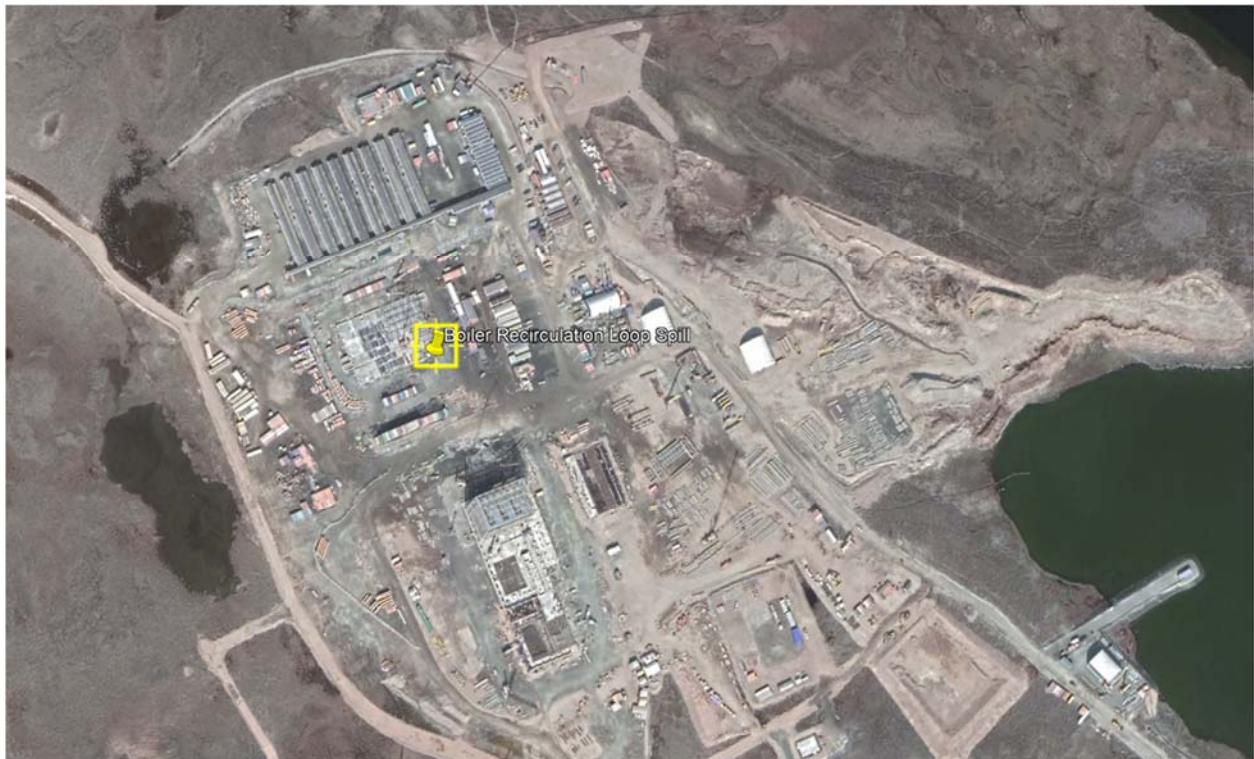
Due to failure of an expansion joint on the boiler recirculation system, approximately 200L of water with corrosion inhibitor (Drewgard 4109) spilled to ground. Most recently the of water was analyzed with a concentration of 0.195ppm of Drewgard. The water froze and 12m³ of snow and ice was transferred to P3, a containment pond within the site's managed water system. No water body was impacted. The nearest body of water is >300m away. The coordinates of the spill were, 63° 2'19.52"N, 92°13'39.97"W.

Site personnel shut off valves preventing further release of water from the boiler recirculation system. Water followed through the floor of the Arctic corridor to ground and froze. Frozen water from the system was cleaned up with heavy equipment. Material was transported and contained in P3, part of the site's water management system.

The release occurred due to the failure of an expansion joint in the boiler recirculation system. The cause of the failed component is unknown and is currently under investigation by the external system provider (BBA). The expansion joint was replaced and the system inspected for leaks.
