Follow Up Report: #20-073

March 8, 2020 Engine Oil Tote Spill

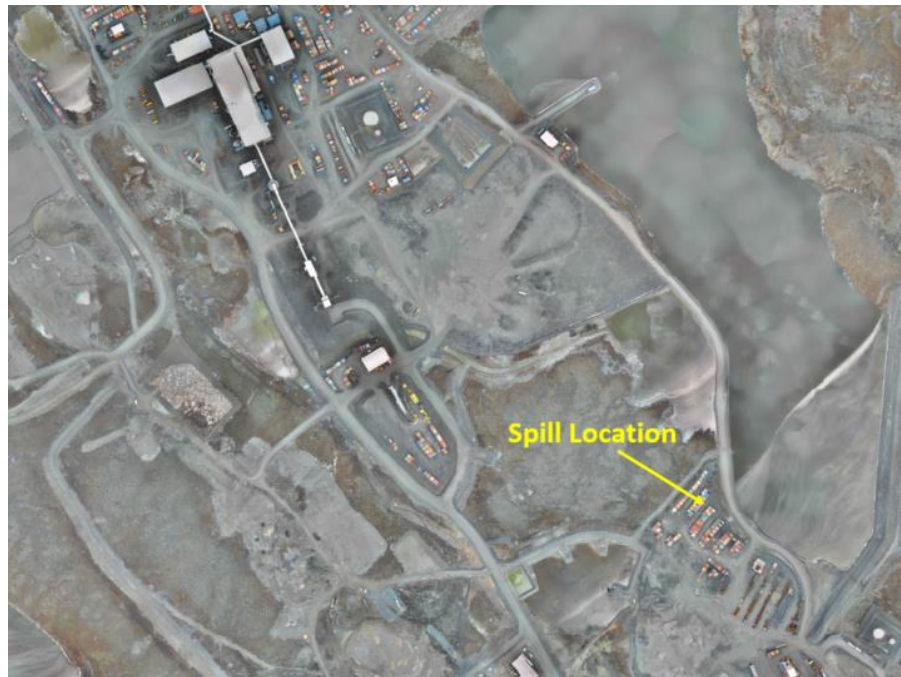
No water bodies were impacted by this spill. The closest natural water body is over 900 m from the spill location. The coordinates of the spill are 63° 01'53"N, 92°12'44"W (Figure 2).

Figure 2: Spill location at warehouse sea-can laydown.
