Follow Up Report: #20-087

March 28th 2020, Emulsion Spill

The following information refers to spill 20-087 reported by Agnico Eagle Mines Ltd. March 28th 2020, and is being provided in accordance with:

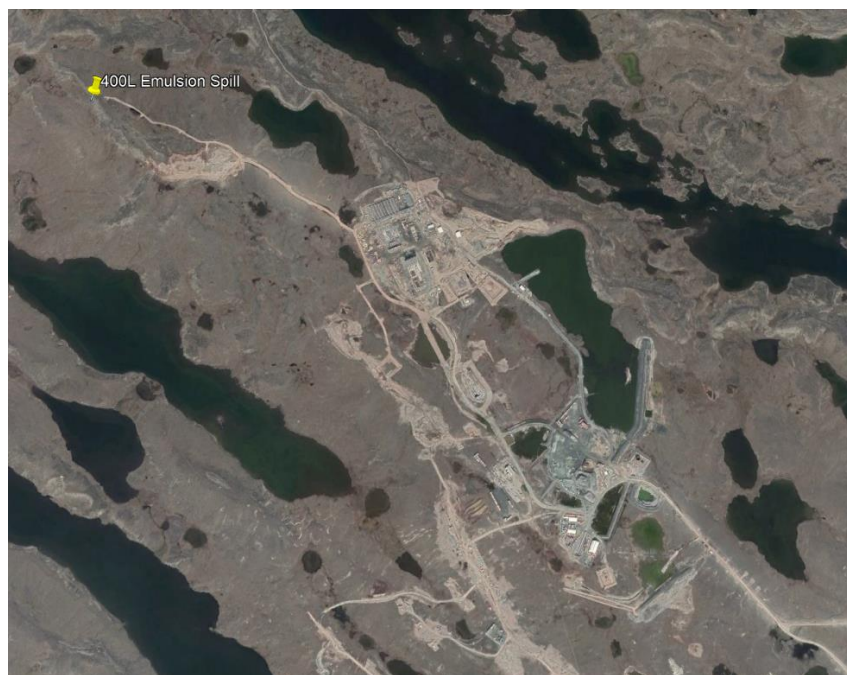
No water bodies were impacted by this spill. The closest natural water body is over 550 m from the spill location. The coordinates of the spill are 63° 2'41.91"N, 92°15'26.42"W (Figure 1).

Figure 1: Location of 400 L emulsion spill and proximity to water bodies.
