# Follow Up Report: #21-016

### 165 m<sup>3</sup> Heat Recovery Water Spill

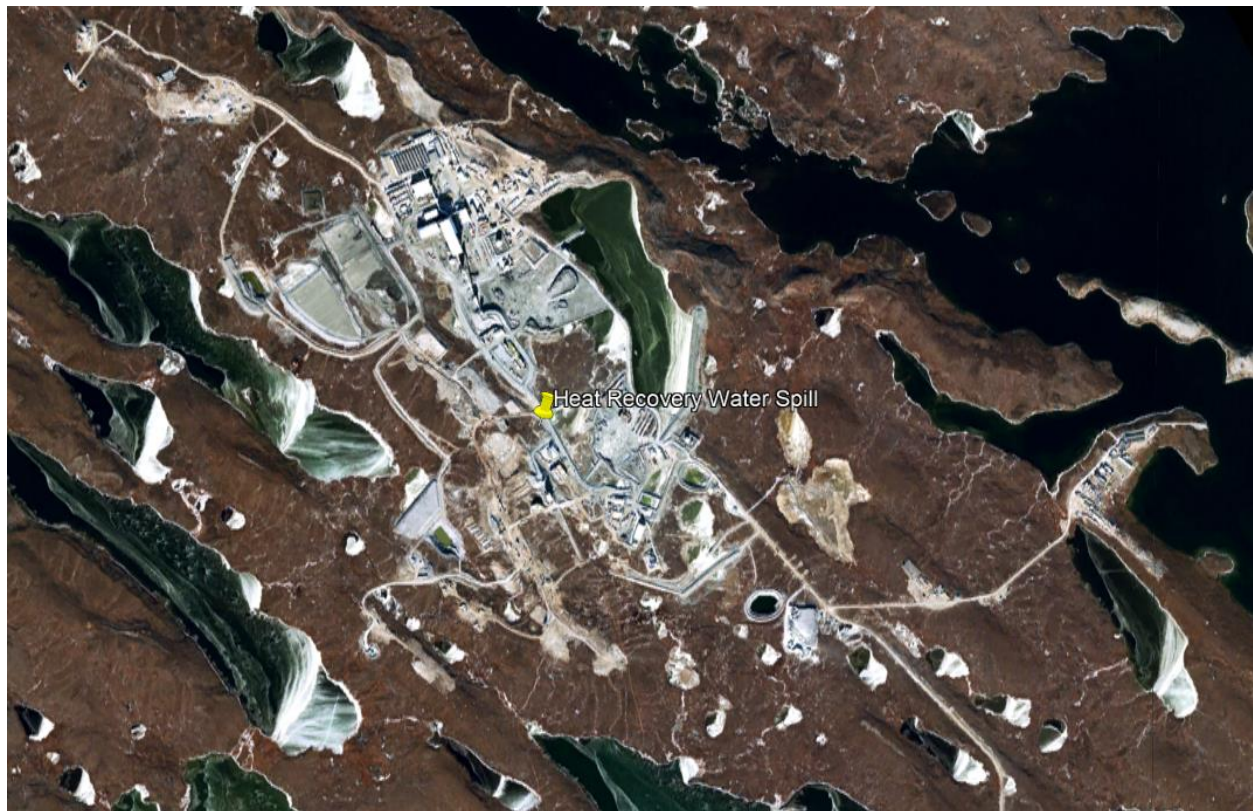
No water bodies were impacted by this spill. The nearest natural water body (B7) is 550 m away. The coordinates of the spill are 63° 1'47.51"N, 92°13'6.96"W (Figure 1).

**Figure 1:** Location of spill 165 m<sup>3</sup> heat recovery water spill in site catchment, east of WRSF 1.
