# Follow Up Report: #21-175

## May 13, 2021 – 80 m<sup>3</sup> Sewage Water

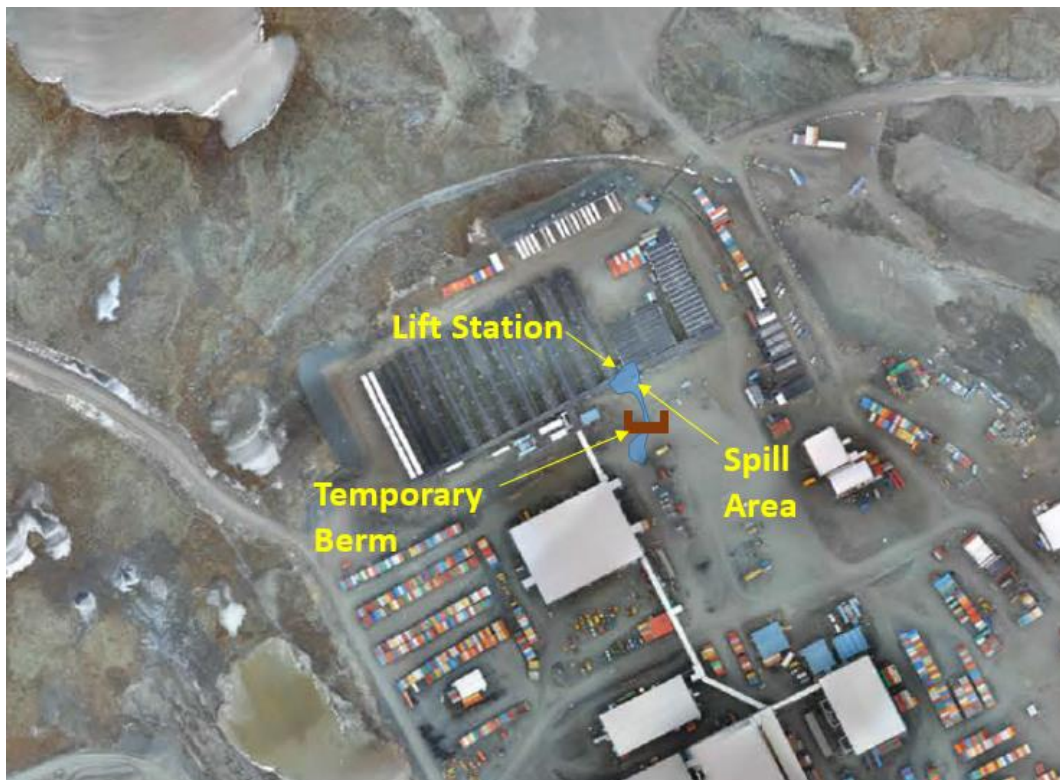
The coordinates of this spill source (lift station) are 63° 2'24"N, 92°13'40"W. No water bodies were impacted by this spill. All water released was contained within the industrial pad.

**Figure 1:** Location of the lift station and affected area in relation to the main camp.
