Follow Up Report: #2022067

March 6th, 2022 – Thickener Process Water Spill

The following information relates to spill 2022067 reported by Agnico Eagle Mines Ltd. On March 6th, 2022, and is being provided in accordance with:

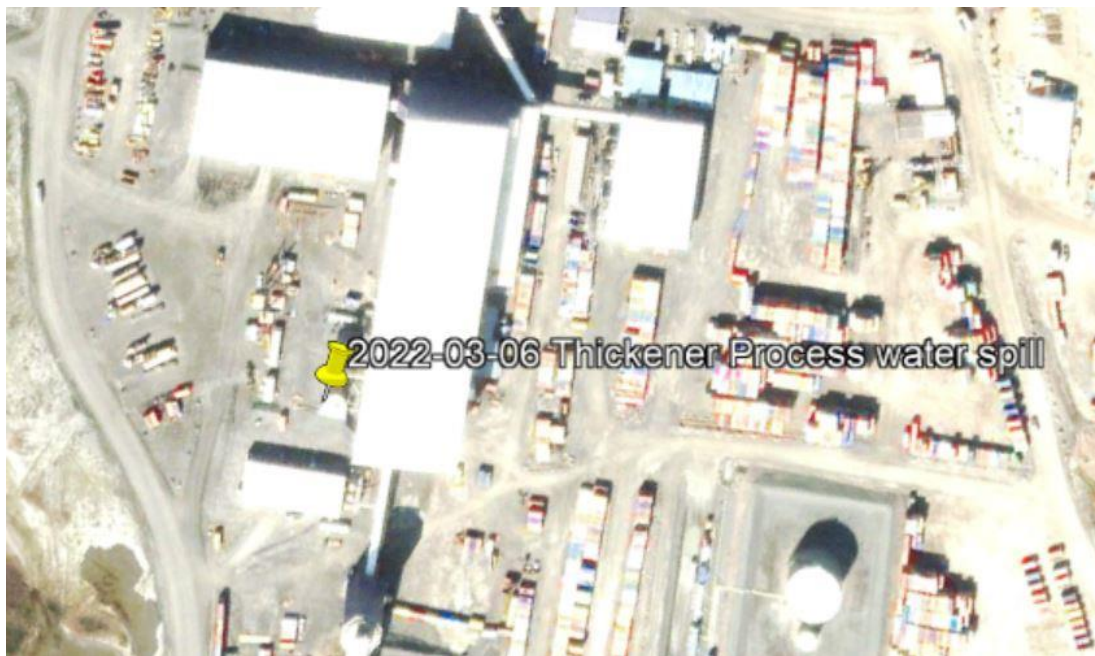
On March 6th, 2022, there was an overflow of approximately 45 m³ of thickener process water on the industrial pad, outside the process plant.

The coordinates of this spill are 63 2'13"N, 92 13'37"W. No water bodies were impacted by this spill; the closest water body (G2) is approximately 600 m northwest.

Figure 1: Location of the March 6th, 2022, thickener process water spill.
