Follow Up Report: #2022076

March 10th, 2022 – Thickener Process Water Spill

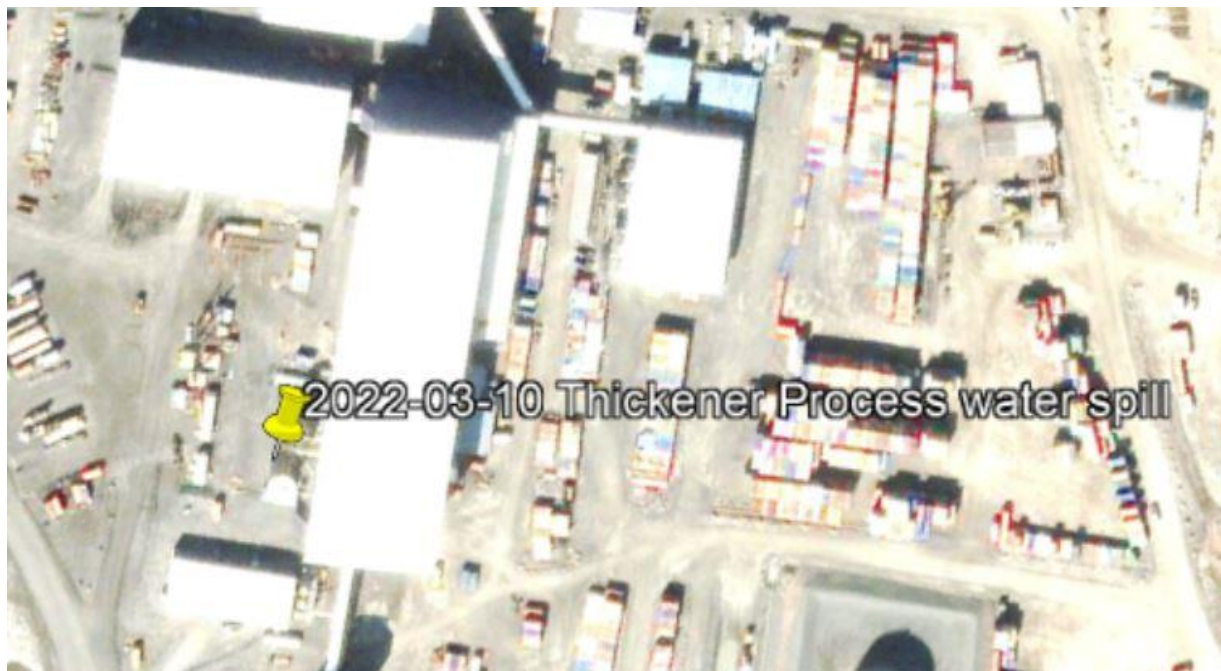
On March 10th, 2022, there was an overflow of approximately 10 m³ of thickener process water on the industrial pad, outside the process plant.

The coordinates of this spill are 63 2'11.5"N, 92 13'35.3"W. No water bodies were impacted by this spill; the closest water body (G2) is approximately 600 m northwest.

Figure 1: Location of the March 10th, 2022, thickener process water spill.
