Follow Up Report: #2022075

March 11th, 2022 – Thickener Process Water Spill

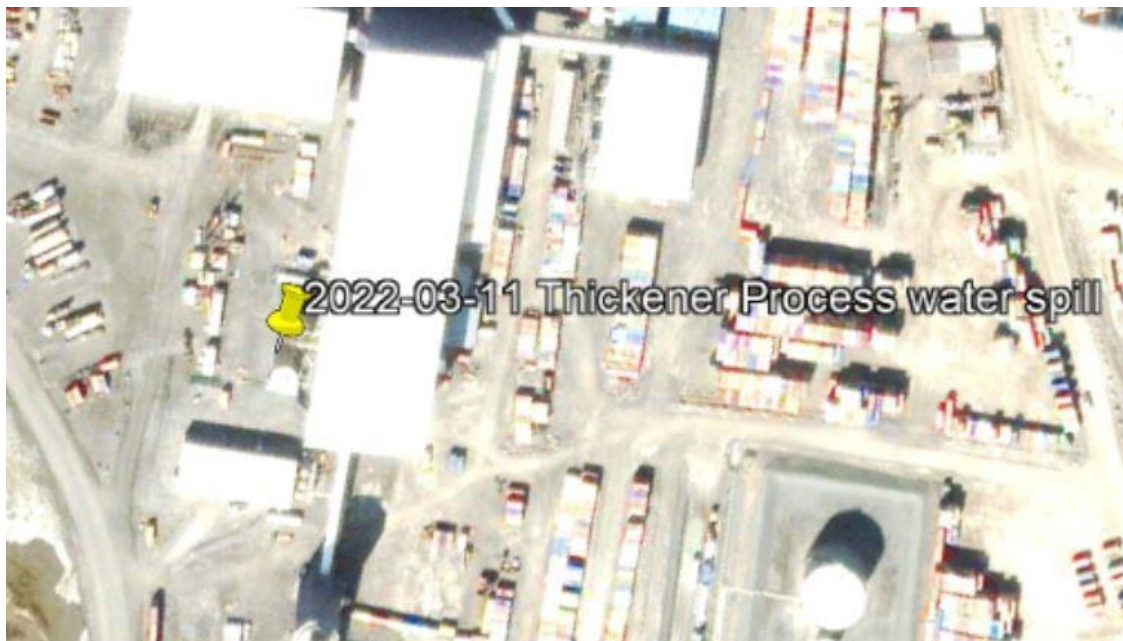
On March 11th, 2022, there was an overflow of approximately 5 m³ of thickener process water on the industrial pad, outside the process plant.

The coordinates of this spill are 63 2'11.5"N, 92 13'35.3"W. No water bodies were impacted by this spill; the closest water body (G2) is approximately 600 m northwest.

Figure 1: Location of the March 6th, 2022, thickener process water spill.
