## Follow Up Report: #2022180 May 11<sup>th</sup>, 2022 – 15 L Sewage

The following information refers to incident #2022180 reported by Agnico Eagle Mines Limited May 12<sup>th</sup>, 2022, and is being provided in accordance with:

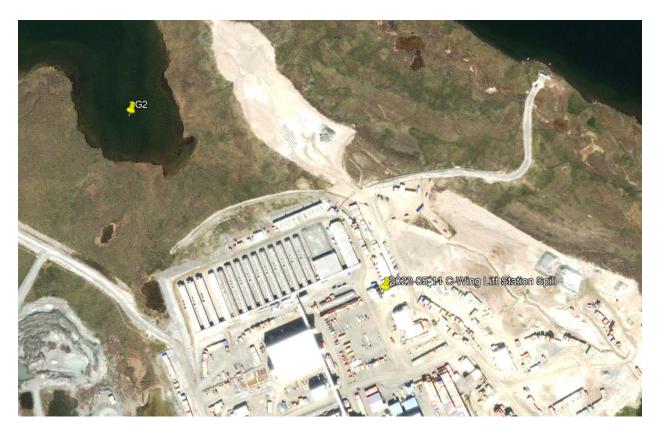
At approximately 11:30 on May 11<sup>th</sup>, 2022, the C wing lift station overflowed resulting in a 15 L of sewage spill to the industrial pad.

The coordinates of this spill are 63° 2′ 22.93"N, 92° 13′ 32.66"W. No water bodies were impacted by this spill. The closest water body (G2) is approximately 370 m north.

Figure 1: Location of the C wing lift station spill
