August 30th, 2022

Re.: Follow-up Report: Spill #2022395– Release of 400 L of Untreated Sewage at the Meliadine Gold Project

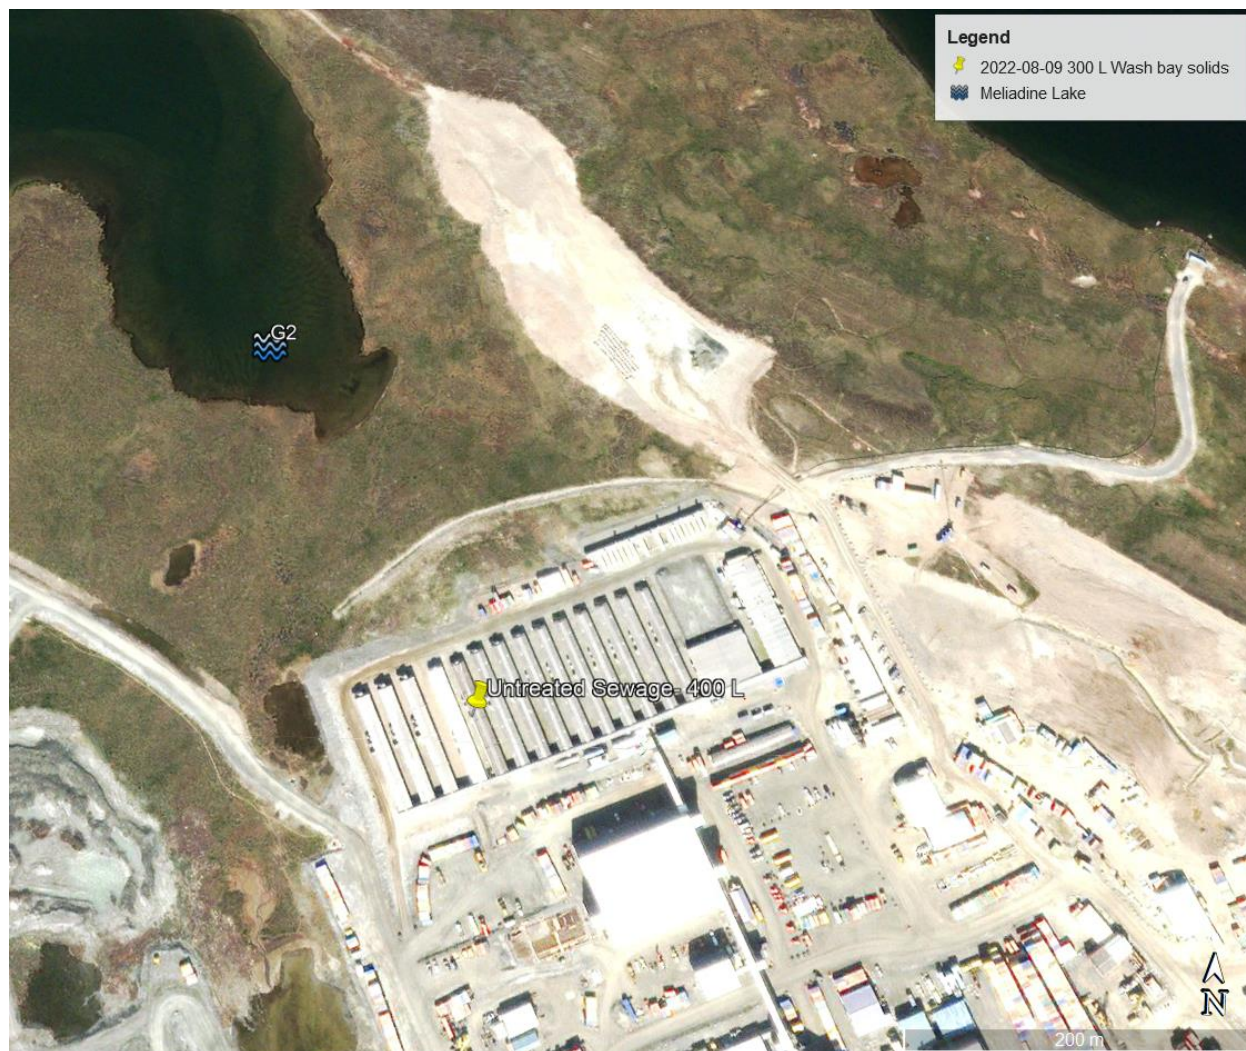
On August 2nd, 2022, at approximately 7:00 pm, an estimated 400 L of untreated sewage was spilled on the industrial pad due to an overflow of the Wing 10 lift station. No water bodies were impacted by this spill. The closest water body (G2) is approximately 200 meters north, as seen in Figure 1.

Figure 1: Location of untreated sewage spill and proximity to water bodies.
