September 1st, 2022

Re.: Follow-up Report: Spill #2022425– Release of 20 L of Untreated Sewage at the Meliadine Gold Project

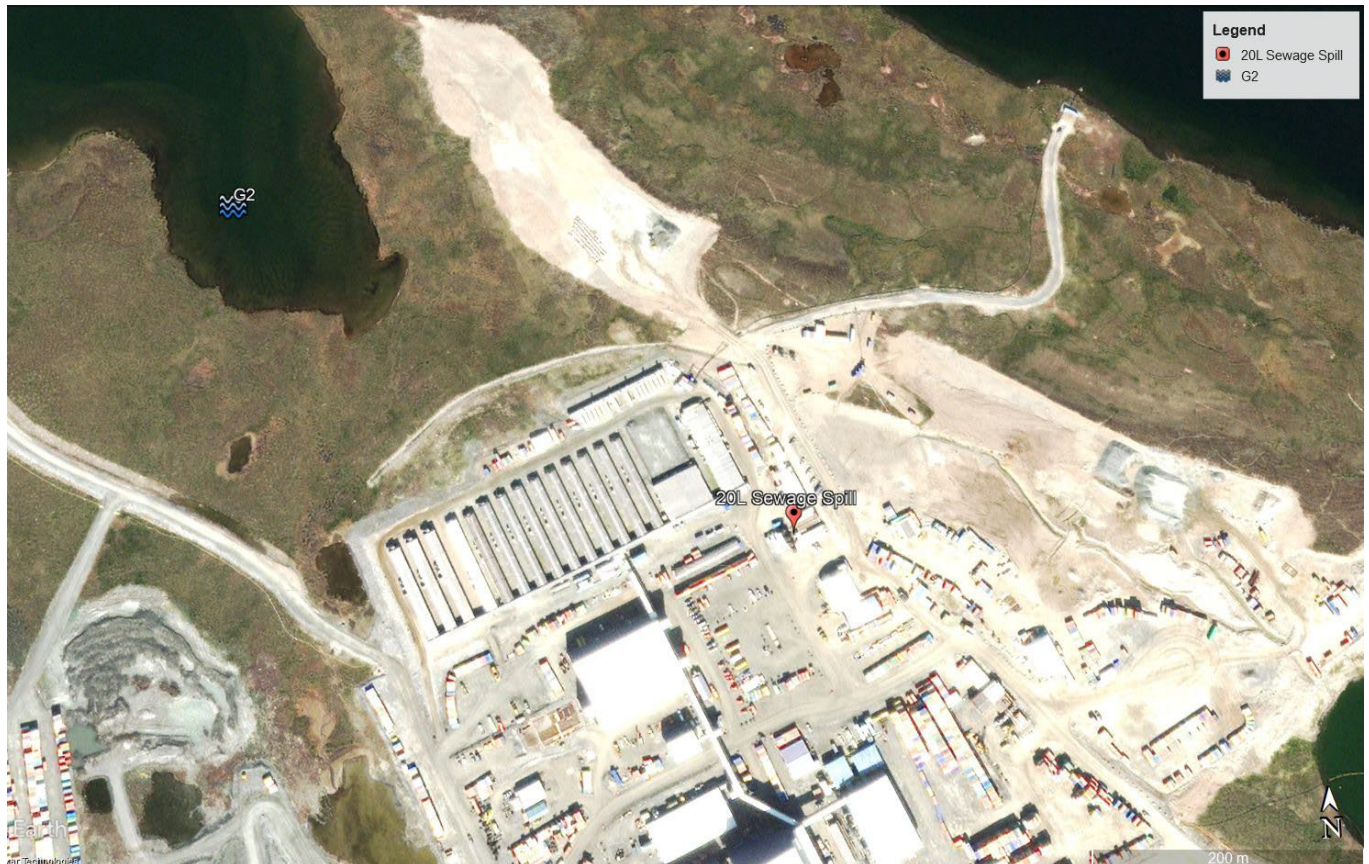
On August 2nd, 2022, at approximately 6:00 pm, an estimated 20 L of untreated sewage was spilled on the industrial pad due to an overflow of the Wing C lift station. No water bodies were impacted by this spill. The closest water body (G2) is approximately 360 meters northwest, as seen in Figure 1.

Figure 1: Location of sewage spill and proximity to water bodies.
