September 14<sup>th</sup> , 2022

## **Re.: Follow-up Report: Spill #2022417– Release of 6 KG of Ammonium Nitrate at the Meliadine Gold Project**

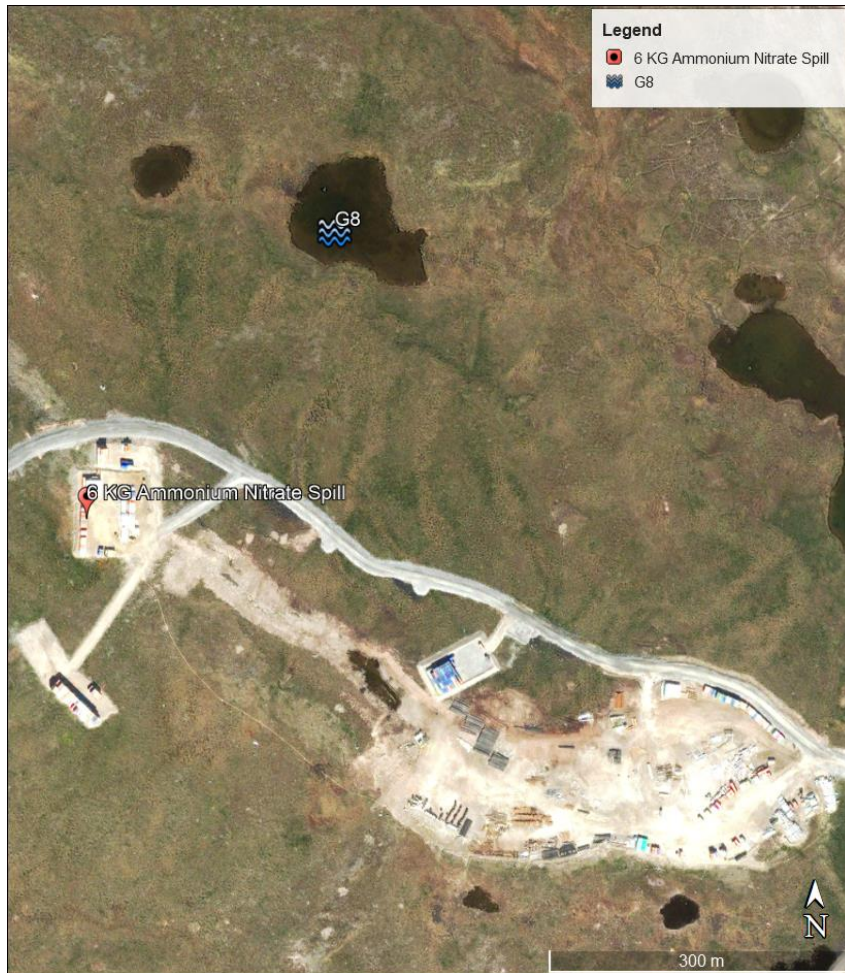
On August 15<sup>th</sup>, 2022, at approximately 7:30 am, an estimated 6 KG of ammonium nitrate was spilled on the Dyno industrial pad while opening a sealed seacan. No water bodies were impacted by this spill. The closest water body (G8) is approximately 330 meters northeast as seen in Figure 1.

**Figure 1:** Location of ammonium nitrate spill and proximity to water bodies.
