December 19<sup>th</sup>, 2022

## **Re.: Follow-up Report: Spill #2022533– Release of 1.5 m<sup>3</sup> of Emulsion at the Meliadine Gold Project**

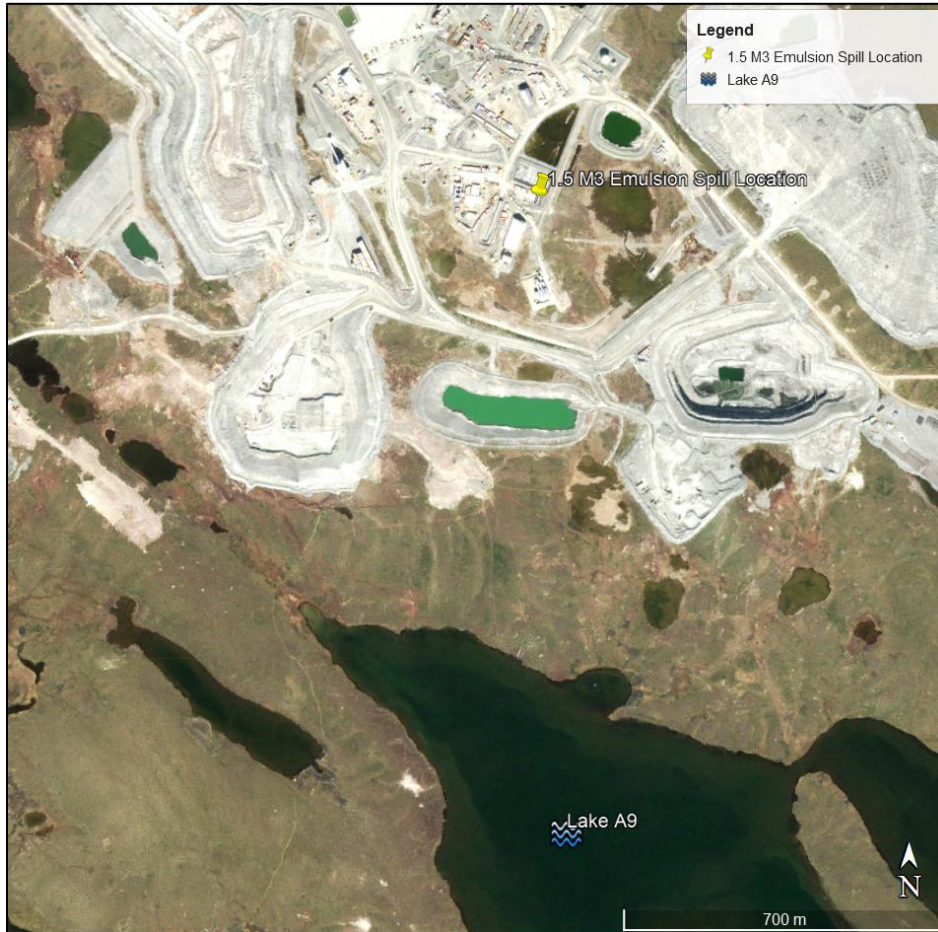
No water bodies were impacted by this spill. The closest water body (A8) is approximately 950 meters southwest, as seen in Figure 1.

**Figure 1:** Location of emulsion spill and proximity to water bodies.
