December 21, 2022

Re.: Follow-up Report: Spill # 2022542 – Release of 30 L of Sewage at the Meliadine Gold Project

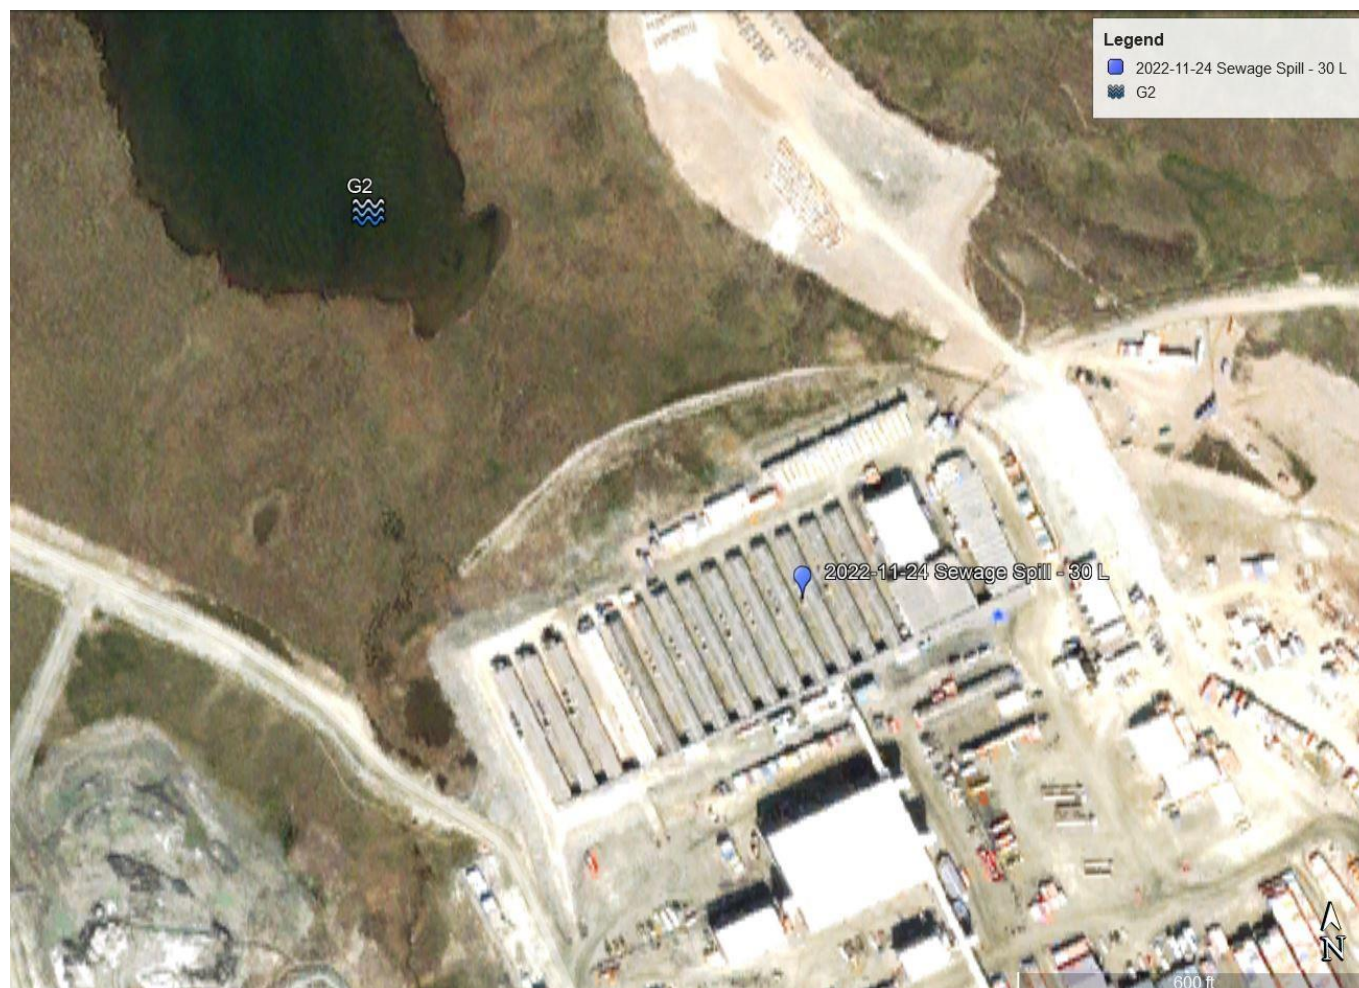
On November 24th, at approximately 6:30 pm, sewage overflowed from the pump of the wing 3 lift station. No water bodies were impacted by this spill. The closest water body (G2) is approximately 222 meters northwest, as seen in Figure 1.

Figure 1: Location of sewage spill and proximity to water bodies.
