Re: Follow-up Report Spill #2022559 – Release of 40L of Sewage at the Meliadine Gold Project

Description of Incident

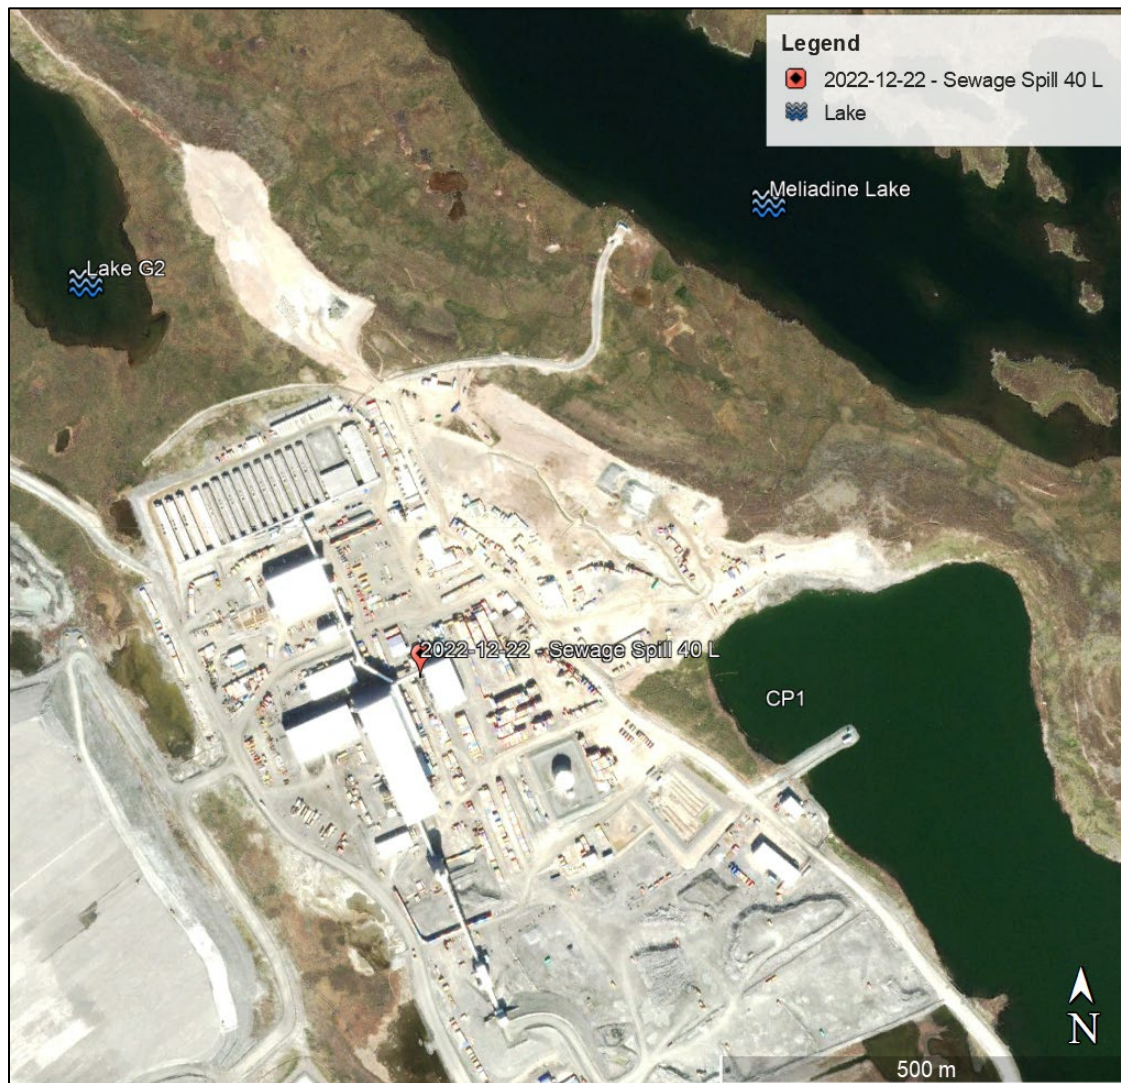
On December 22nd, 2022, at approximately 10:00 am, an estimated 40L of sewage was spilled on the industrial pad from a damaged distribution line from the power plant lift station. The line sustained damage due to freezing. No water bodies were impacted by this spill. The closest water body (G2) is approximately 520 meters north-northwest, as seen in Figure 1.

Figure 1: Location of the sewage spill and proximity to water bodies.
