May 27<sup>th</sup>, 2023

## Re: Follow-up Report Spill #2023-183 – Release of 10 L of Sewage at the Meliadine Gold Mine

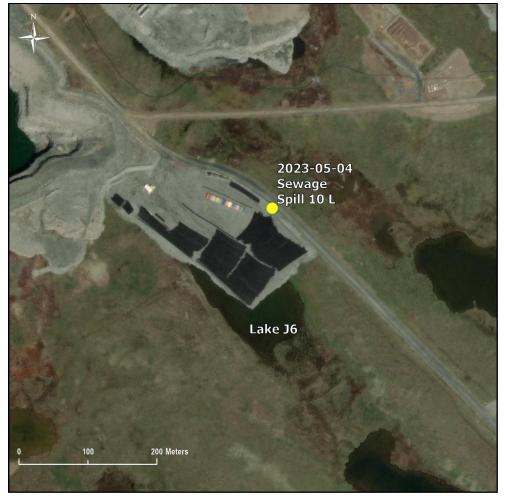
On May 4<sup>th</sup>, 2023, at approximately 23:00, an estimated 10 L of sewage was spilled onto the fusion pad by the fusion pad wash car due to a fracture in the sewage line. No water bodies were impacted by this spill. The closest water body (J6) is approximately 108 meters south, as seen in Figure 1.

Figure 1: Location of the sewage spill and proximity to water bodies.

The operator notified his supervisor of the incident. The supervisor then contacted the environment department to assess the spill. The sewage-impacted gravel and ice was excavated and brought to Landfarm A as per the Spill Contingency Plan.
