June 15, 2023

Re: Follow-up Report Spill #2023-213 – Release of 15 L of Sewage at the Meliadine Gold Mine

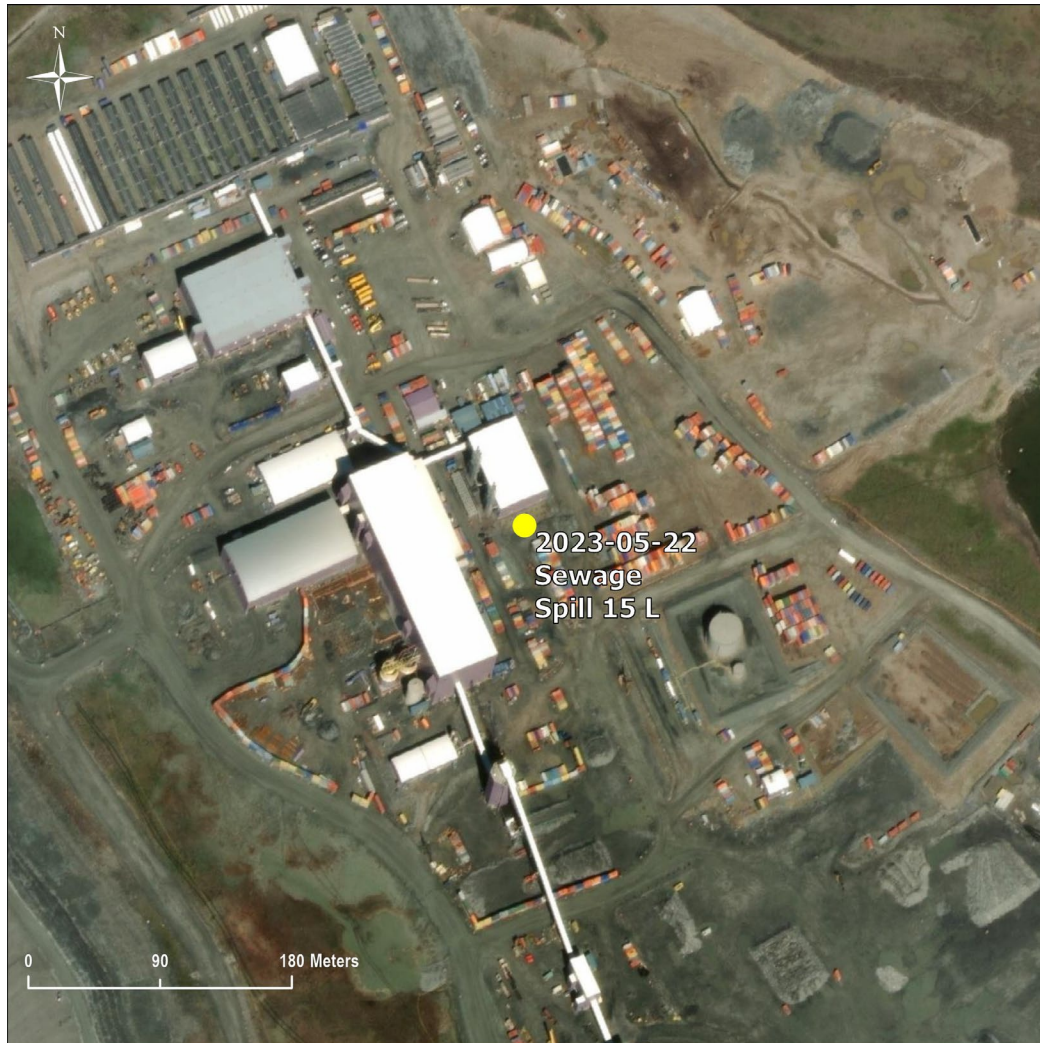
On May 22nd, 2023, at approximately 07:30, an estimated 15 L of sewage was spilled onto the industrial pad by the temporary power plant wash car due to a connection failure. No water bodies were impacted by this spill. The closest water body (G2) is approximately 565 meters west, as seen in Figure 1.

Figure 1: Location of the sewage spill and proximity to water bodies.
