June 16, 2023

Re: Follow-up Report Spill #2023-211 – Release of 200 L of Sewage at the Meliadine Gold Mine

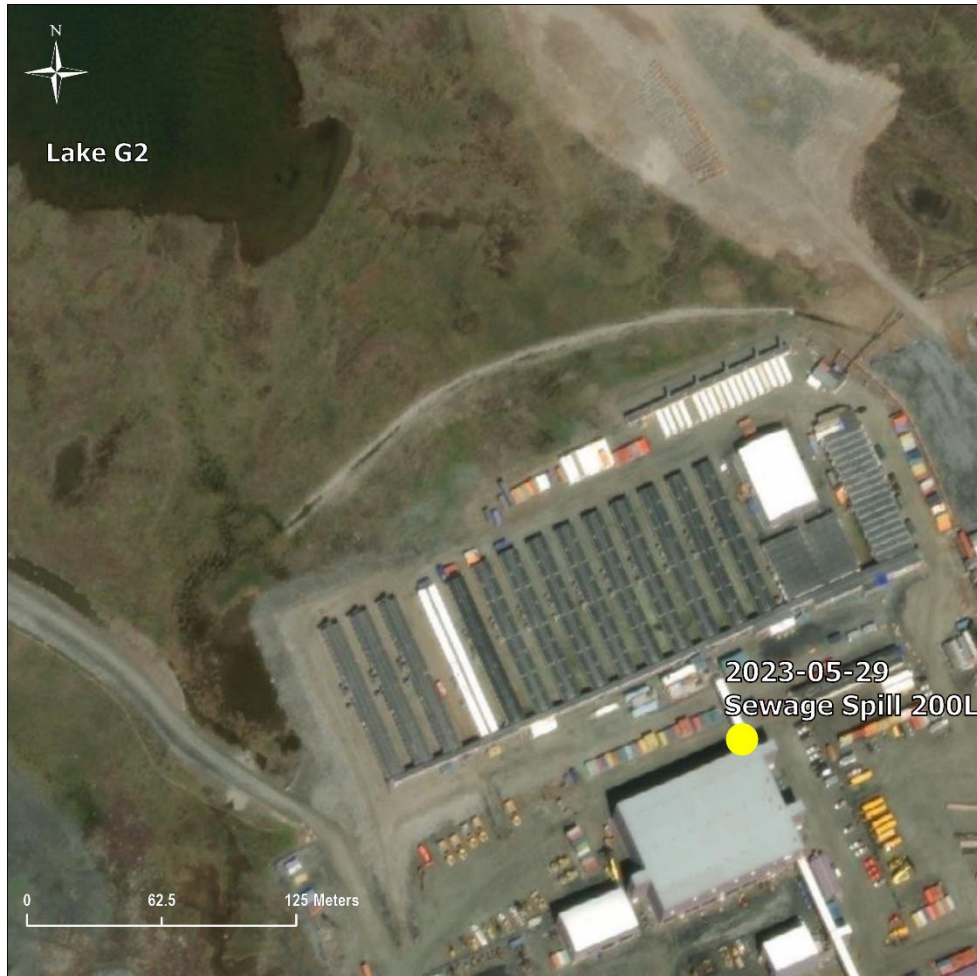
No water bodies were impacted by this spill. The closest water body (G2) is approximately 325 meters northwest, as seen in Figure 1.

Figure 1: Location of the sewage spill and proximity to water bodies.
