August 22nd, 2023

Re: Follow-up Report Spill # 2023-331 – Release of 125 L of Sewage at the Meliadine Gold Project

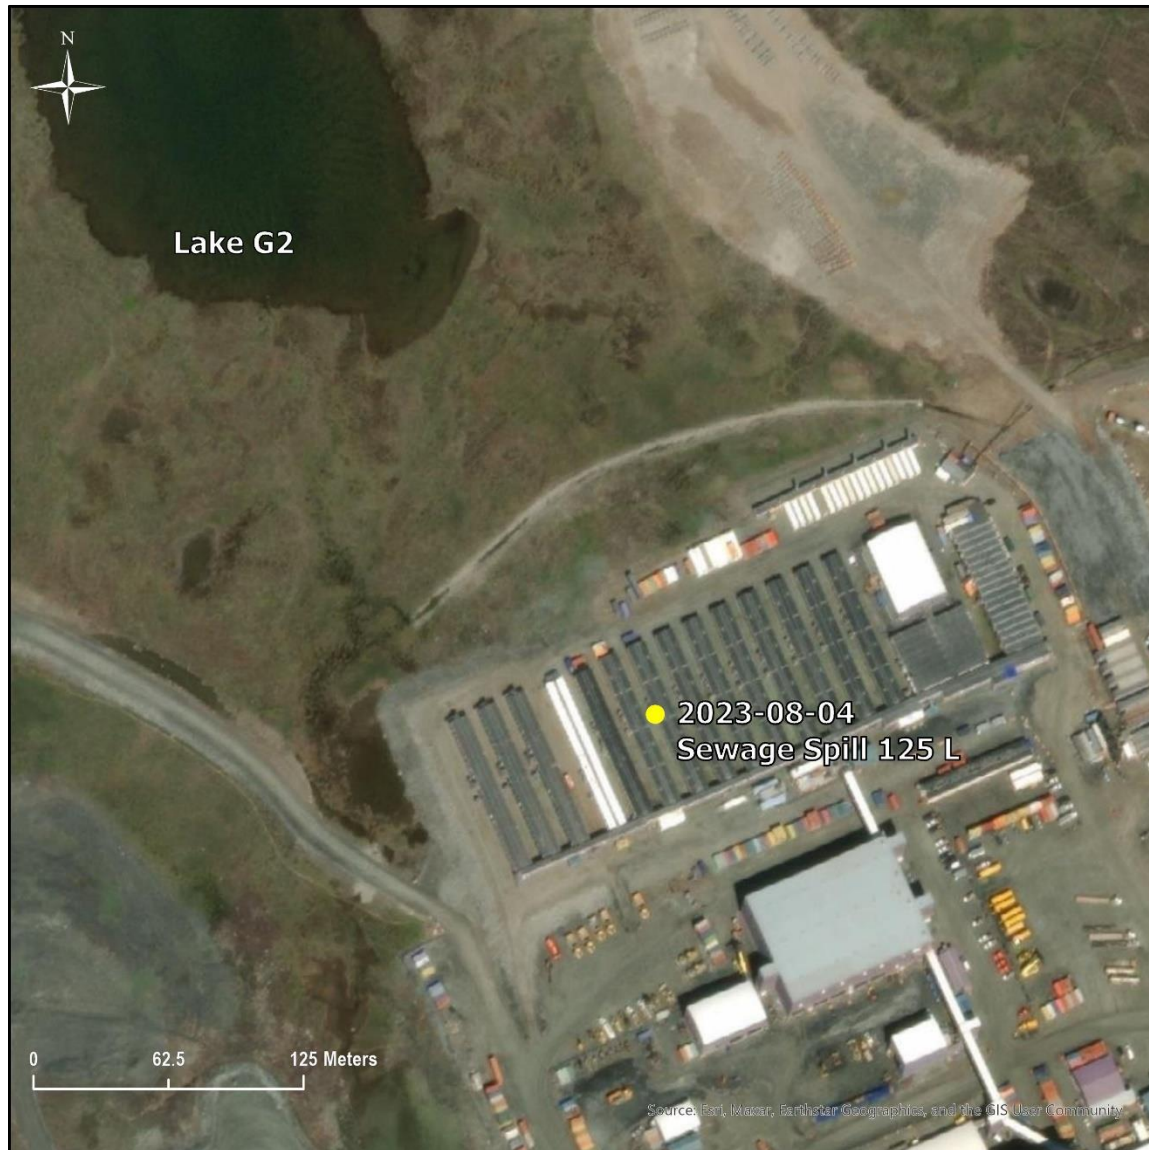
On August 4th, 2023, at approximately 6:00 pm, an estimated 125 L of sewage was spilled onto the industrial pad at the wing 8 lift station. The Energy and Infrastructure department was notified of an overflow occurring at wing 8 lift station. A plumber was dispatched to address the situation and restore the system to its intended operational state. The spilled sewage was contained to the immediate local area, and no water bodies were impacted by the spill. The closest water body (Lake G2) is approximately 208 meters northwest, as seen in Figure 1.

Figure 1: Location of the sewage spill and proximity to water bodies.
