October 19, 2023

## **Re: Follow-up Report Spill #2023-402 – Release of 40 L of Sewage at the Meliadine Gold Mine**

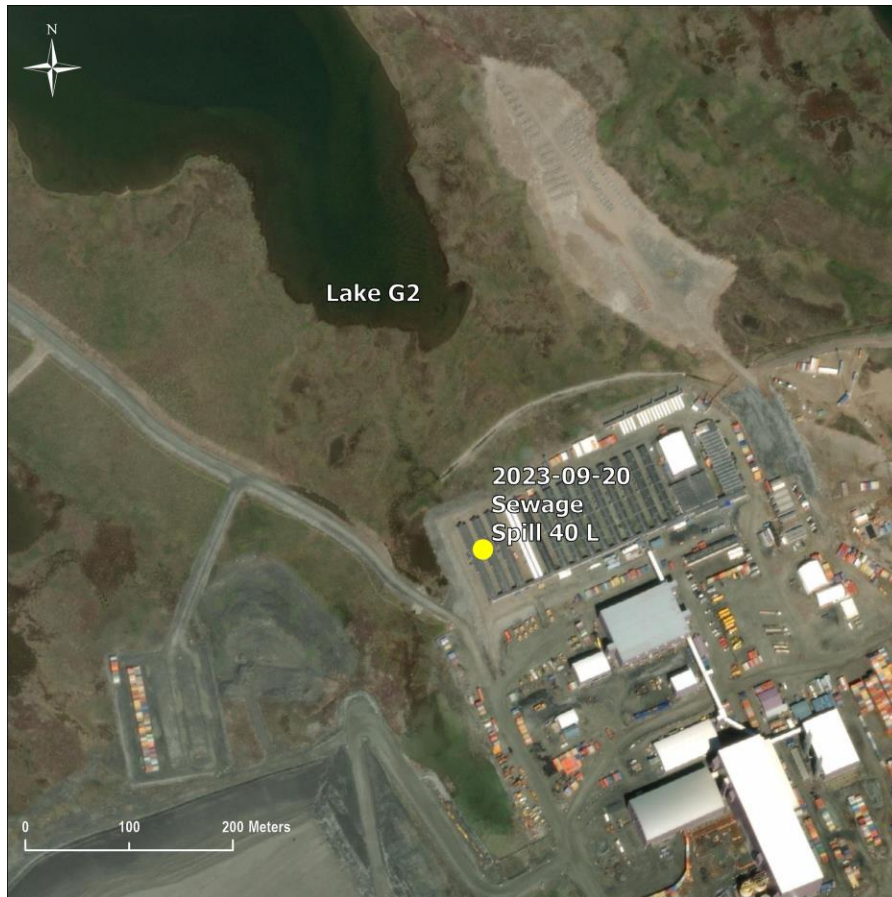
**Figure 1:** Location of the sewage spill and proximity to water bodies.

On September 20<sup>th</sup>, 2023, at approximately 18:00, an estimated 40 L of sewage was spilled onto the industrial pad by wing 13 lift station. The pump was unplugged during routine lift station maintenance at wing 13 and was not plugged back in during the restart, causing the spill. No water bodies were impacted by this spill. The closest water body (Lake G2) is approximately 200 meters northwest, as seen in Figure 1.
