December 5th, 2023

Re: Follow-up Report Spill #2023-464 – Release of 50 L of Sewage at the Meliadine Gold Mine

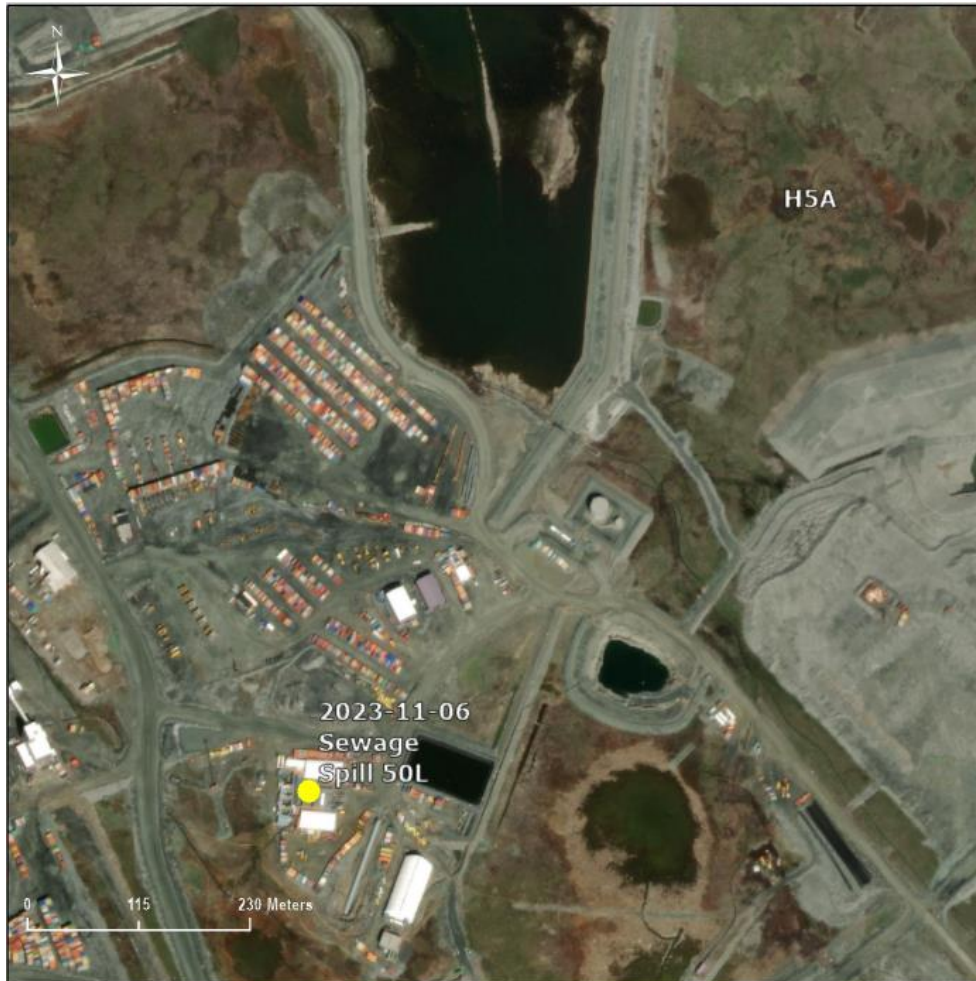
On November 6th, 2023, at approximately 06:30, an estimated 50 L of sewage was spilled onto the ground at the Orbit Garant holding tank. The facility was serviced but its valve was inadvertently left partially open, allowing for sewage to leak from the valve into the enclosure. No water bodies were impacted by this spill. The closest water body (Lake H5A) is approximately 650 m northeast, as seen in Figure 1.

Figure 1: Location of the sewage spill and proximity to water bodies.

Upon detection of the spill, a member of the Energy & Infrastructure (E&I) department closed the valve stopping the leak. Following this, E&I personnel used a vacuum truck to remove free liquid within the secondary containment and the ground surface. E&I personnel then hand-excavated the area to recover the contaminated material. Snowfall occurred later in the morning; a loader was utilized to perform a final scraping in the affected area. The material collected was transported to Landfarm A as per the Spill Contingency Plan.
