December 6th, 2023

Re: Follow-up Report Spill #2023-469 – Release of 50 L of Sewage at the Meliadine Gold Mine

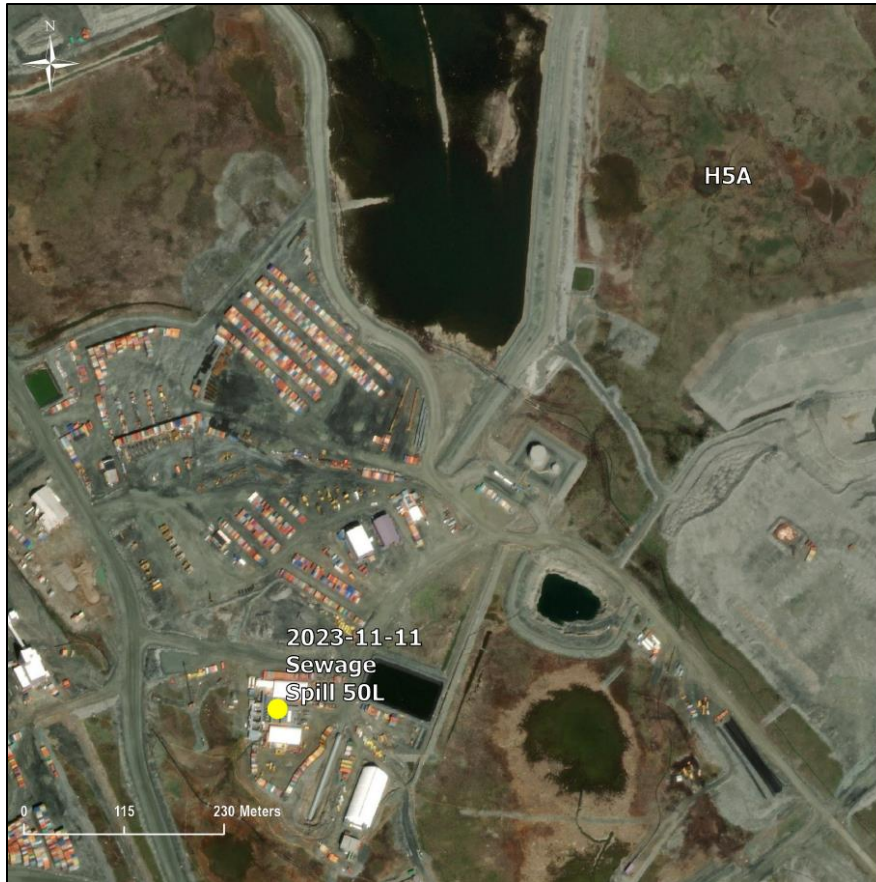
On November 11th, 2023, at approximately 06:00, an estimated 50 L of sewage was spilled onto the ground by Orbit Garant holding tank. The Energy and Infrastructure (E&I) department discovered a leak resulting from a malfunctioning valve. The closest water body (Lake H5A) is approximately 650 m northeast, as seen in Figure 1.

Figure 1: Location of the sewage spill and proximity to water bodies.
