## **Re: Follow-up Report Spill #2023-517 – Release of 10 L of Sewage at the Meliadine Gold Mine**

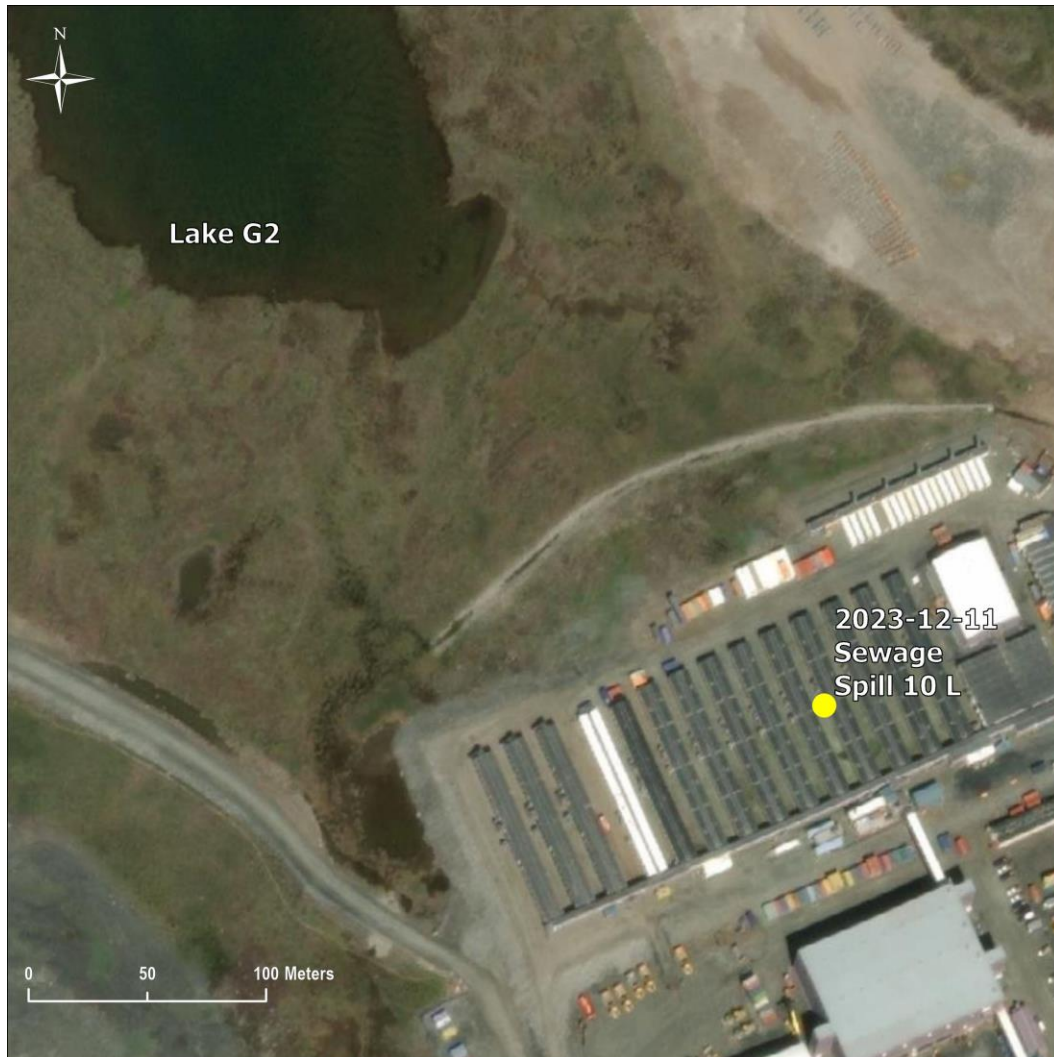
On December 11<sup>th</sup>, 2023, at approximately 11:30, an estimated 10 L of sewage was spilled onto the industrial pad at the wing 4 lift station. Due to a site power outage, the transfer pump did not engage allowing the lift station holding tank to overflow. No water bodies were impacted by the spill. The closest water body (Lake G2) is approximately 220 m northwest, as seen in Figure 1.

**Figure 1:** Location of the sewage spill and proximity to water bodies.
