January 9th, 2024

Re: Follow-up Report Spill #2023-518 – Release of 10 L of Sewage at the Meliadine Gold Mine

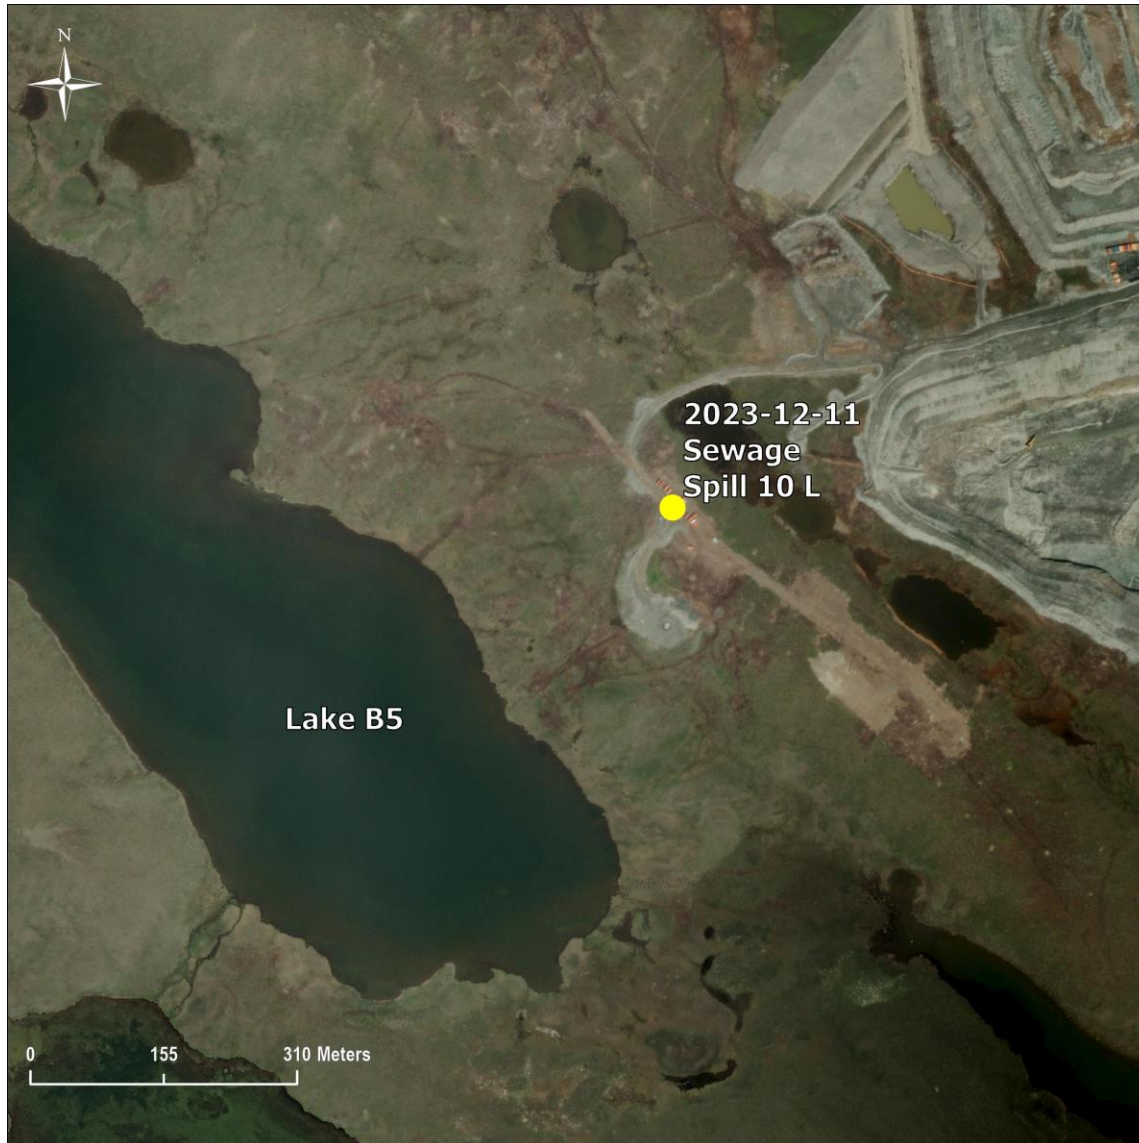
On December 11th, 2023, at approximately 12:30, an estimated 10 L of sewage was spilled onto the industrial pad by the west exhaust raise. Residual sewage in vacuum truck transfer hose was released when disconnecting the hose from a wash car holding tank, resulting in the sewage spill. No water bodies were impacted by this spill. The closest water body (Lake B5) is approximately 260 m southwest, as seen in Figure 1.

Figure 1: Location of the sewage spill and proximity to water bodies.
