January 9th, 2024

Re: Follow-up Report Spill #2023-520 – Release of 5 L of Sewage at the Meliadine Gold Mine

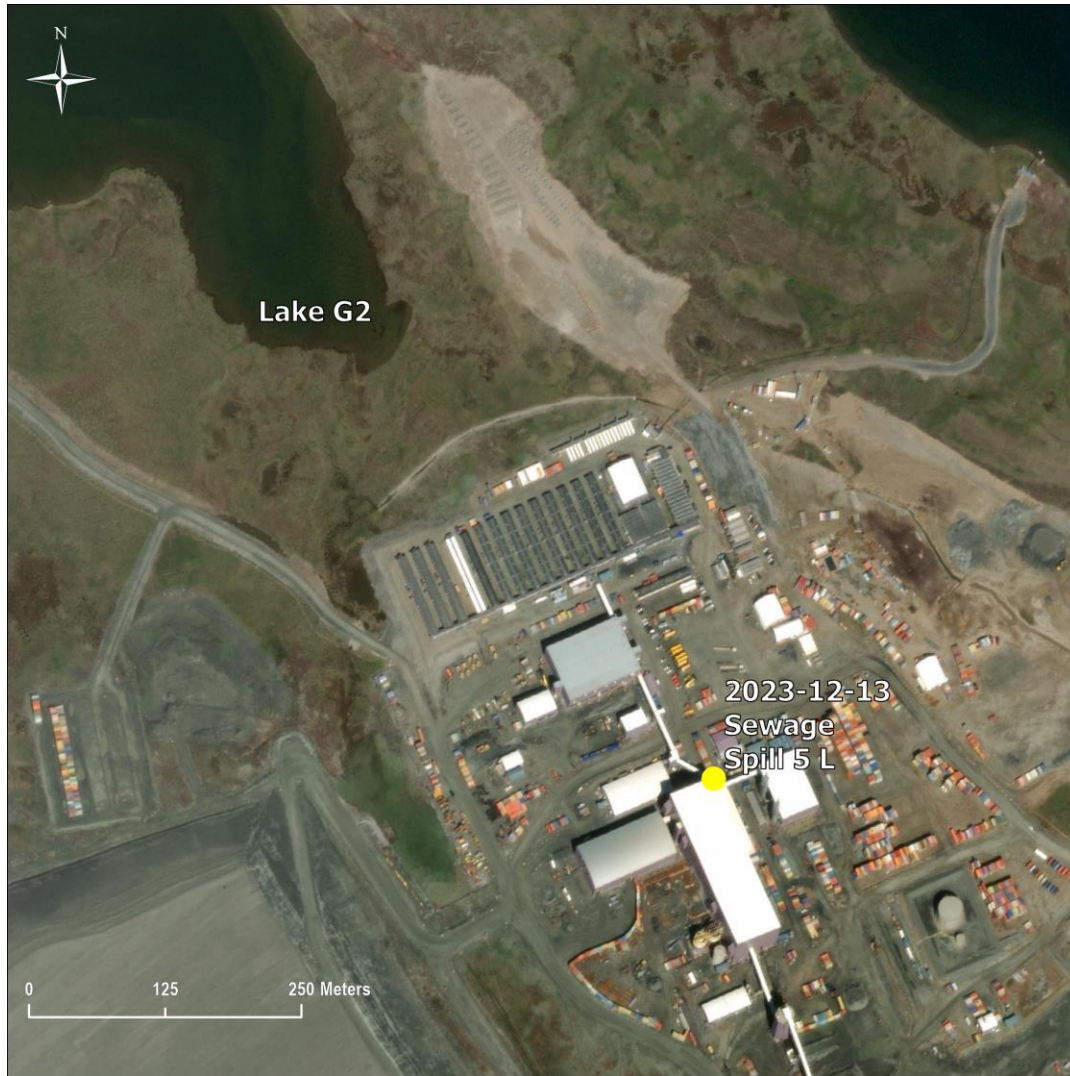
On December 13th, 2023, at approximately 12:15, an estimated 5 L of sewage was spilled onto the industrial pad at the mill lift station. The transfer pump failed to empty the lift station holding tank, resulting in sewage overflowing and causing the spill. No water bodies were impacted by this spill. The closest water body (Lake G2) is approximately 500 m northwest, as seen in Figure 1.

Figure 1: Location of the sewage spill and proximity to water bodies.
