January 20th, 2024

**Re: Follow-up Report Spill #2023-539 – Release of 100 L of Sewage at the Meliadine Gold Mine**

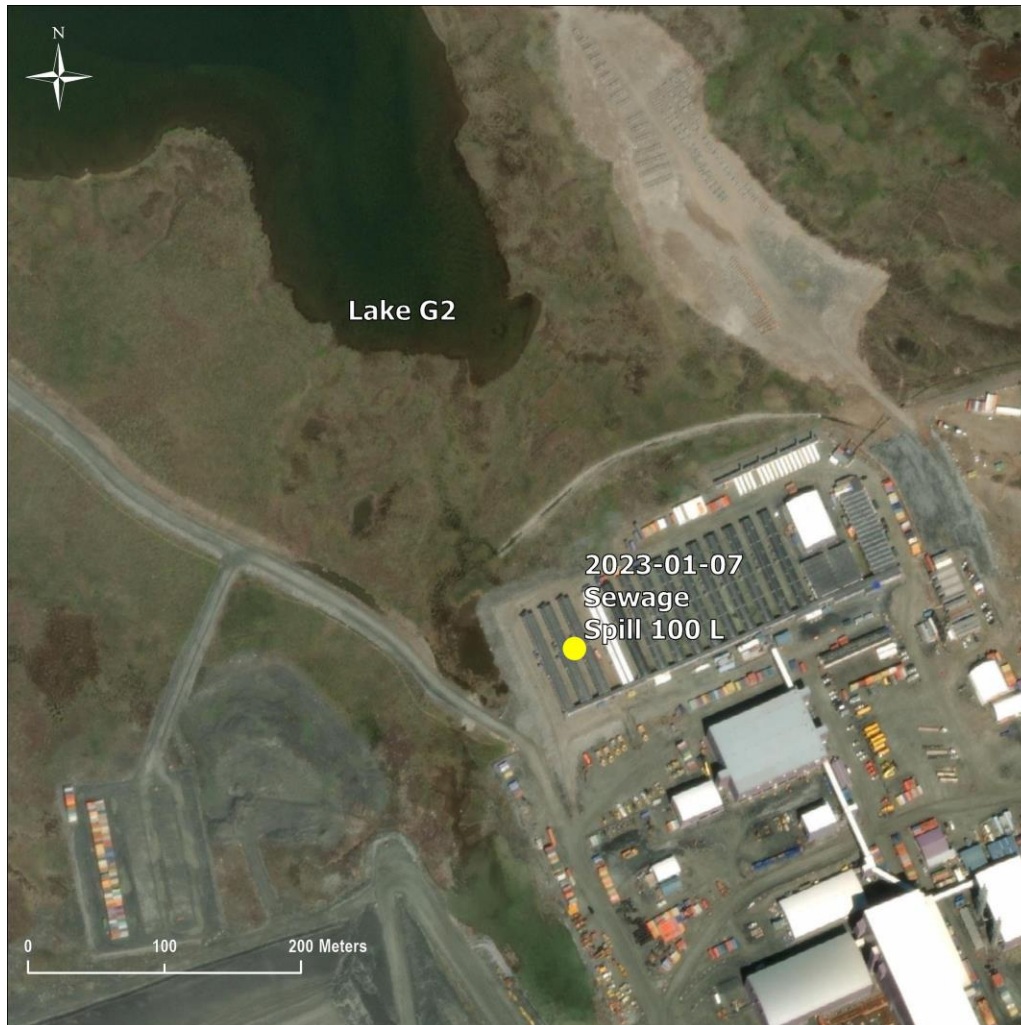
No water bodies were impacted by the spill. The closest water body (Lake G2) is approximately 200 m north, as seen in Figure 1.

**Figure 1:** Location of the sewage spill and proximity to water bodies.
