February 11th, 2024

Re: Follow-up Report Spill #2024-016 – Release of 5 L of Sewage at the Meliadine Gold Mine

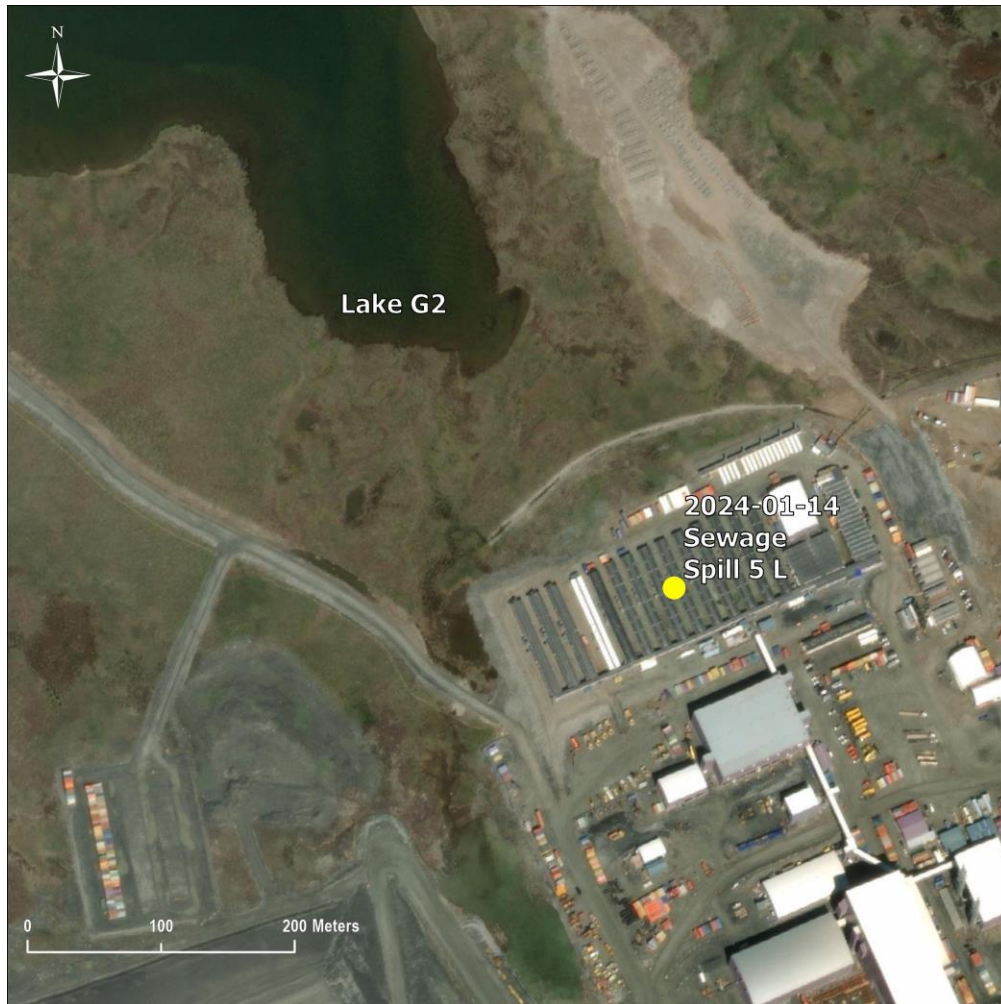
No water bodies were impacted by the spill. The closest water body (Lake G2) is approximately 215 m northwest, as seen in Figure 1.

Figure 1: Location of the sewage spill and proximity to water bodies.
