July 30th, 2024

Kyle Amsel
Water Resource Officer
Kivalliq Region, Field Operations Unit
Crown-Indigenous Relations and Northern Affairs Canada
Rankin Inlet, NU
XOC OGO

Re: Follow-up Report Spill #2024-217 – Release of 1.5m³ of Sewage at the Meliadine Gold Mine

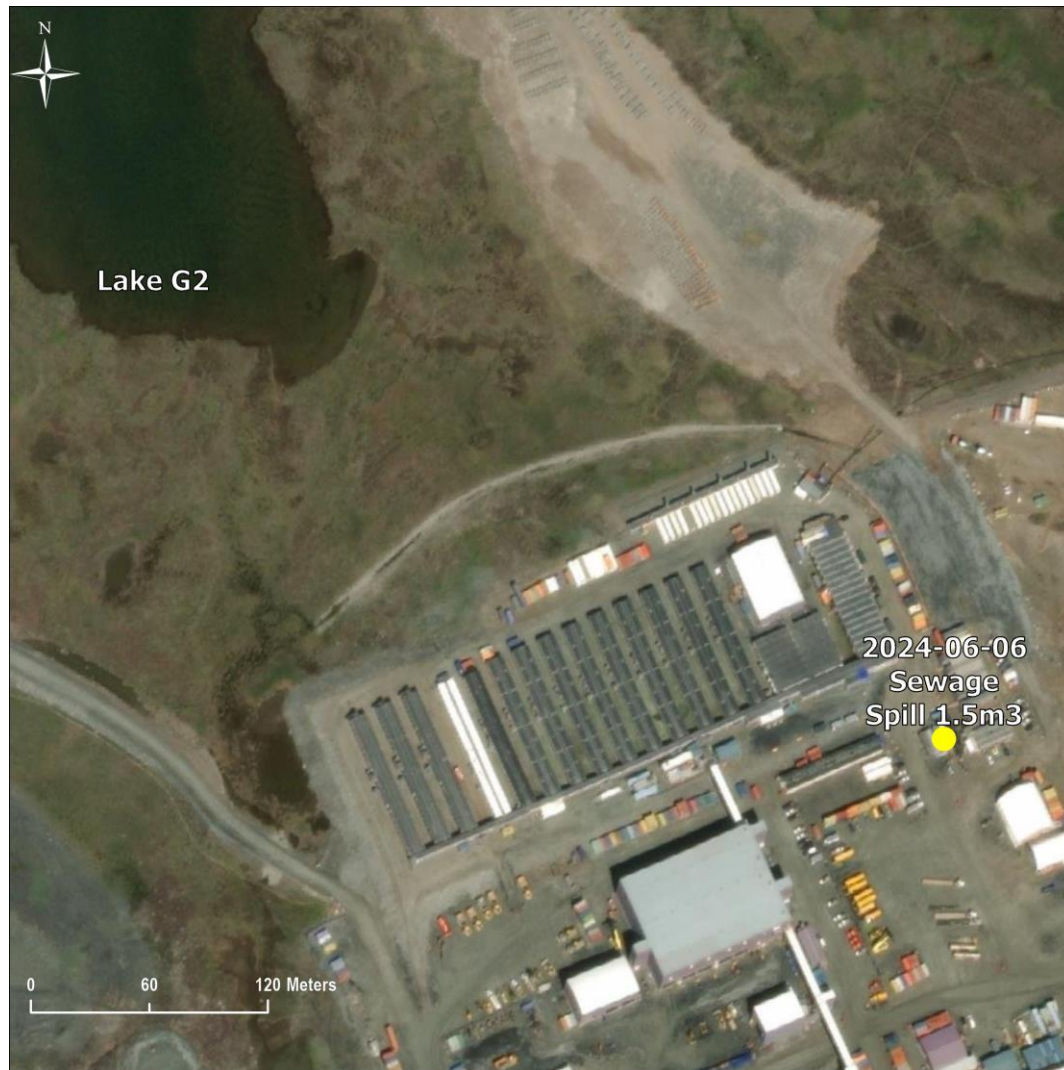
No water bodies were affected by the spill. The closest water body, Lake G2, is approximately 350 meters northwest, as seen in Figure 1.

Figure 1: Location of the sewage spill and proximity to water bodies.
