January 18th, 2025

Re: Follow-up Report Spill #2025-007 – Release of 1,000 L of waste oil at the Meliadine Gold Project

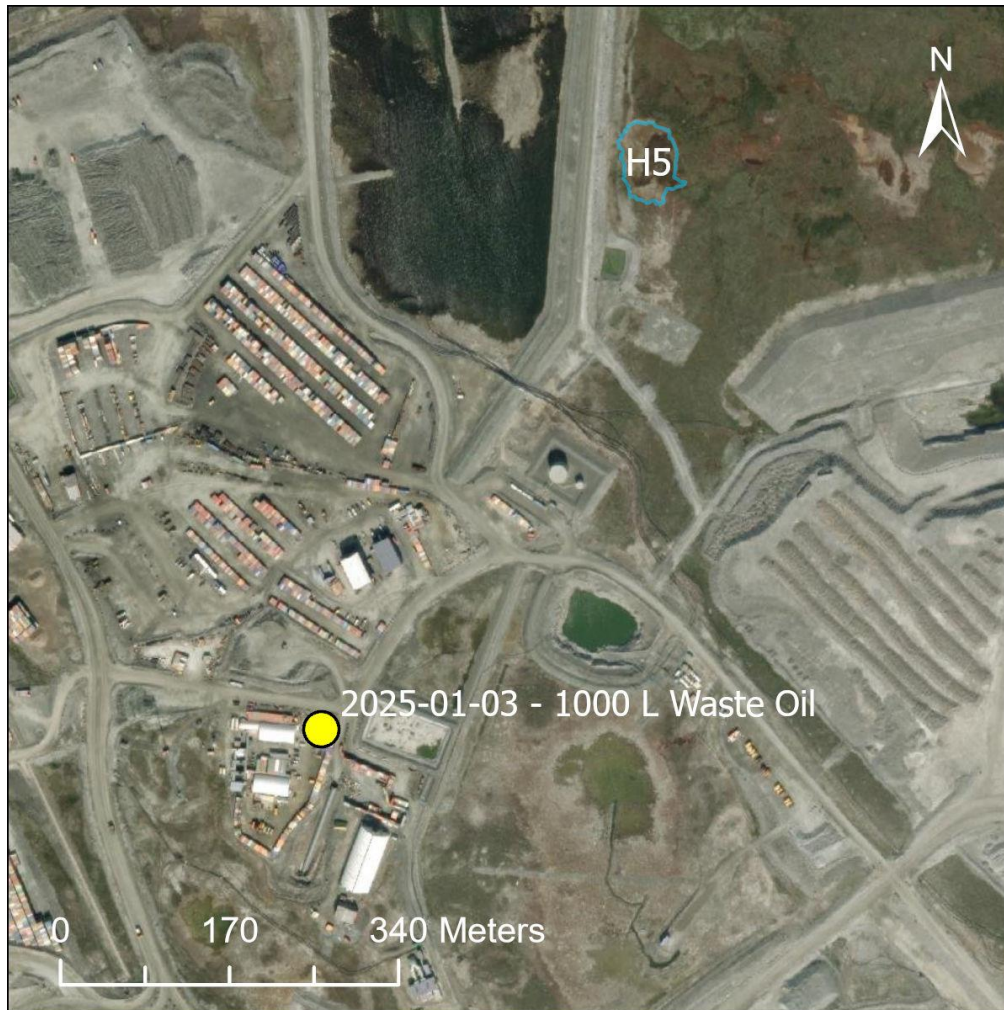
The spill occurred within the site's water management infrastructure, and as such, no waterbodies were impacted by the spill. The closest water body (H5) is approximately 620 meters northeast, as seen in Figure 1.

Figure 1: Location of the spill and proximity to waterbodies.
