Re: Follow-up Report Spill #2025-103 — Release of 1135 kg of emulsion at the Meliadine Gold Project

Description of Incident

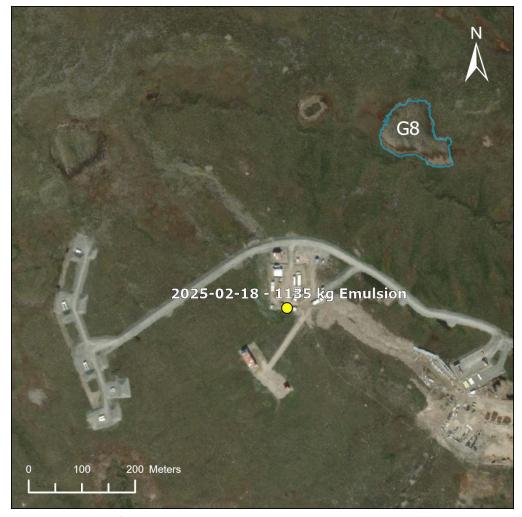
No waterbodies were impacted by the spill. The closest water body (G8) is approximately 350 meters northeast, as seen in Figure 1.

Figure 1: Location of the spill and proximity to waterbodies.
