## **Re: Follow-up Report Spill #2025-154 – Release of 30 L of Sewage at the Meliadine Gold Project**

### **Description of Incident**

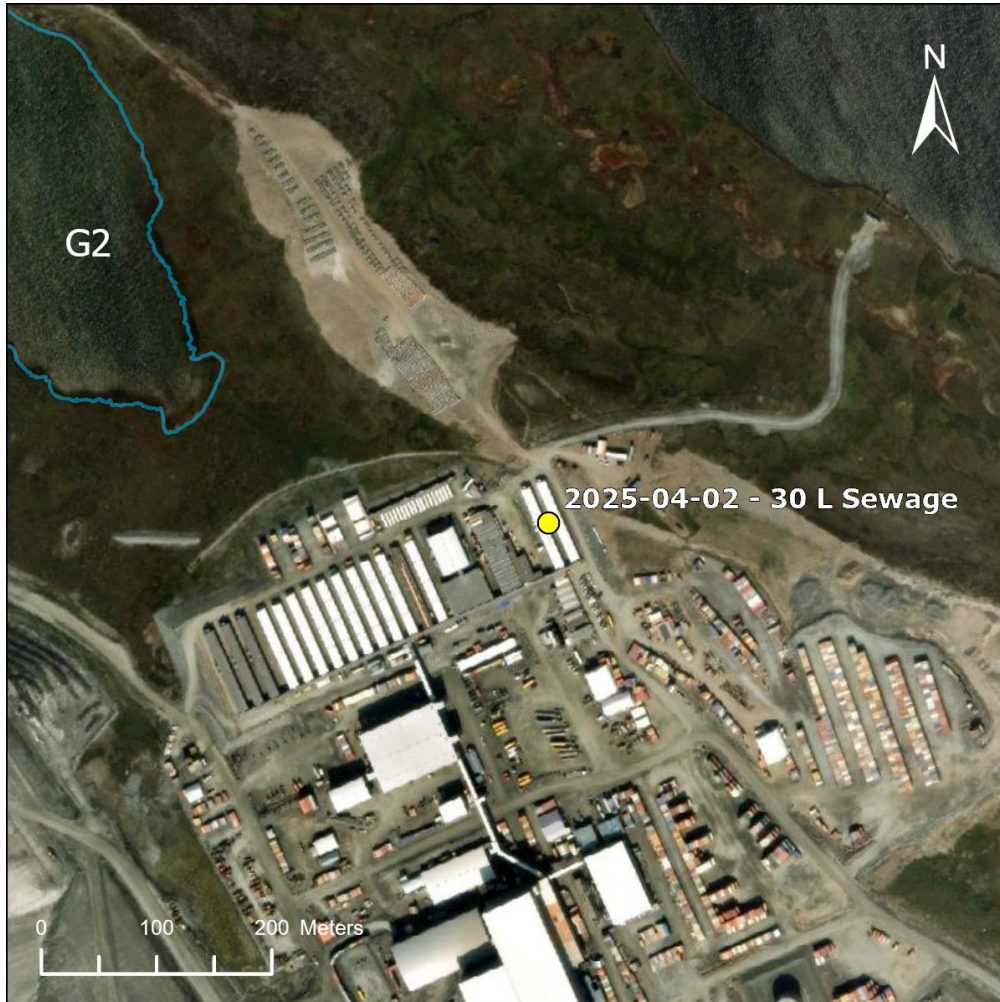
The spill occurred within the site's water management infrastructure, and as such, no waterbodies were impacted by the spill. The closest water body (Lake G2) is approximately 260 meters northwest, as seen in Figure 1.

**Figure 1:** Location of the spill and proximity to waterbodies.
