April 30<sup>th</sup>, 2025

## **Re: Follow-up Report Spill #2025-169 – Release of 38 L of Sewage at the Meliadine Gold Project**

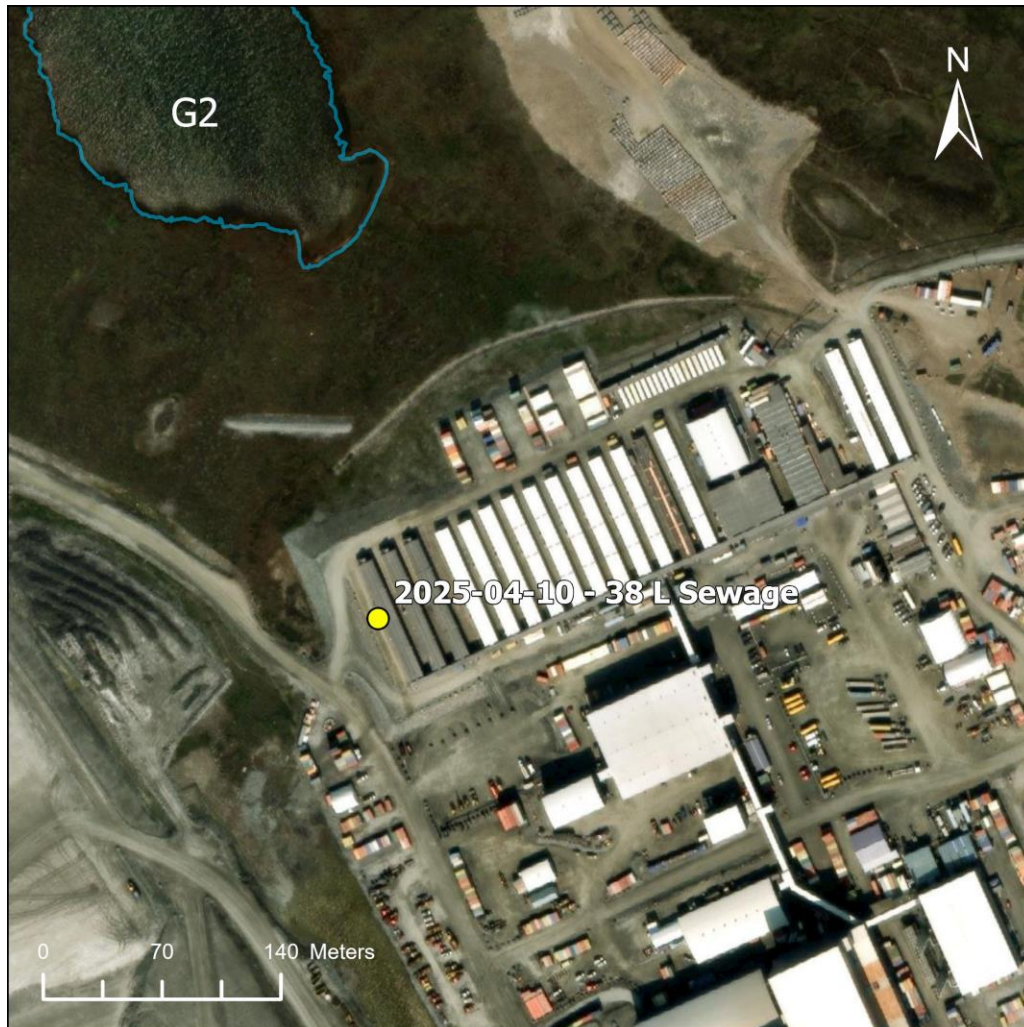
On April 10<sup>th</sup>, 2025, at 06:30, approximately 38 L of sewage spilled onto the industrial pad outside the Wing 14 lift station. Upon inspection, it was discovered the lift station pump impeller was obstructed by non-compliant material, which led to the pump's failure and the lift station to overflow.

The spill occurred within the site's water management infrastructure, and as such, no waterbodies were impacted by the spill. The closest water body (Lake G2) is approximately 217 meters north, as seen in Figure 1.

**Figure 1:** Location of the spill and proximity to waterbodies.

Upon discovering the spill, a vacuum truck and a plumber were dispatched to respond to the spill. The vacuum truck was utilized to empty the contents within the secondary containment. The contaminated material was excavated and transported to Landfarm A in accordance with the Spill Contingency Plan.
