Re: Follow-up Report Spill #2025-223 – Release of 120 L of Sewage at the Meliadine Gold Project

Description of Incident

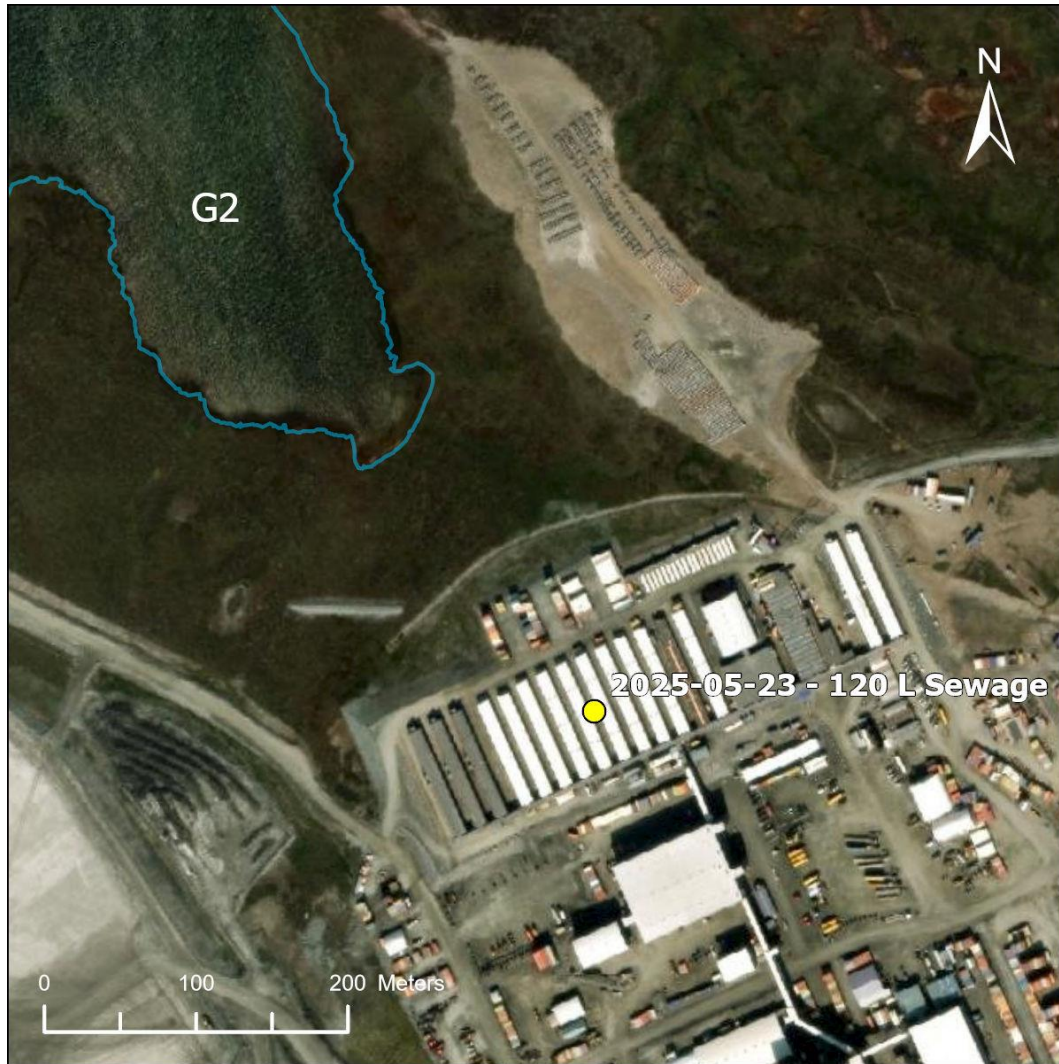
On May 23rd, 2025, at 06:30, approximately 120 L of sewage spilled onto the industrial pad outside the Wing 6 lift station. Upon inspection, it was discovered the lift station pump impeller was obstructed by non-compliant material, which led to the pump's failure and caused the lift station to overflow.

The spill occurred within the site's water management infrastructure, and as such, no waterbodies were impacted by the spill. The closest water body (Lake G2) is approximately 220 meters north, as seen in Figure 1.

Figure 1: Location of the spill and proximity to waterbodies.

Upon discovering the spill, a vacuum truck and a plumber were dispatched to respond to the spill. The vacuum truck was utilized to empty the contents within the secondary containment. The contaminated material was excavated and transported to Landfarm A in accordance with the Spill Contingency Plan.
