Re: Follow-up Report Spill #2025-359 – Release of 10 L of sewage at the Meliadine Gold Project

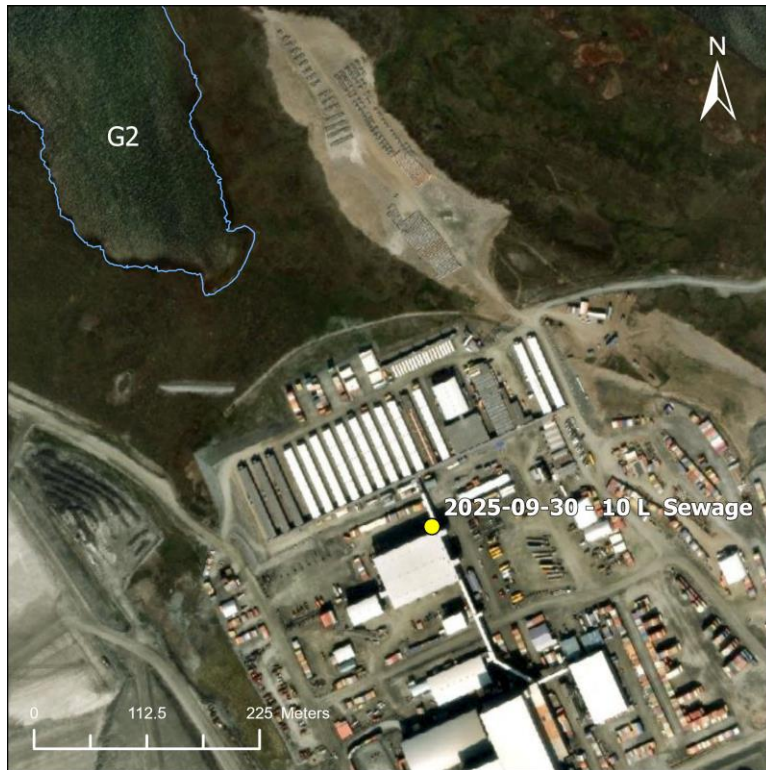
The spill occurred within the bounds of the site's runoff collection system. No water bodies were impacted by the spill. The closest water body (Lake G2) is approximately 315 meters northwest, as seen in Figure 1.

Figure 1: Location of the spill and proximity to waterbodies.
