November 2nd, 2025

Re: Follow-up Report Spill #2025-404 – Release of 140 L of hydraulic oil at the Meliadine Gold Project

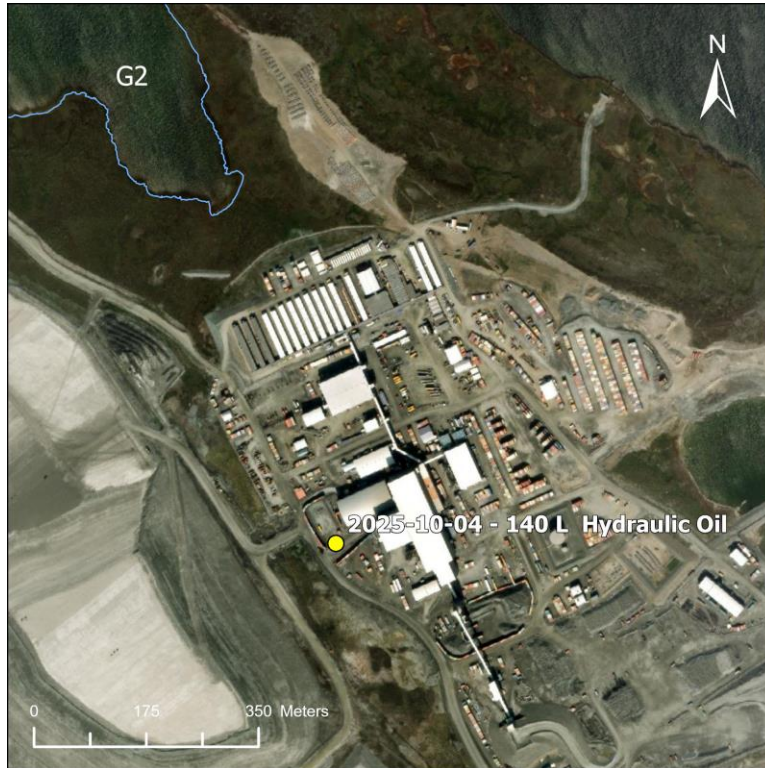
On October 4th, 2024, at approximately 9:00 PM, a worker in the Surface Operations department was operating a loader in the vicinity of the tailings dewatering building when a hydraulic line broke releasing approximately 140 L of hydraulic oil outside of the tailings dewatering building.

The spill occurred within the bounds of the site's runoff collection system. No waterbodies were impacted by the spill. The closest water body (Lake G2) is approximately 550 meters northwest, as seen in Figure 1.

Figure 1: Location of the spill and proximity to waterbodies.

- The hydraulic hose broke due to wear.

- Preventative maintenance programs for mobile equipment are ongoing and include inspection and replacement protocols to reduce the risk of wear-related failures.
- An advanced hose protection system utilizing silicone-coated textile material designed to shield hydraulic hoses from abrasion, heat exposure, and contamination from fine particulate matter will be trialed at the Meliadine mine site. The trial will assess its effectiveness in mitigating hose wear and reducing the risk of hydraulic failures in high-debris environments.
