Re: Follow-up Report Spill #2025-408 – Release of 100 L of Effluent Water Treatment Plant Sludge at the Meliadine Gold Project

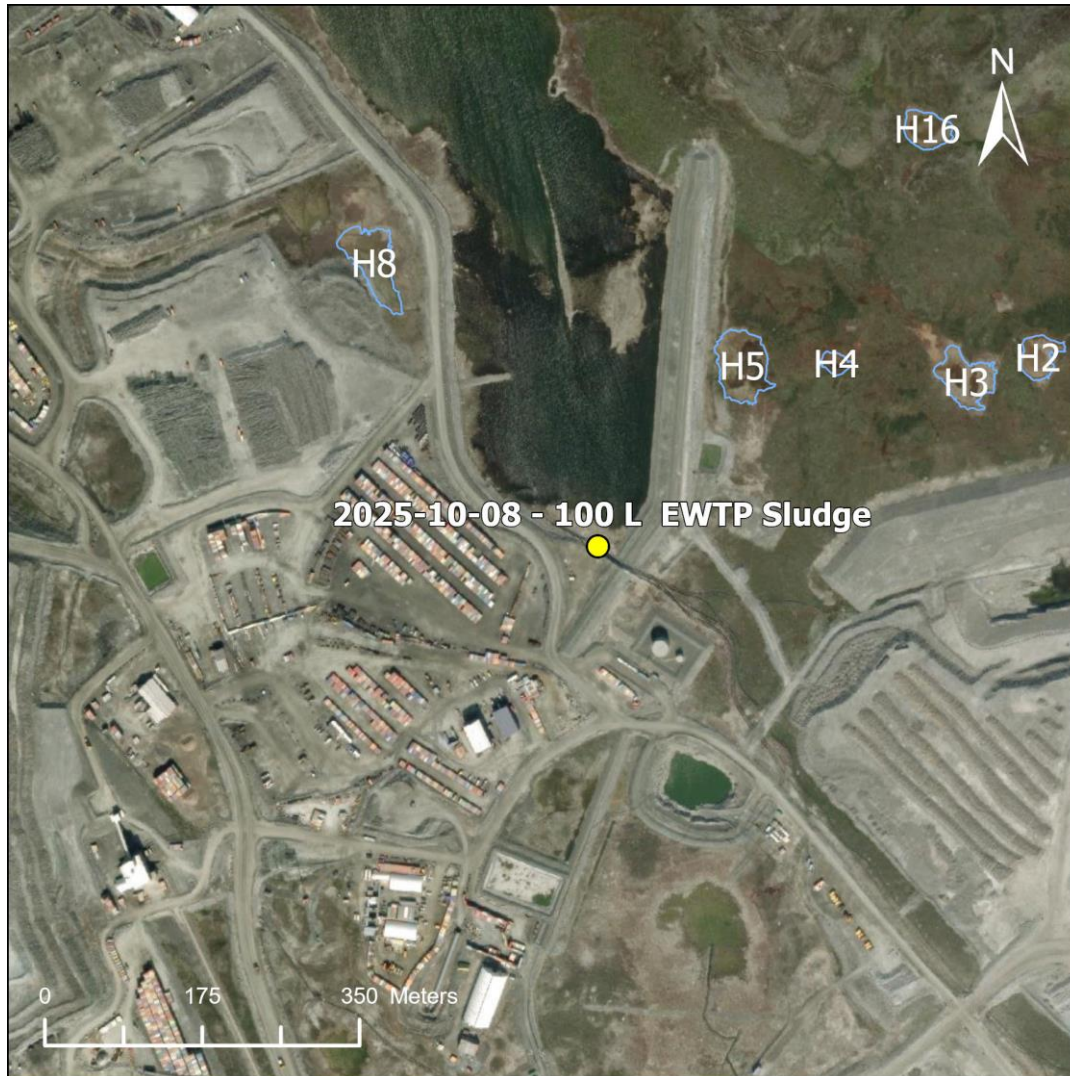
On October 8th, 2025, at approximately 1:30AM, it was noted during an inspection of the EWTP to TIRI02 sludge line that sludge was leaking from a hugger, releasing approximately 100 L of EWTP sludge onto the ground at the southern toe of CP1.

The spill occurred within the site's contact water management system, and as such, no water bodies were impacted by the spill. The closest natural water body, Lake H5, is approximately 220 meters northeast, as seen in Figure 1.

Figure 1: Location of the spill and proximity to waterbodies.
