November 30th, 2025

Re: Follow-up Report Spill #2025-425 – Release of 30 L of sewage at the Meliadine Gold Project

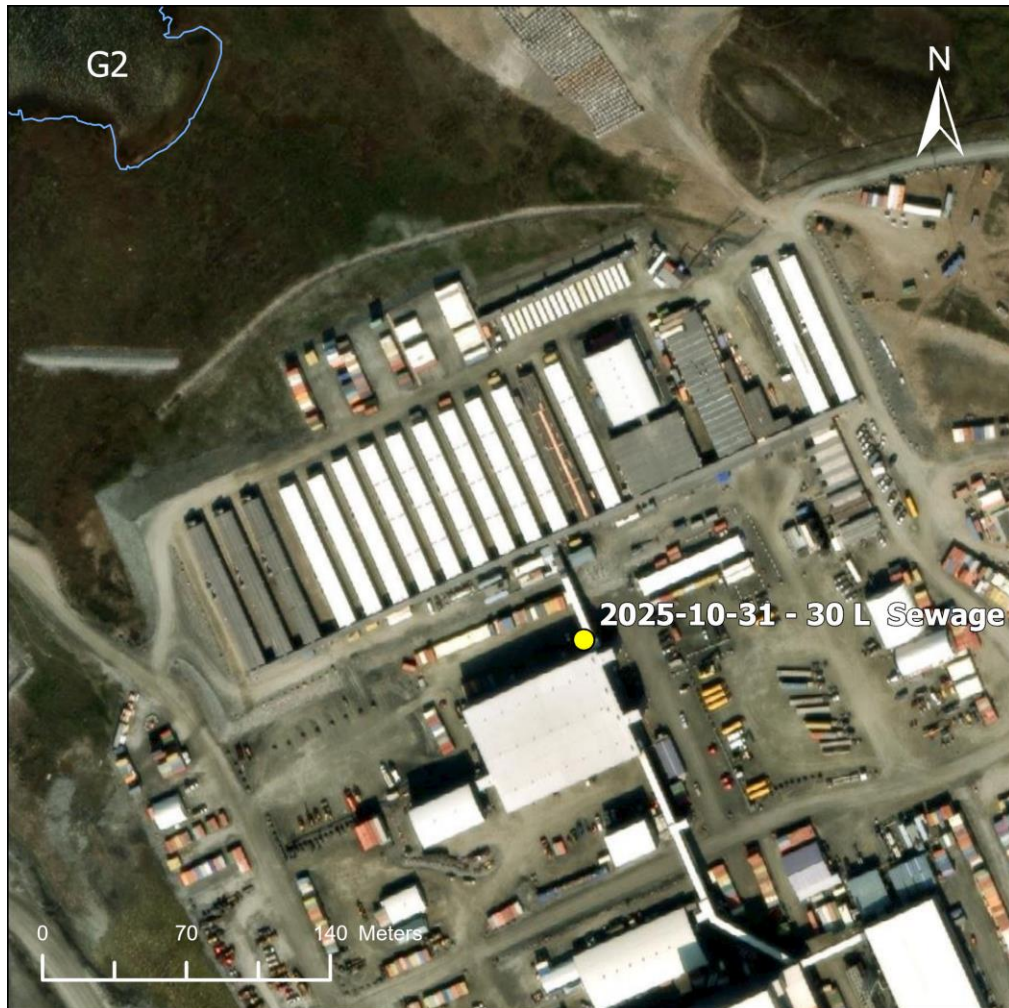
The spill occurred within the bounds of the site's runoff collection system. As such, no water bodies were impacted by the spill. The closest water body (Lake G2) is approximately 315 meters northwest, as seen in Figure 1.

Figure 1: Location of the spill and proximity to waterbodies.
