March 28, 2026

Re: Follow-up Report Spill #2026-052 – Release of 250 L of Glycol at the Meliadine Gold Project

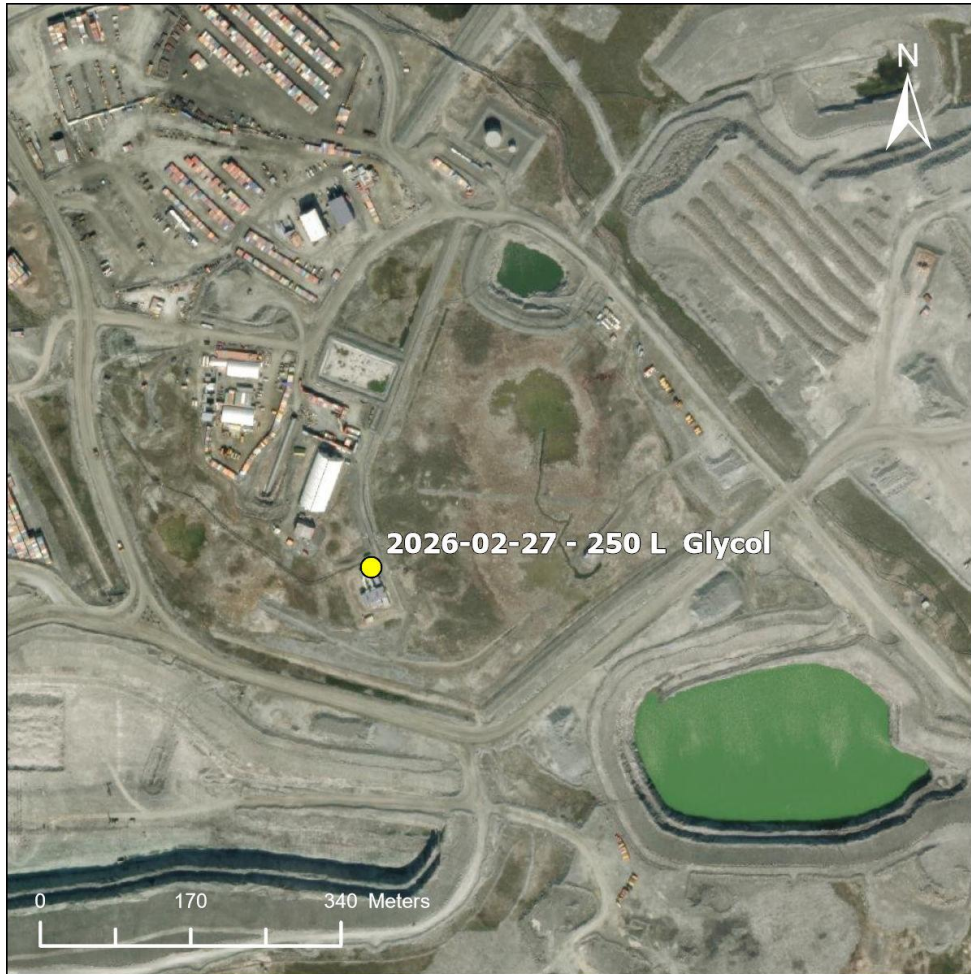
On February 27th, 2026, at approximately 10:30PM, 250 L of glycol was found on the ground at the east vent raise. The pump is in the pump house at the east vent raise. While most of the glycol was contained within the building, some escaped through the entryway.

The spill occurred within the bounds of the site's runoff collection system; no freshwater bodies were impacted or are at risk of being impacted by the spill. The closest freshwater body (Lake H5) is approximately 800 meters north.

Figure 1: Location of the spill and proximity to waterbodies.
