BAFFINLAND IRON MINES CORPORATION

MARY RIVER PROJECT

**APPENDIX 4. DETAILED HABITAT ASSESSMENTS AND SUMMARY OF RESULTS FOR RAILWAY AND TOTE ROAD REALIGNMENT STREAM CROSSINGS**

## Phase 2 Milne Rail Corridor Aquatic Habitat Assessment

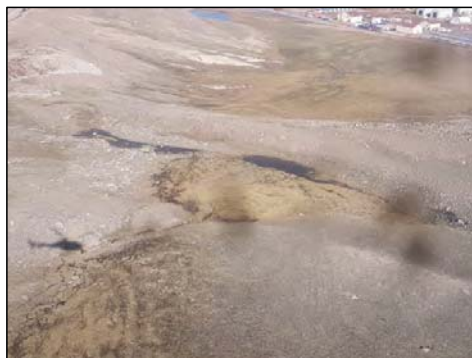
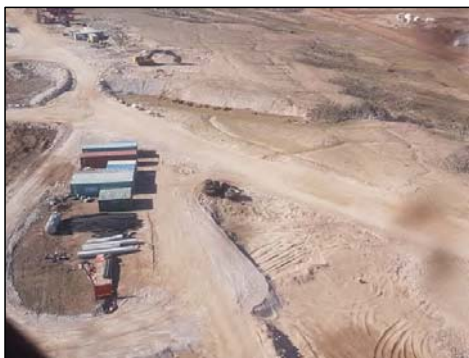
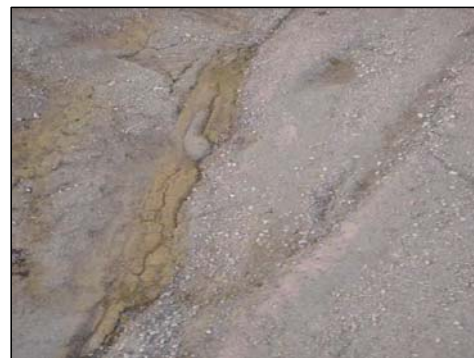
Both sites cross the same stream, which typically has low flows throughout the open-water period (based on observations from baseline studies at Milne Inlet). The two sites are also upstream of a previously identified permanent vertical barrier that is impassable under all flows with no access to overwintering habitat. The sites are never fish bearing.

**Figure 1.** Aerial views of CV-0-1 and CV-0-2 in late June near crossings (A) and showing nearby infrastructure (B) and in late August (C).

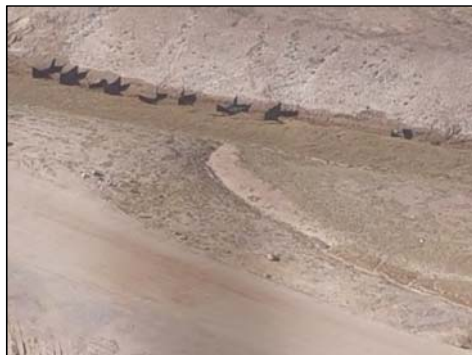
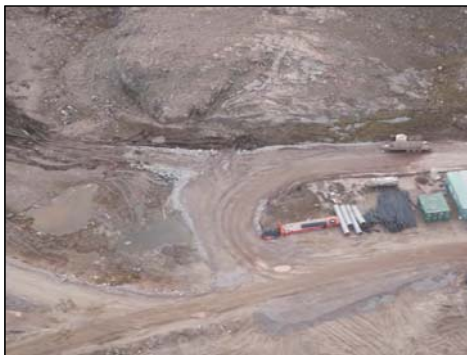
Crossing CV-0-3 was dry or nearly so in 2018, which is typical based on observations from Milne Inlet baseline and annual Tote Road studies of the area. The combination of low flows and vertical barriers downstream prevent all fish movements upstream from Phillips Creek.

**Figure 1.** Aerial views of CV-0-3 during summer (A) and fall (B).

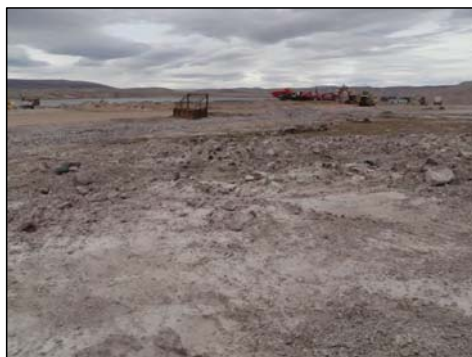
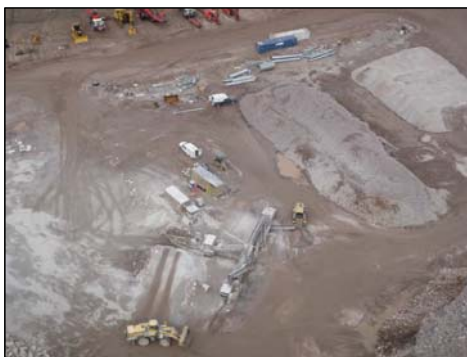
This was a dry spot surrounded by Milne Inlet Port Site infrastructure and equipment during the 2018 survey. There are multiple permanent barriers to fish movement between the site and Phillips Creek downstream. There is never aquatic habitat.

**Figure 1.** Summer ground (A) and fall aerial (B) views of CV-1-1.

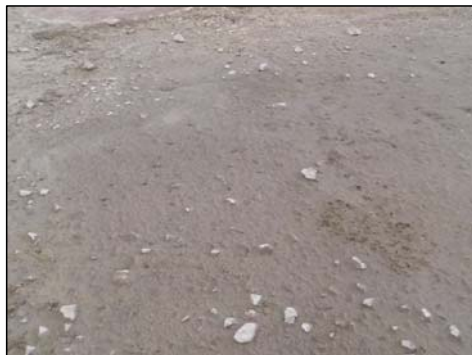
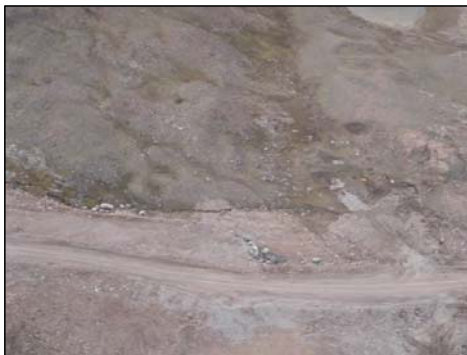
This was a dry creek bed during the 2018 survey. Based on previous surveys of Milne Inlet and Tote Road waterbodies, there are multiple permanent barriers to fish movement between the site and Phillips Creek downstream that are impassable under all flows. There is never aquatic habitat at this crossing.

**Figure 1.** Summer ground (A) and fall aerial (B) views of CV-1-2.

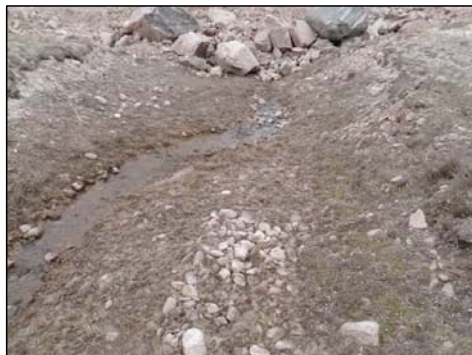
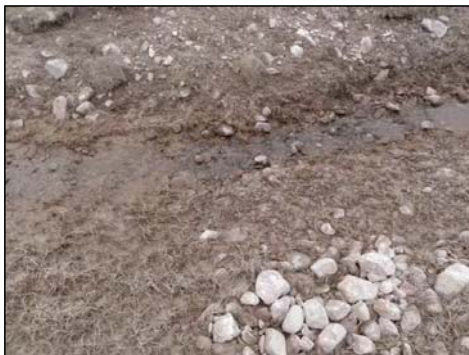
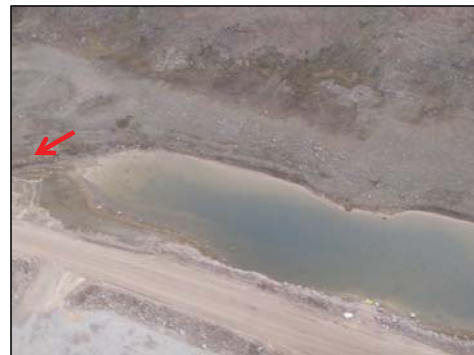
This crossing is the outflow of a small, shallow, fishless pond. The stream had very low flows in 2018 with a steep downstream gradient. There are multiple permanent barriers to fish movement between the site and Phillips Creek downstream that are impassable under all flows. There is never aquatic habitat at this crossing.

**Figure 1.** Views of CV-1-3 looking downstream towards a barrier (A) and across the stream (B) during summer, and a fall aerial (C) view of the upstream pond (arrow is the outlet crossing area).

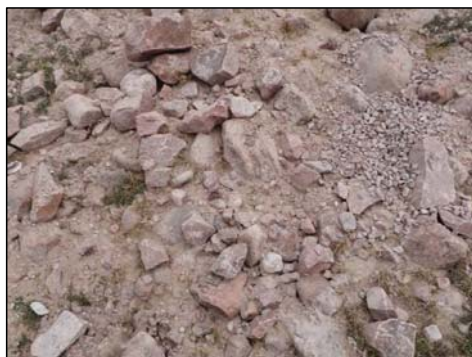
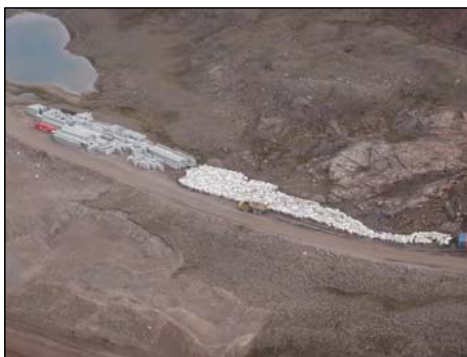
There was no water at this low point in 2018. There are multiple permanent vertical barriers to fish movement between the site and Phillips Creek downstream that are impassable under all flows. There is never aquatic habitat at this crossing.

**Figure 1.** Views of CV-1-4 during summer (A) and aerially during fall (B) showing the surrounding terrain.

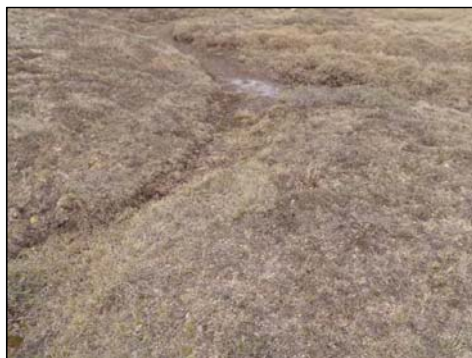
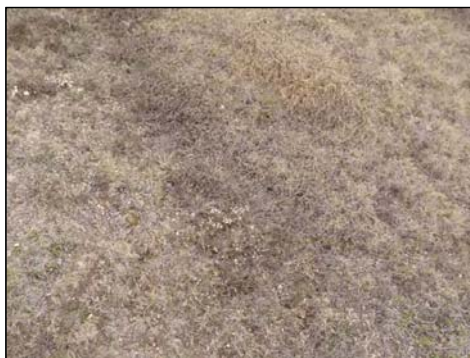
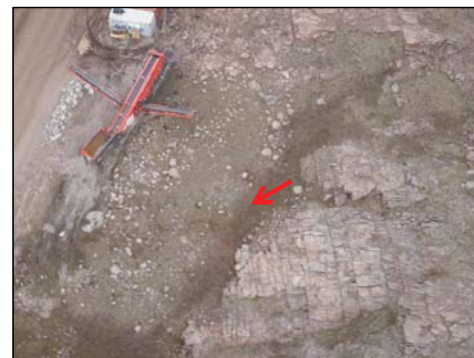
This crossing was a nearly dry low point in 2018. There is no connectivity to overwintering habitat and never aquatic habitat at this crossing.

**Figure 1.** Views of CV-1-5 during summer downstream (A), and at (B) the crossing (A) and aerially during fall (C) showing the surrounding terrain (arrow is the crossing).

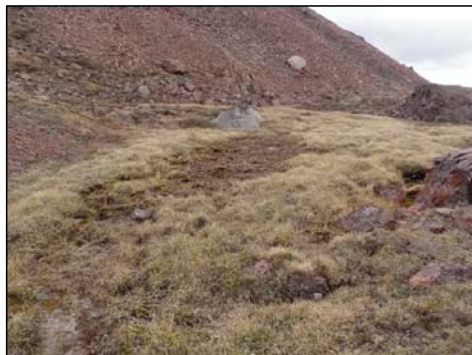
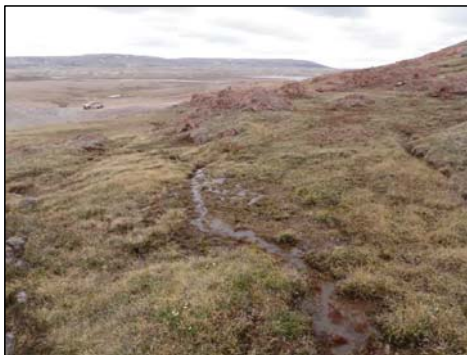
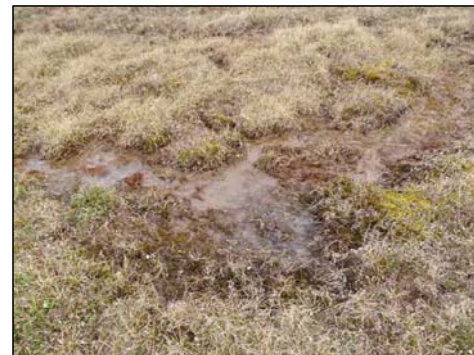
This crossing was nearly dry in 2018. In addition, there are permanent vertical barriers to fish movement between the site and Phillips Creek downstream that are impassable under all flows. There is never aquatic habitat at this crossing.

**Figure 1.** Views of CV-1-6 during summer, looking upstream (A) downstream (B) and across (C).

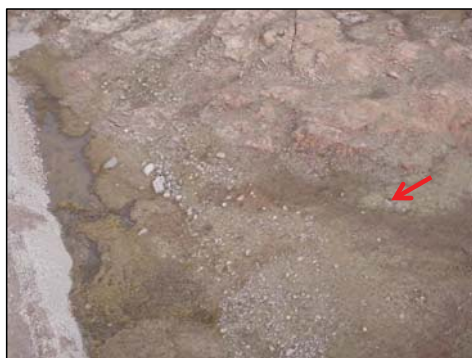
**Figure 2.** Aerial view of CV-1-6 during fall (arrow is the crossing area).

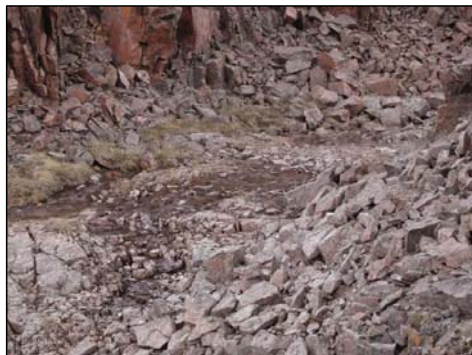
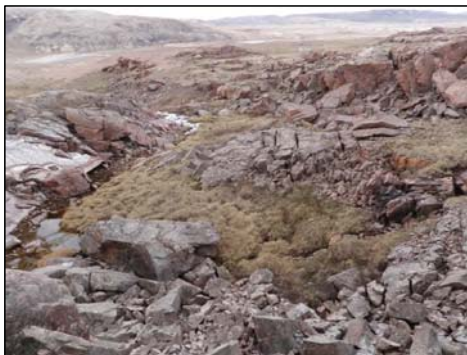
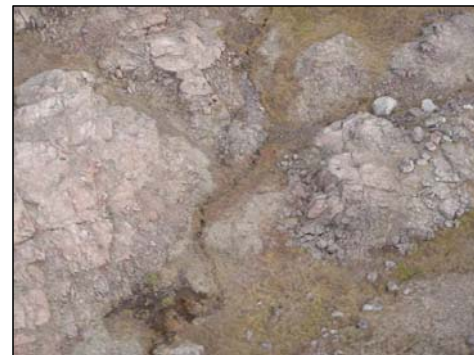
This crossing was nearly dry in 2018. In addition, there are permanent vertical barriers to fish movement between the site and Phillips Creek downstream that are impassable under all flows. There is never aquatic habitat at this crossing.

**Figure 1.** Views of CV-1-7 during summer, looking upstream (A) and downstream (B) from the crossing and a fall aerial view (C).

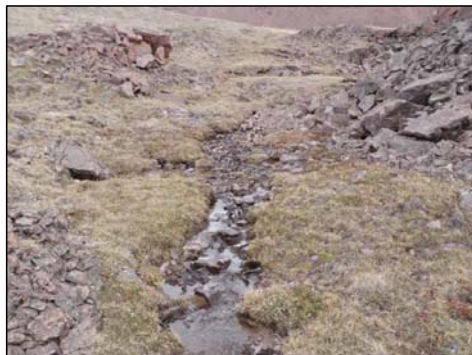
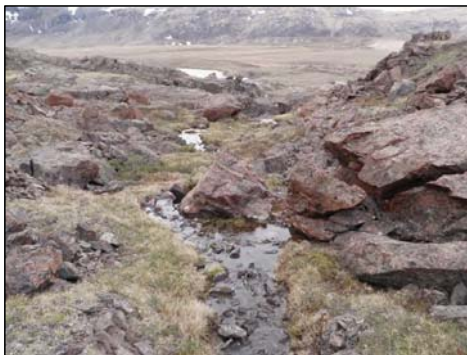
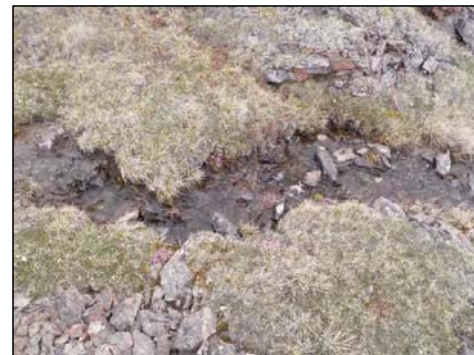
This stream was shallow, but maintained flows during the 2018 open-water period. However, there are several permanent vertical barriers to fish movement between the site and Phillips Creek downstream that are impassable under all flows. There is never aquatic habitat at this crossing.

**Figure 1.** Views of CV-1-8 during summer, looking upstream (A) downstream (B) and across (C).

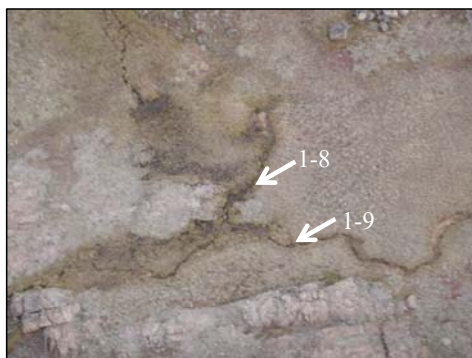
**Figure 2.** Aerial views of CV-1-8 and adjacent CV-1-9 during fall.

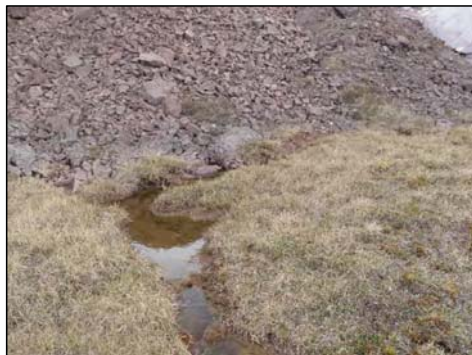
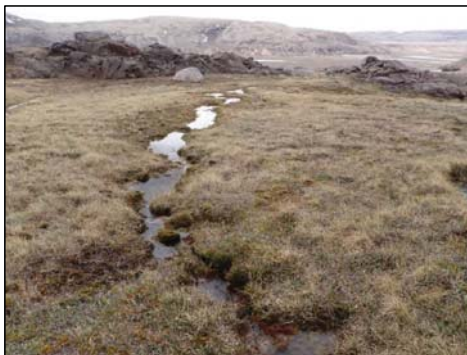
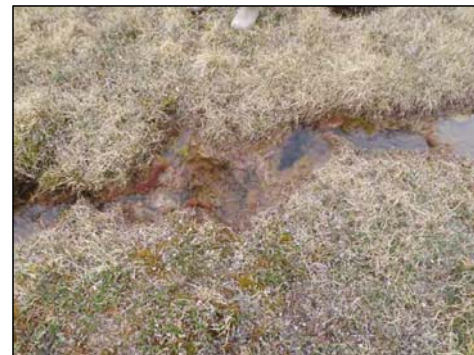
This stream was shallow, but maintained flows during the 2018 open-water period. However, there are several permanent vertical barriers to fish movement between the site and Phillips Creek downstream that are impassable under all flows. There is never aquatic habitat at this crossing.

**Figure 1.** Views of CV-1-9 during summer, looking upstream (A) downstream (B) and across (C).

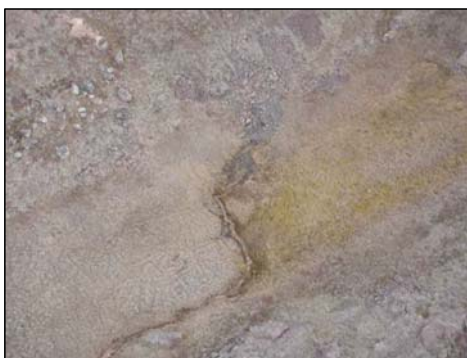
**Figure 2.** Aerial views of CV-1-9 and adjacent CV-1-8 (A) and the upstream end of CV-1-9 (B) during fall.

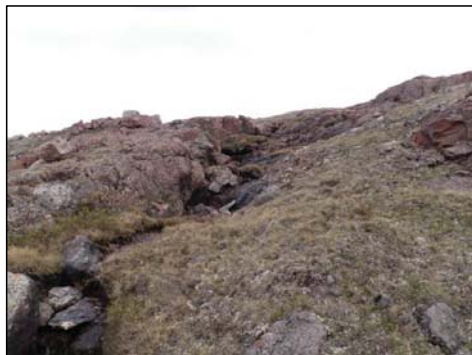
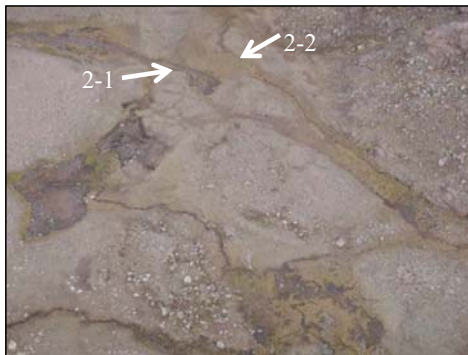
This stream was shallow, but maintained flows during the 2018 open-water period. However, there are several permanent vertical barriers to fish movement at the crossing and between the site and Phillips Creek downstream that are impassable under all flows. There is never aquatic habitat at this crossing.

**Figure 1.** Views of CV-2-1 during summer (A) and aerially, with nearby CV-2-2, during fall (B).

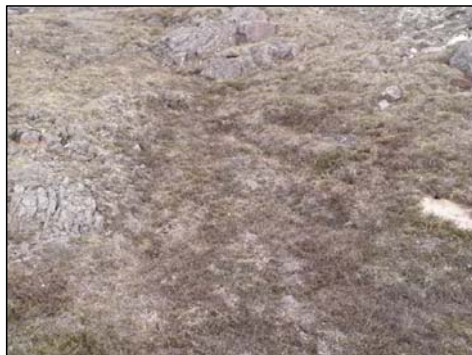
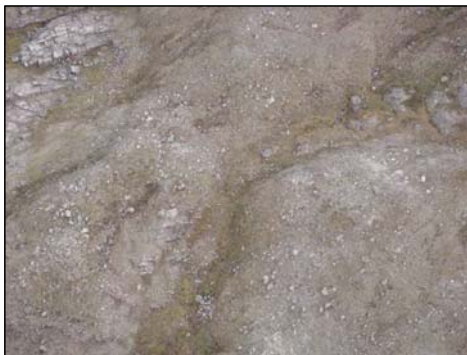
This stream was dry during the 2018 open-water period. In addition, there are several permanent vertical barriers to fish movement between the site and Phillips Creek downstream that are impassable under all flows. There is never aquatic habitat at this crossing.

**Figure 1.** Views of CV-2-2 during summer (A) and aerially during fall (B).

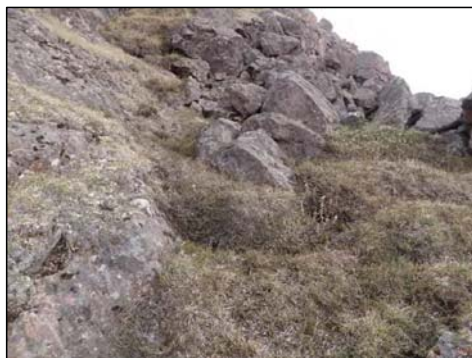
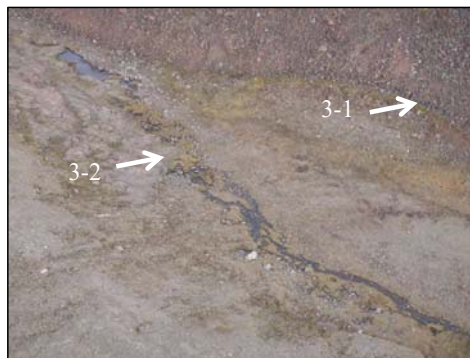
This crossing is a low point on a dry hillside. There is never aquatic habitat at this crossing.

**Figure 1.** Views of CV-3-1 during summer (A) and aerially, with nearby CV-3-2, during fall (B).

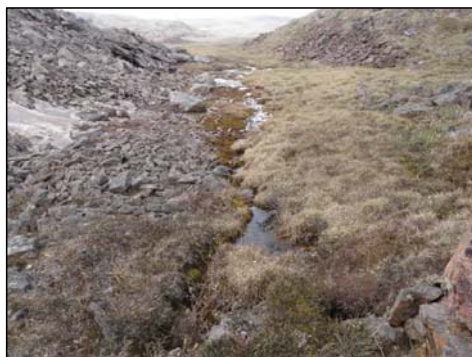
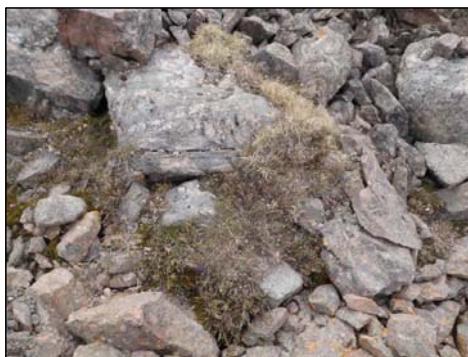
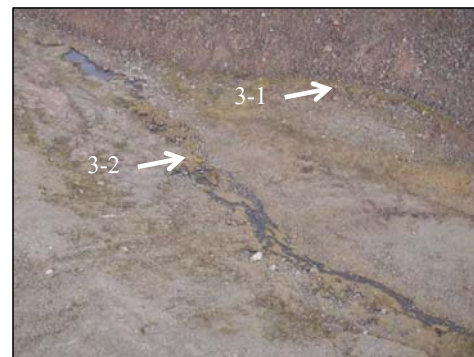
This crossing was shallow with low flows during 2018. There are both soft (subsurface flow, high gradient) and permanent (vertical drops) barriers to fish movement at and downstream of the crossing. There is never aquatic habitat at this crossing.

**Figure 1.** Views of CV-3-2 during summer downstream from (A) and at (B) the crossing, and aerially, with nearby CV-3-1, during fall (C).

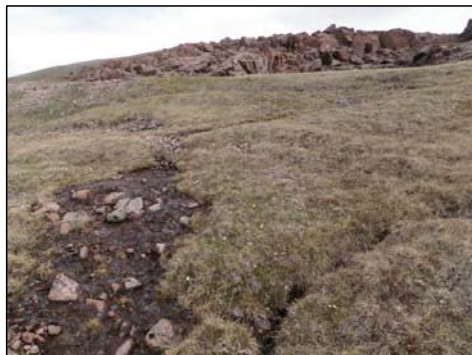
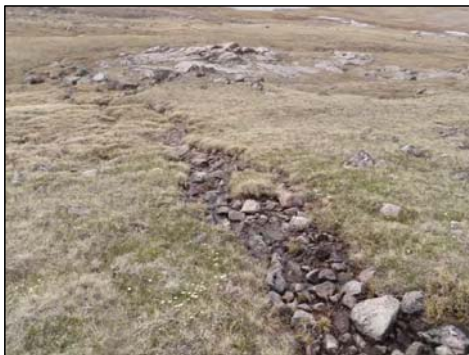
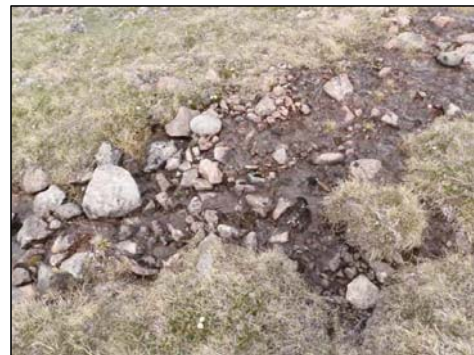
This crossing was shallow with low flows during 2018. There are both soft (subsurface flow, high gradient) and permanent (vertical drops) barriers to fish movement at and downstream of the crossing. There is never aquatic habitat at this crossing.

**Figure 1.** Views of CV-4-1 during summer, looking upstream (A) downstream (B) and across (C).

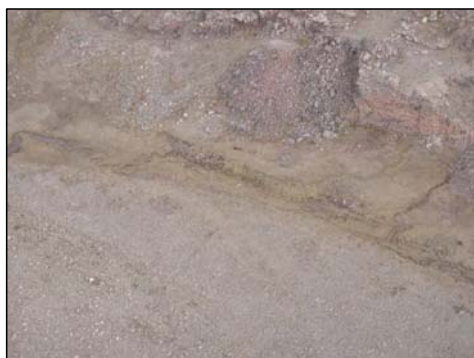
**A**  
**Figure 2.** Aerial view of CV-4-1 during fall.

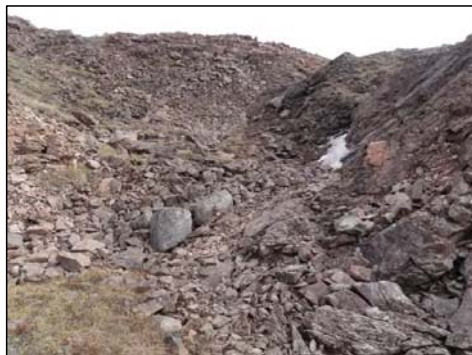
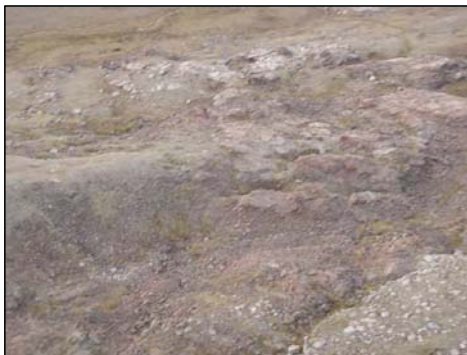
This crossing was nearly dry in 2018 and on a steep rocky hillside. There are permanent (vertical drop) barriers to fish movement at and downstream of the crossing. There is never aquatic habitat at this crossing.

**Figure 1.** Views of CV-4-2 during summer (A) and aerially during fall (B).

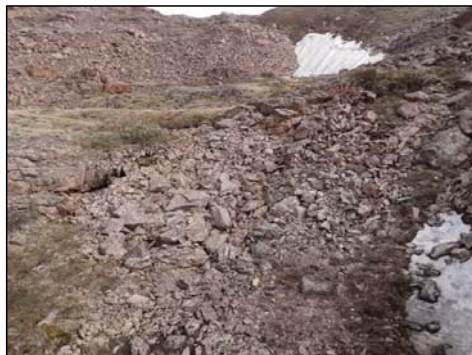
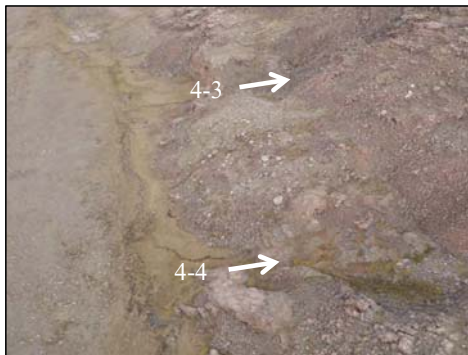
This crossing was nearly dry in 2018 and on a steep rocky hillside. There are permanent (vertical drop) barriers to fish movement at and downstream of the crossing. There is never aquatic habitat at this crossing.

**Figure 1.** Views of CV-4-3 during summer (A) and aerially, with nearby CV-4-4, during fall (B).

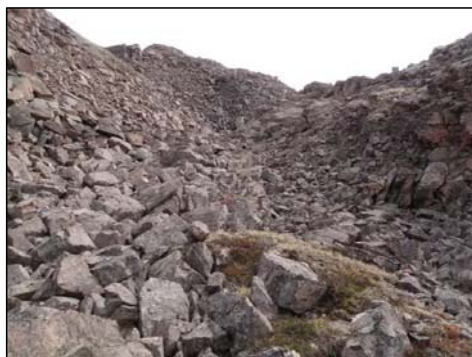
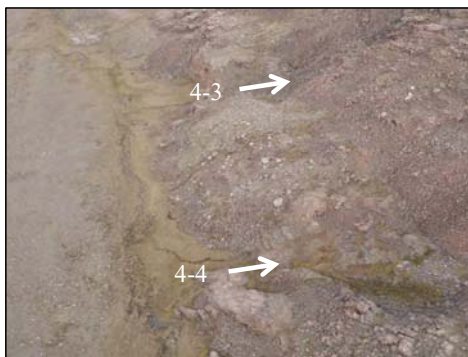
This crossing was dry in 2018 and on a steep rocky hillside. There are permanent (vertical drop) barriers to fish movement at and downstream of the crossing. There is never aquatic habitat at this crossing.

**Figure 1.** Views of CV-4-4 during summer (A) and aerially, with nearby CV-4-3, during fall (B).

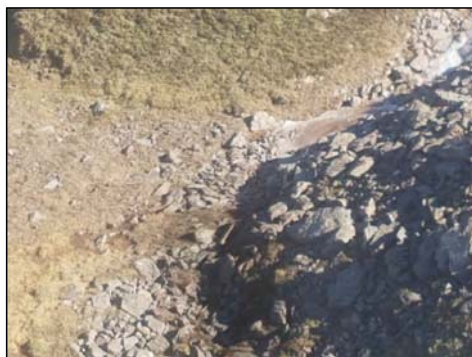
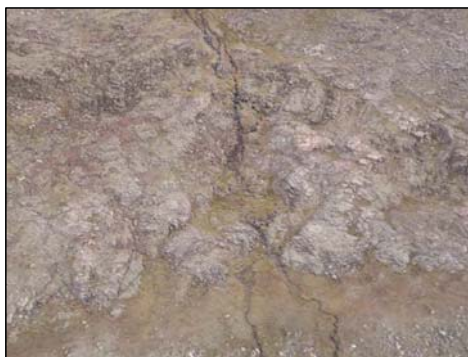
This crossing was nearly dry in 2018 and on a steep rocky hillside. There are permanent (vertical drop) barriers to fish movement downstream of the crossing. There is never aquatic habitat at this crossing.

**Figure 1.** Aerial views of CV-4-5 during summer (A) and fall (B).

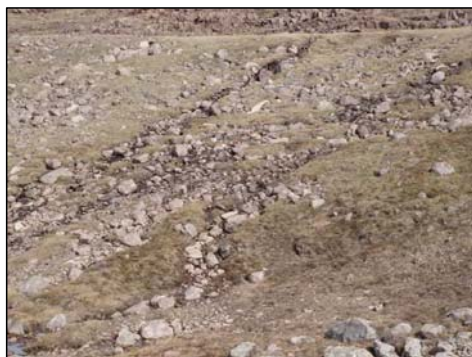
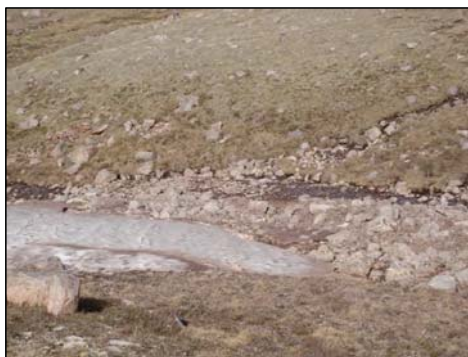
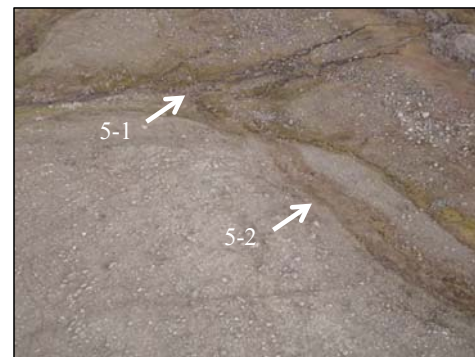
This crossing was nearly dry in 2018 and on a steep rocky hillside. There are permanent (vertical drop) barriers to fish movement downstream of the crossing. There is never aquatic habitat at this crossing.

**Figure 1.** Views of CV-5-1 during summer looking upstream (A) and downstream (B) from the crossing, and an aerial view during fall (C) with nearby CV-5-2.

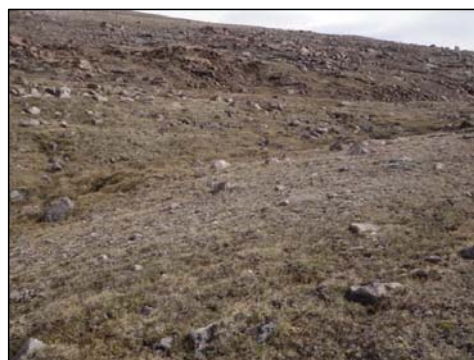
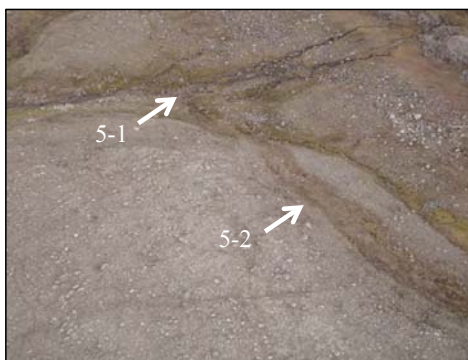
This crossing is a dry spot on a hillside. There is never aquatic habitat at this crossing.

**Figure 1.** Views of CV-5-2 during summer (A) and an aerial view during fall (B) with nearby CV-5-1.

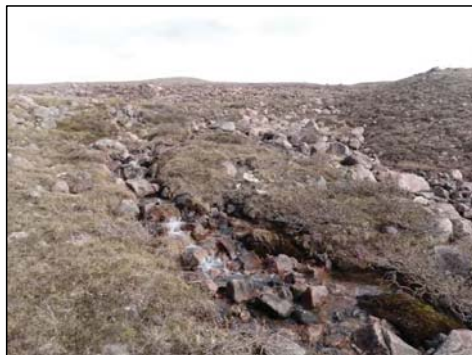
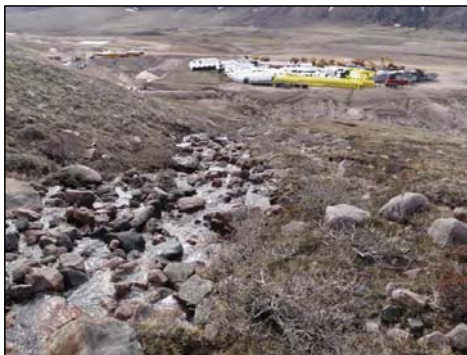
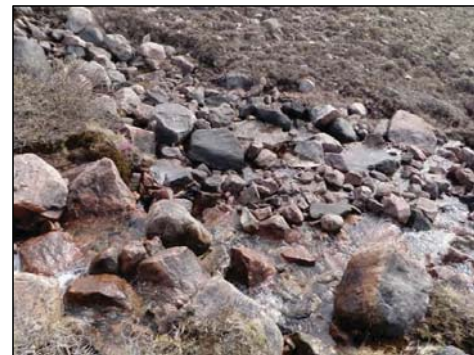
This stream on a steep hillside had low flows in 2018. In addition there are several permanent vertical barriers to fish movement at the crossing and between the site and Phillips Creek downstream that are impassable under all flows. There is never aquatic habitat at this crossing.

**Figure 1.** Views of CV-5-3 during summer, looking upstream (A) downstream (B) and across (C).

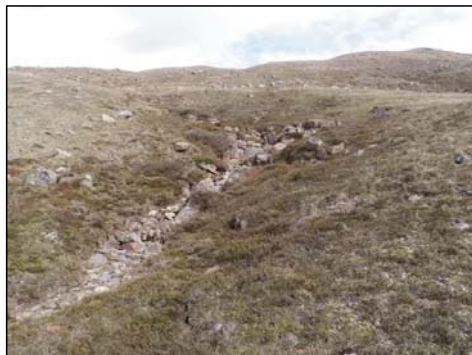
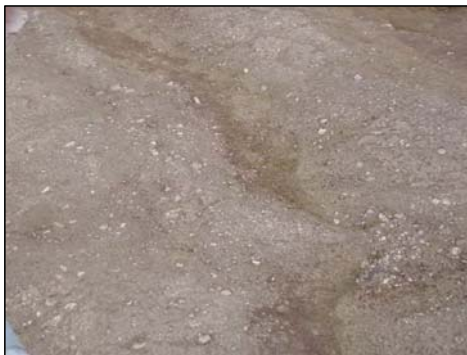
This steep stream was nearly dry in 2018. In addition there are several permanent vertical barriers to fish movement at the crossing and between the site and Phillips Creek downstream that are impassable under all flows. There is never aquatic habitat at this crossing.

**Figure 1.** Views of CV-5-4 during summer (A) and aerially during fall (B).

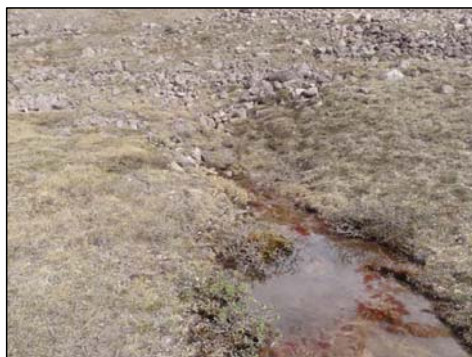
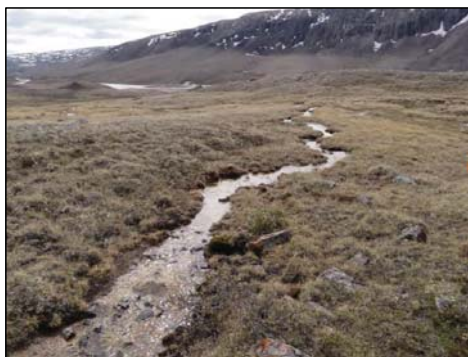
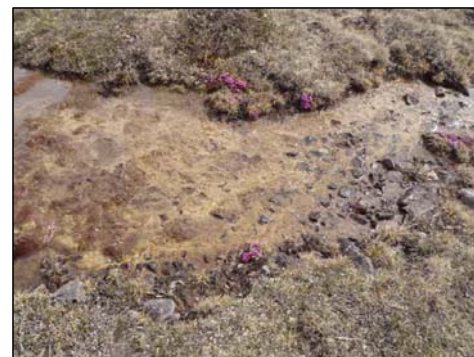
This stream had flows in summer, but was largely dry in fall 2018. There are permanent vertical barriers to fish movement upstream of the crossing and between the Tote Road and Phillips Creek downstream that are impassable under all flows. There is never aquatic habitat at this crossing.

**Figure 1.** Views of CV-5-5 during summer looking upstream (A) downstream (B) and across (C).

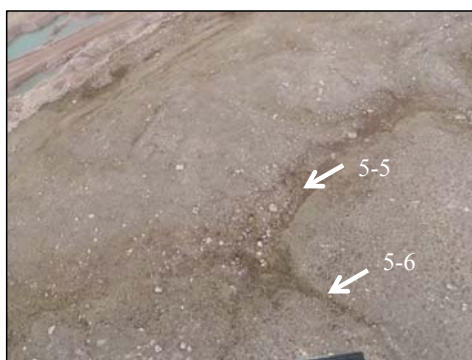
**Figure 2.** Aerial view of CV-5-5 and nearby 5-6 during fall.

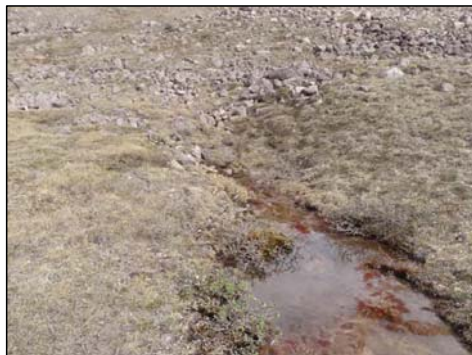
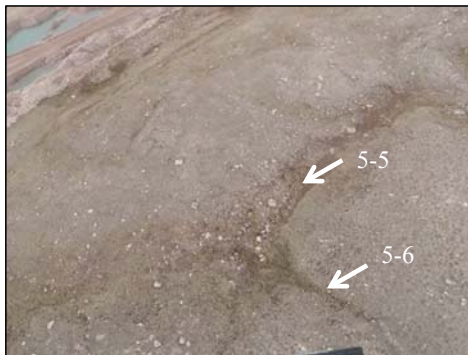
This stream was nearly dry in 2018. In addition, there are permanent vertical barriers to fish movement upstream of the crossing and between the Tote Road and Phillips Creek downstream that are impassable under all flows. There is never aquatic habitat at this crossing.

**Figure 1.** Views of CV-5-6 during summer (A) and fall with nearby CV-5-5 (B).

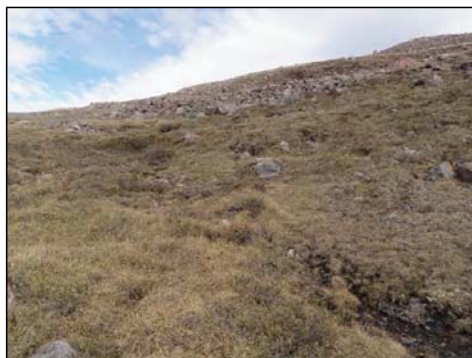
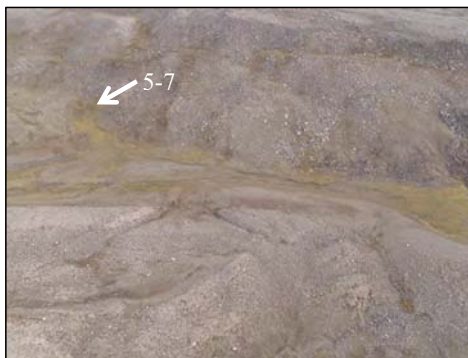
This site was a dry hillside in 2018. There is never aquatic habitat at this crossing.

**Figure 1.** Views of CV-5-7 during summer (A) and aerially during fall (B).

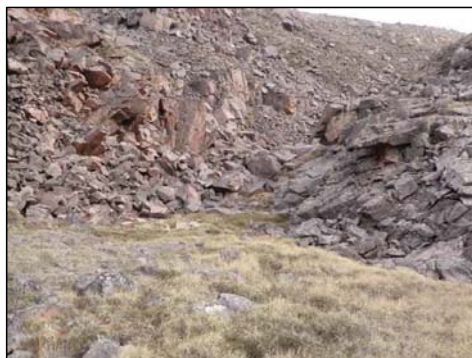
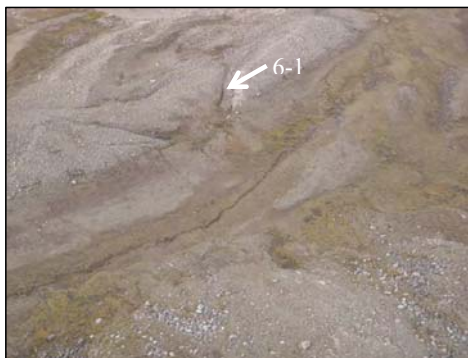
This site was a dry hillside in 2018. There is never aquatic habitat at this crossing.

**Figure 1.** Views of CV-6-1 during summer (A) and aerially during fall (B).

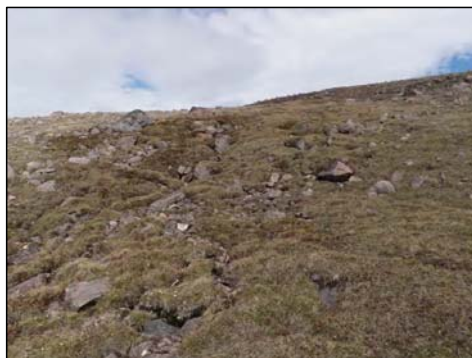
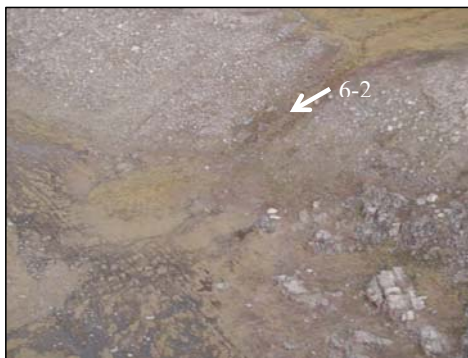
This site was a nearly dry low point on a hillside in 2018. There is never aquatic habitat at this crossing.

**Figure 1.** Views of CV-6-2 during summer (A) and aerially during fall (B).

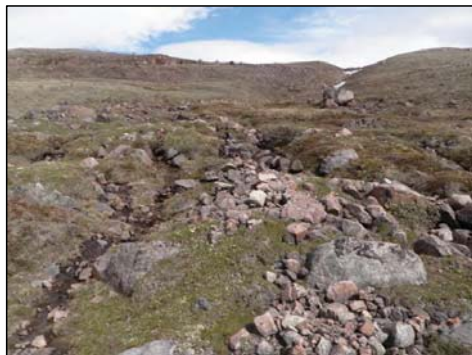
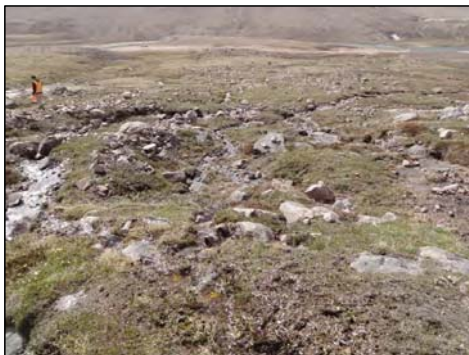
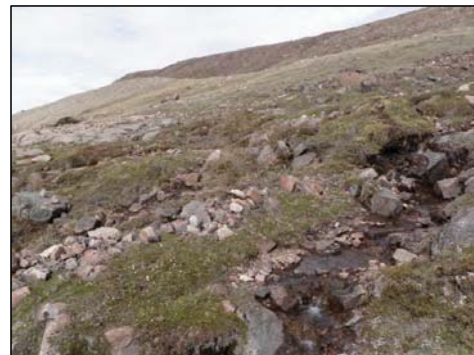
This is a steep, shallow stream. In addition, there are permanent vertical barriers to fish movement between the site and Phillips Creek downstream that are impassable under all flows. There is never aquatic habitat at this crossing.

**Figure 1.** Views of CV-6-3 during summer, looking upstream (A) downstream (B) and across (C).

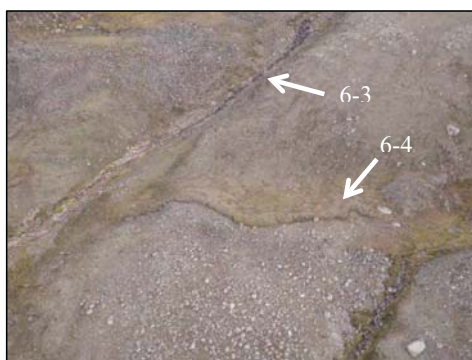
**Figure 2.** Aerial view of CV-6-3 and nearby 6-4 during fall.

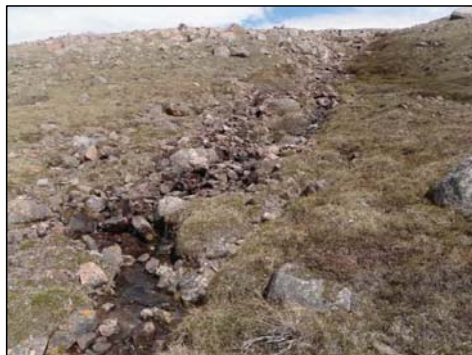
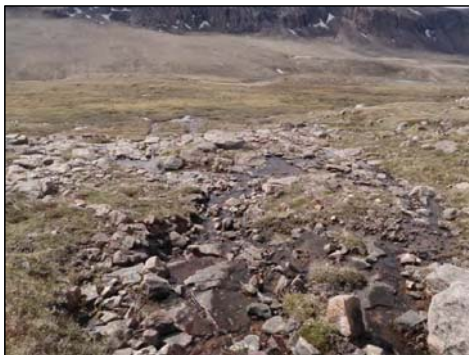
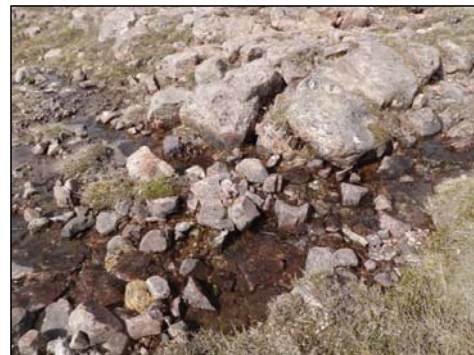
This is a steep, shallow stream. In addition, there are permanent vertical barriers to fish movement between the site and Phillips Creek downstream that are impassable under all flows. There is never aquatic habitat at this crossing.

**Figure 1.** Views of CV-6-4 during summer, looking upstream (A) downstream (B) and across (C).

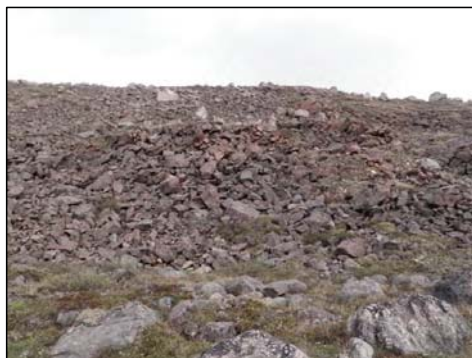
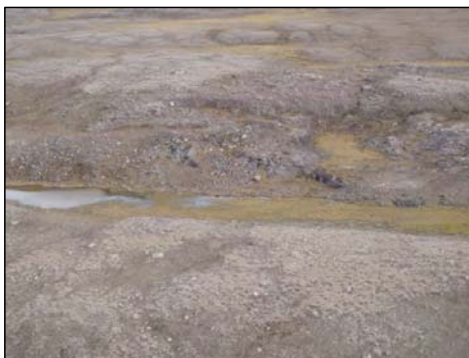
This site is a steep, dry low point on a hillside near a flat marshy area. There is never aquatic habitat at this crossing.

**Figure 1.** Views of CV-7-1 during summer (A) and aerially during fall (B).

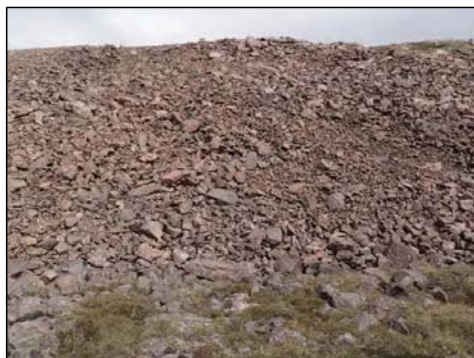
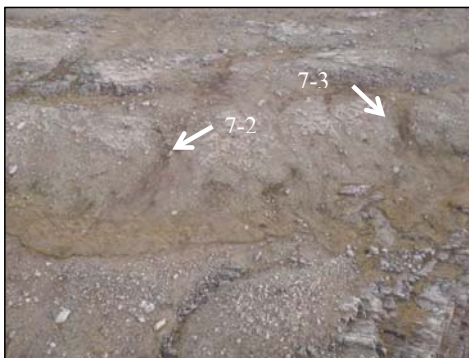
This site is a steep, dry low point on a hillside near a flat marshy area. There is never aquatic habitat at this crossing.

**Figure 1.** Views of CV-7-2 during summer (A) and aerially with nearby 7-3 during fall (B).

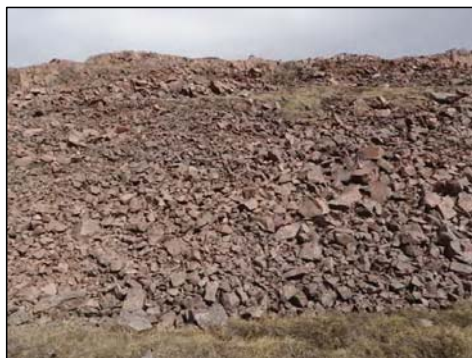
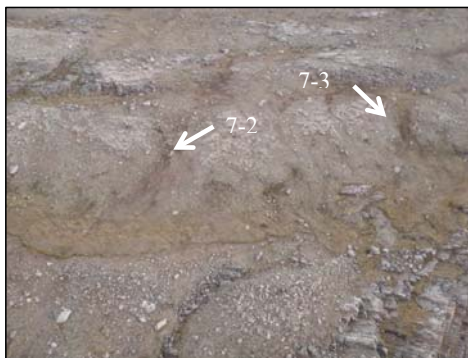
This site is a steep, dry low point on a hillside near a flat marshy area. There is never aquatic habitat at this crossing.

**Figure 1.** Views of CV-7-3 during summer (A) and aerially with nearby 7-2 during fall (B).

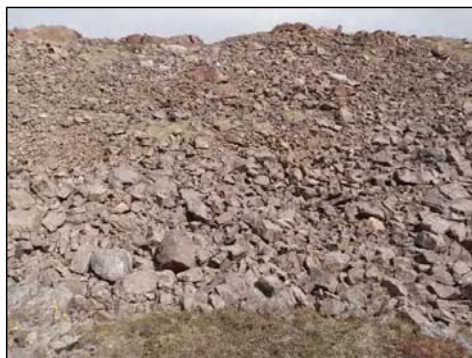
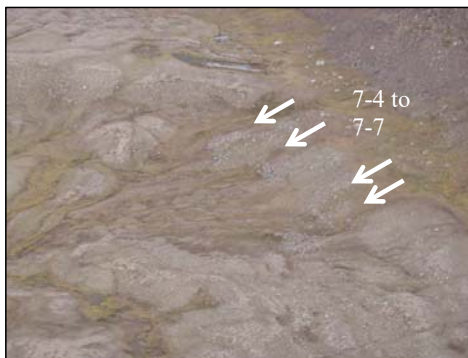
This site is a steep, dry low point on a hillside near a flat marshy area. There is never aquatic habitat at this crossing.

**Figure 1.** Views of CV-7-4 during summer (A) and aerially with several nearby crossings during fall (B).

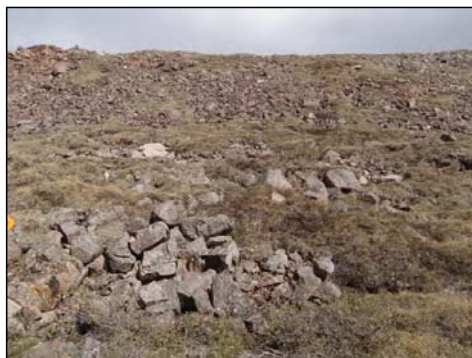
A

This site is a steep, dry low point on a hillside near a flat marshy area. There is never aquatic habitat at this crossing.

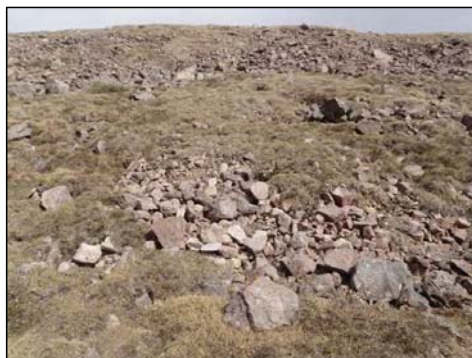
**A**

This site is a steep, dry low point on a hillside near a flat marshy area. There is never aquatic habitat at this crossing.

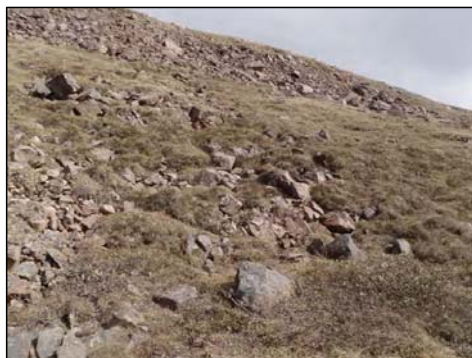
**A**

This site is a steep, dry low point on a hillside near a flat marshy area. There is never aquatic habitat at this crossing.

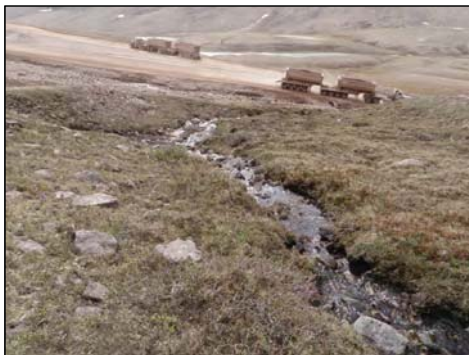
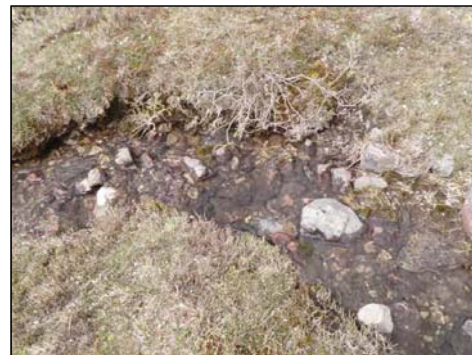
This small stream maintains flows throughout the open-water period, but there is a very steep gradient and vertical barriers between the rail crossing and Phillips Creek downstream. Fish have never been captured or observed in this stream during annual Tote Road monitoring and there is no fish habitat use in the vicinity of the rail crossing.

**Figure 1.** Summer views of CV-8-0 at the rail crossing; (A) looking upstream; (B) looking downstream; and (C) looking across.

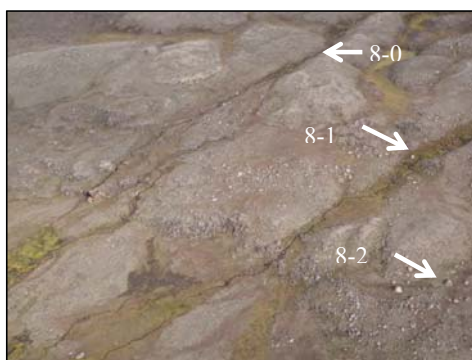
**Figure 2.** Aerial views of CV-8-0 and nearby crossings CV-8-1 and 8-2 during fall (A).

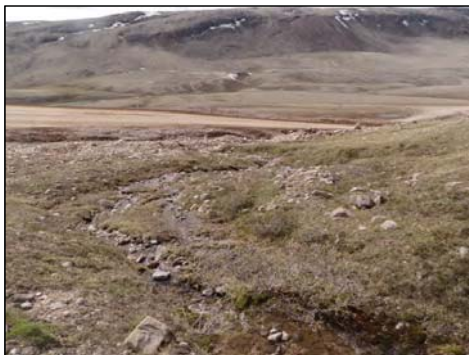
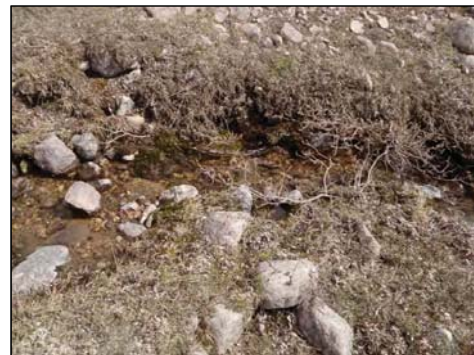
This small stream maintains flows throughout the open-water period, but there is a very steep gradient and vertical barriers between the rail crossing and Phillips Creek downstream. Fish have never been captured or observed in this stream during annual Tote Road monitoring and there is no fish habitat use in the vicinity of the rail crossing.

**Figure 1.** Summer views of CV-8-1 at the rail crossing; (A) looking upstream; (B) looking downstream; and (C) looking across.

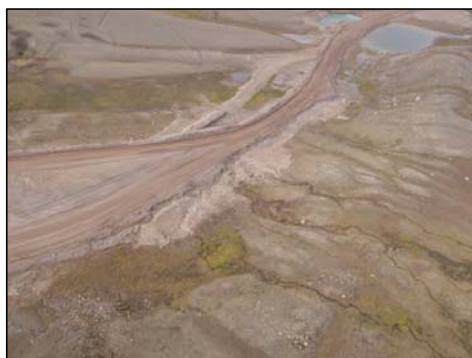
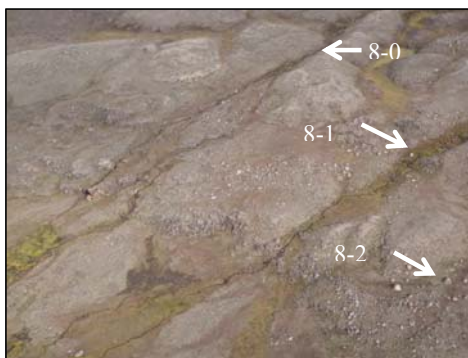
**Figure 2.** Aerial views of CV-8-1 and nearby crossings CV-8-0 and 8-2 during fall; (A) and (B).

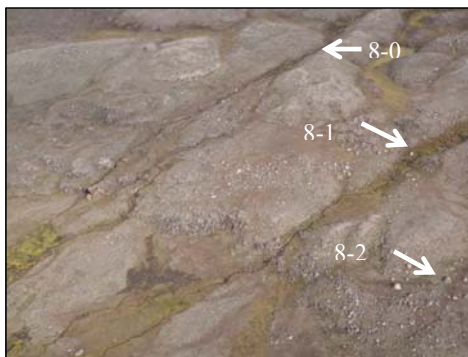
This site was moist throughout the open-water period in 2018, but there is a very steep gradient and permanent vertical barriers between the rail crossing and Phillips Creek downstream. Fish have never been captured or observed in this stream during annual Tote Road monitoring and there is no fish habitat use in the vicinity of the rail crossing.

**Figure 1.** Views of CV-8-2 at the rail crossing during summer (A) and, aerially with nearby 8-0 and 8-1, during fall (B).

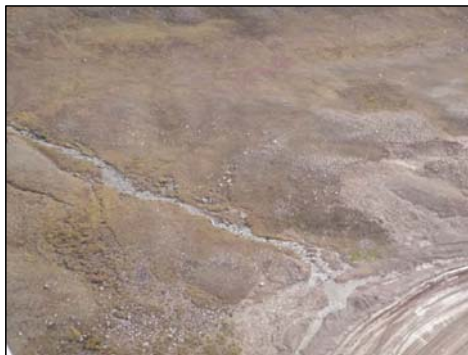
This shallow rail crossing is immediately upstream of the Tote Road. There are permanent vertical barriers between the rail crossing and Phillips Creek downstream. Fish have never been captured or observed in this stream during annual Tote Road monitoring and there is no fish habitat use in the vicinity of the rail crossing.

**Figure 1.** Views of CV-8-3 at the rail crossing during summer (A) and aerially during fall (B).

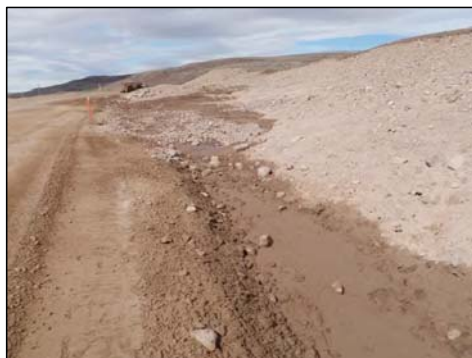
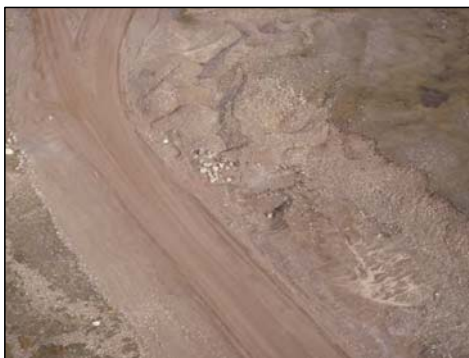
This site is a roadside ditch. There is never aquatic habitat at this crossing.

**Figure 1.** Views of CV-8-4 at the rail crossing during summer (A) and aerially during fall (B).

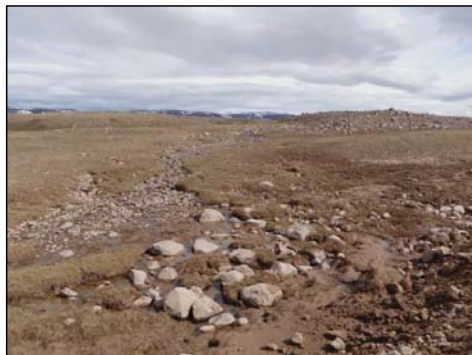
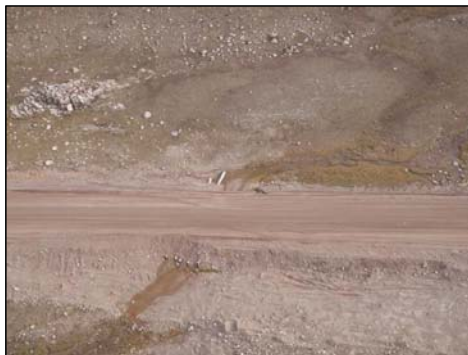
This stream had low flows during both surveys. It flows into a fishless pond downstream of the Tote Road and then into Phillips Creek. In addition to several soft barriers (subsurface flow), there is a permanent vertical barrier between the pond and Phillips Creek preventing fish access to the rail site. There is never aquatic habitat at this crossing.

**Figure 1.** Views of CV-9-1 at the rail crossing during summer (A) and aerially during fall (B).

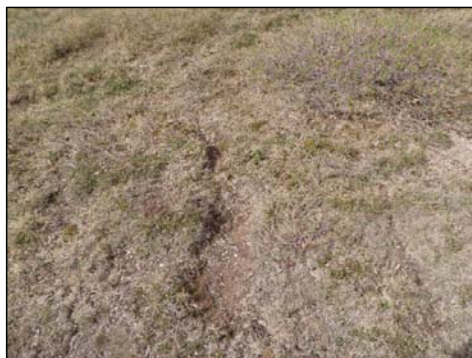
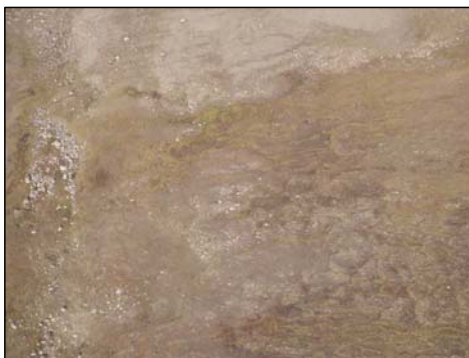
This is a dry, low point on a hillside. There is never aquatic habitat at this crossing.

**Figure 1.** Views of CV-10-1 at the rail crossing during summer (A) and aerially during fall (B).

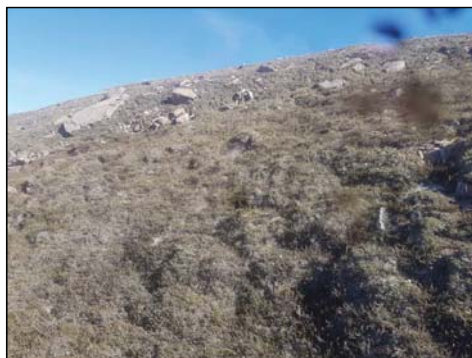
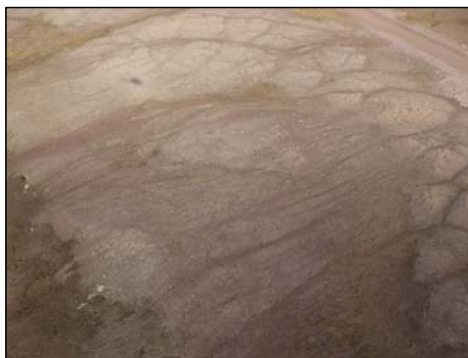
This site is a dry, low point that may collect some snowmelt in early spring, but never provides aquatic habitat.

**Figure 1.** Views of the CV-10-2 low point in late June (A) and an aerial image showing surrounding terrain in late August (B).
